# Small-Scale Heritage Features Survey

Technical Report: Crosby Garrett  
November 2023

WESTMORLAND DALES

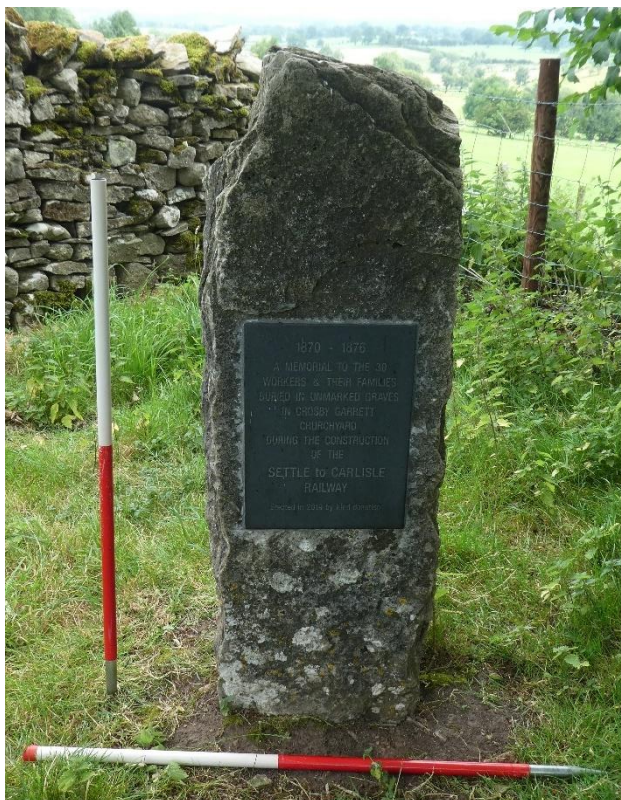
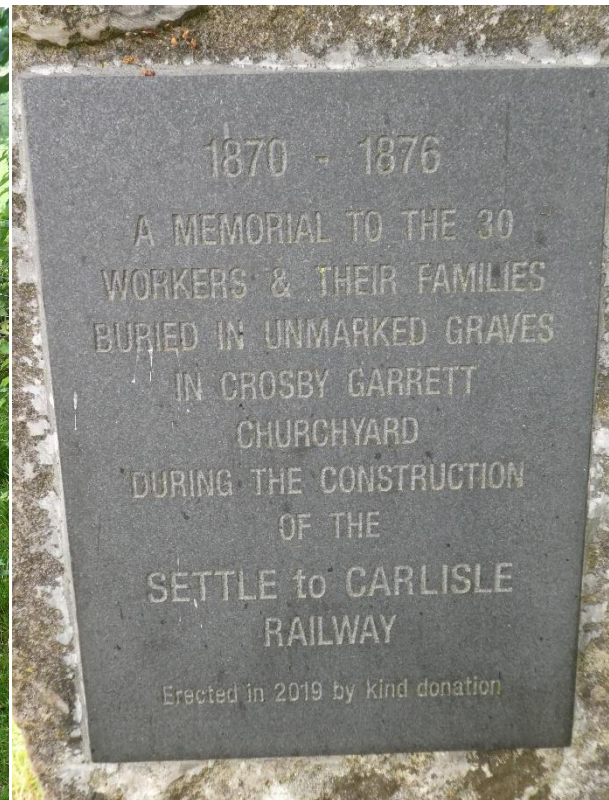
4.10 The first of these - C03 - is a single limestone gate stoop which is located in the north-east corner of St Andrew's churchyard. The stoop has an inscribed plaque attached to its front face (Figure 6).

Figure 6: Image showing the memorial to the railway workers located in St Andrew's Churchyard.

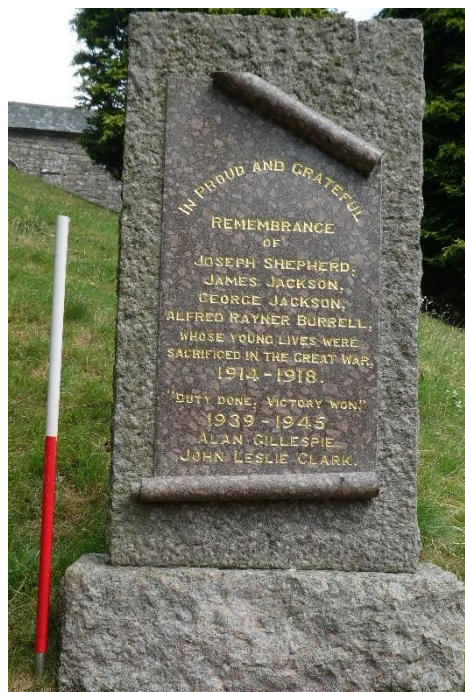
4.12 A First and Second World War memorial (C033, Figure 8) is located in the south of St Andrew's Church yard, not far from the pathway and has a series of steps leading up to it. The memorial is made from Shap granite and is set on a plinth. The centre section is polished and shaped like a scroll with an inscription inlaid with

Figure 8: Image showing WWI and WWII war memorial.

gold leaf. The memorial is in good condition and wreaths are actively laid there during remembrance services.

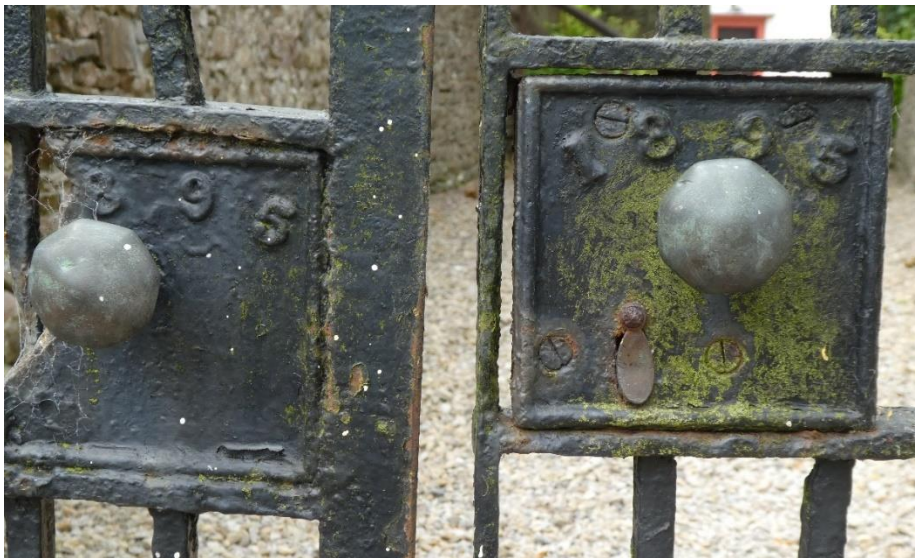
4.13 Two metal lock plates (C034, Figure 9) with the date “1895” either embossed or cast onto them were identified on a set of gates. The right lock plate is in good condition, while the left is broken on the outside edge so the “1” is missing. The gates are associated with some former stabling (MYD64468; 1145023) and the Old Rectory (MYD66870; 1145022) and are directly mentioned as part of the formers Grade II listing (1145023). However, no reference to the significance of the date is mentioned in the listing or elsewhere.

*Figure 9: Image showing the dated lock plates outside the Old Rectory.*

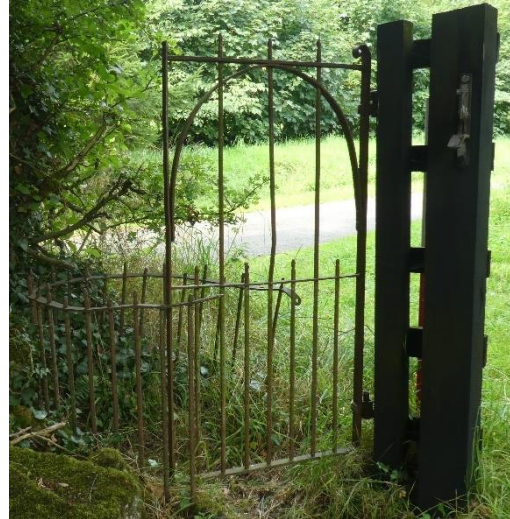
4.16 The gate was recorded as being in 'poor' condition as part of the metal arms have been cut (Figure 11). Nonetheless, it can be speculated that they might have been the work of the former blacksmith based on their location.

*Figure 10: Image showing the half-round kissing gate in Crosby Garrett, showing the arms which have been partly cut.*

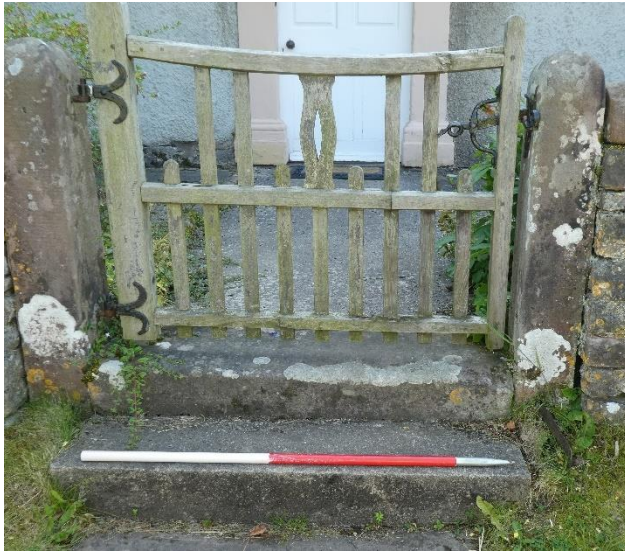
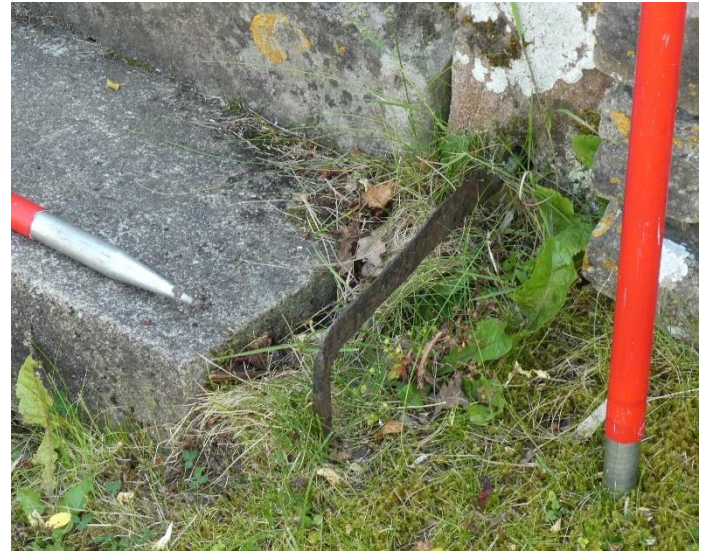
*Figure 12: Image showing the boot scraper (C006c) to the right of steps leading to a possible former farmstead and connected to the gate stoop (C006b). Also visible is some interesting metal gate attachments.*

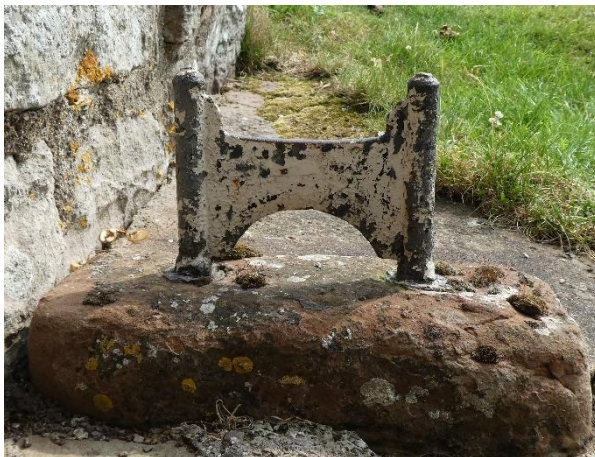
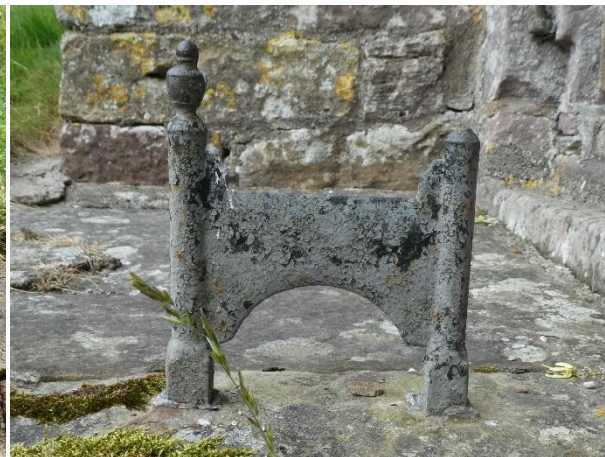
4.25 The two boot scrapers (Figure 13) at St Andrew's Church are more ornate than the one above. One of the scrapers is located outside the main Church entrance (C029) and is a robust "H" shape, leaded into a stone on the right side of the doorway. It probably had finials at the top, however these are now missing. The other scraper (C030) is located on the right side of the priest's door, it is also 'H' shaped but appears slightly more refined in its design and retains one of its finials.

*Figure 13: Image showing two boot scrapers, the left scraper (C029) is found outside the main entrance and the right scraper (C030) outside the priest's door.*

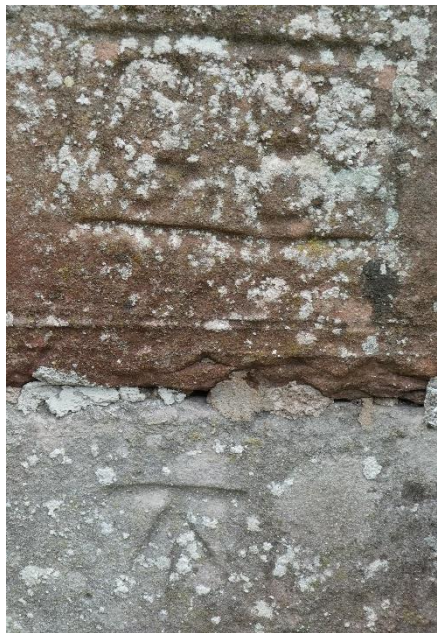
*Figure 14: Image showing a carving of the letters GB with an OS bench mark below it (C044).*

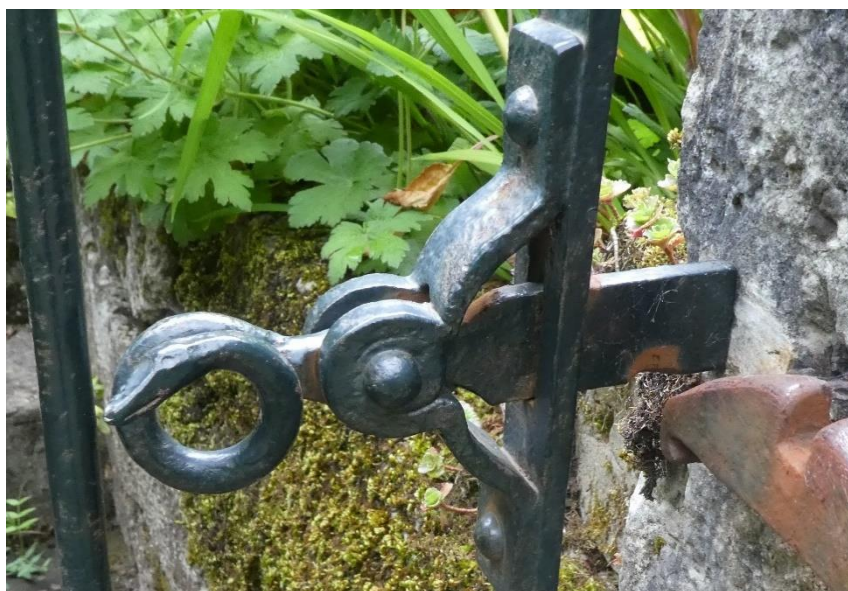
*Figure 16: Image showing the gate latch on the gate between a pair of gate stoops (C076).*

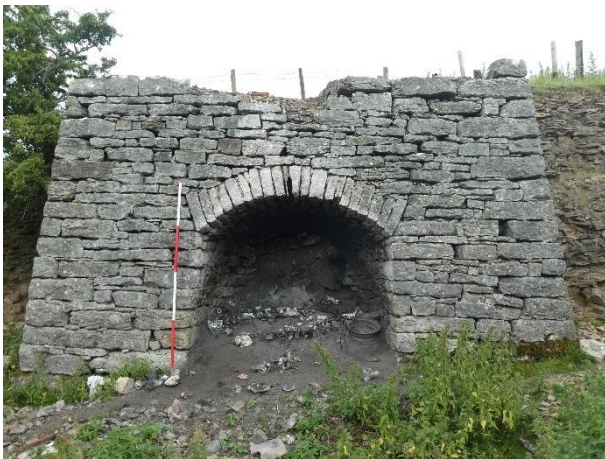
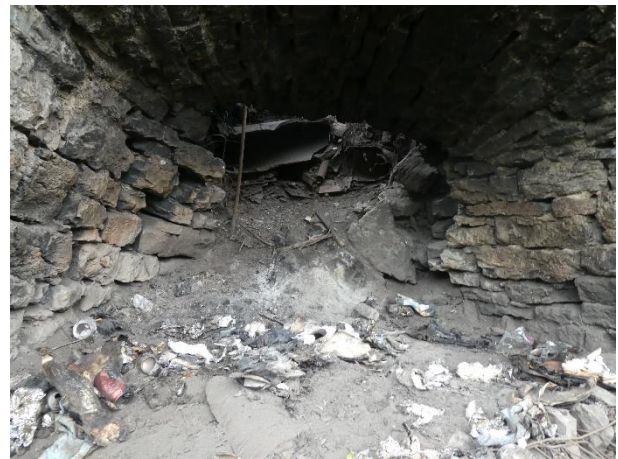
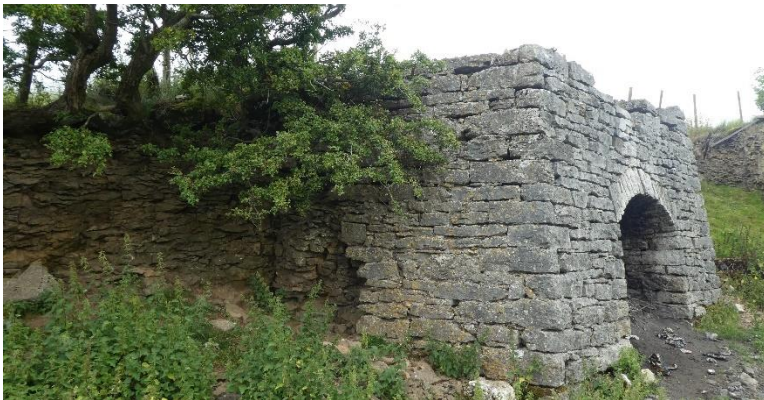
*Figure 21: Images showing lime kiln C84a – Top left image showing the front face with modern rubbish and deterioration to the top.*

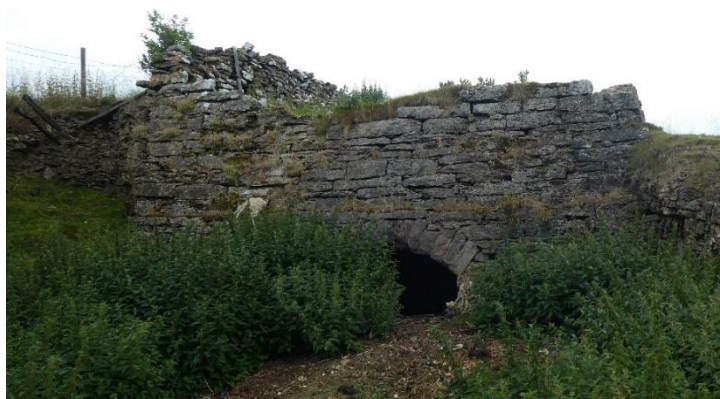
*Figure 22: Image showing lime kiln C087b which seems to be in a better state of repair than C087a, although some deterioration to the top is still visible.*

4.51 The north-facing lime kiln (C087b, Figure 22) is slightly less accessible and seems to be in a better state of repair, although the top also shows signs of deterioration.

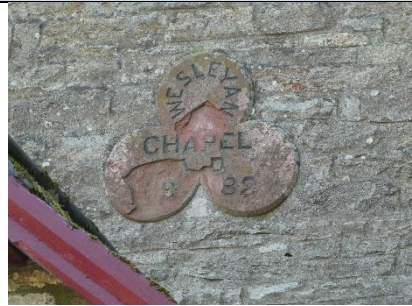
| Feature No. | Feature Type | Description | Condition | Threats | Photograph |
|---|---|---|---|---|---|
| C003 | Date Stone | Methodist Chapel marked on the historic 6" OS map and Methodist Chapel (Wesleyan) marked on the 25" OS map. A sandstone date stone in a trefoil shape, is located on the gable end above the front porch, the stone is engraved with "Wesleyan Chapel 1882". Date stone damaged is damaged with parts of the stone chipped. | Poor | Erosion | |

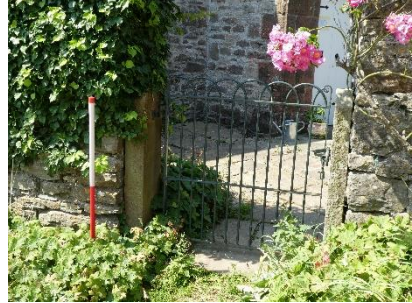
| Feature No. | Feature Type | Description | Condition | Threats | Photograph |
|---|---|---|---|---|---|
| C012 | Gate Stoops (Pair) | Pair of sandstone gate stoops with trapezoid tops located at entrance to private garden (former Baptist Chapel). Left stoop has two hinges on the inside face, right stoop has gate catch on the inside face with metal gate attached. Left stoop has crack near the top from the hinge. | Fair | Erosion; vegetation | |

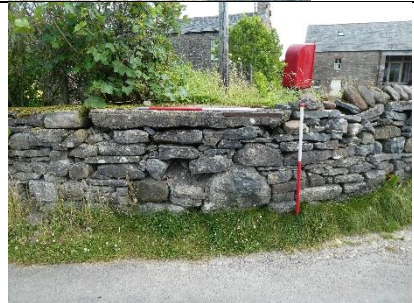
| Feature No. | Feature Type | Description | Condition | Threats | Photograph |
|---|---|---|---|---|---|
| C018 | Churn Stand | Concrete slab placed on dry stone wall for use as a churn stand. A metal strap/bracket is located on the right-side outer edge located on a top section of dry stone wall outside a former farmstead (MYD66009) and bank barn (MYD63038). | Poor | Vehicles; erosion; wall collapse | |

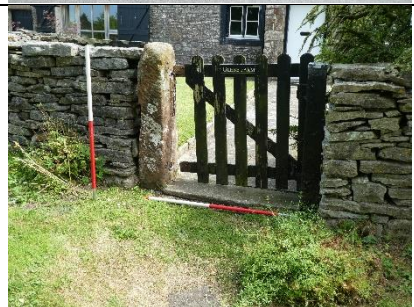
| Feature No. | Feature Type | Description | Condition | Threats | Photograph |
|---|---|---|---|---|---|
| C019 | Gate Stoop (Single) | Single sandstone gate stoop with rounded top, located on left side of gateway to former farmstead (MYD660011) now private house (Glebe Farm). Two broken hinges on inside face of stoop, one of which now has chain coming from it. Stone has some chipping and delamination. | Fair | Erosion | |

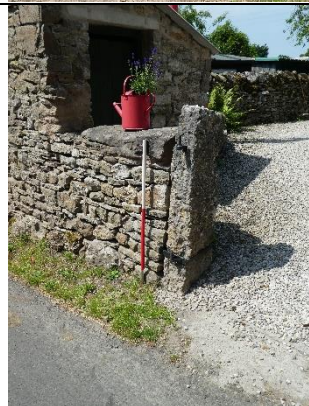
| Feature No. | Feature Type | Description | Condition | Threats | Photograph |
|---|---|---|---|---|---|
| C022 | Gate Stoop (Single) | Single limestone gate stoop with a flat top, located on the left side of driveway to private residence. Stoop has one hinge on the front face and one hole for a former hinge near the base. A metal strap for a hinge also goes around the stoop near the base. Stoop has some delamination. | Fair | Erosion | |

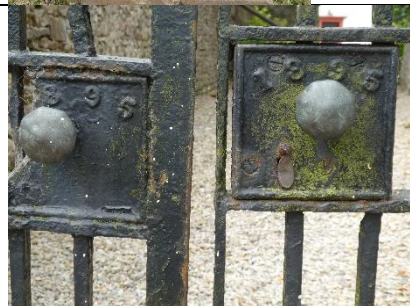
| Feature No. | Feature Type | Description | Condition | Threats | Photograph |
|---|---|---|---|---|---|
| C034 | Lock plates | Wrought iron gates embossed with the date "1895" on the lock-plates, date located above the handles on either gate. Left lock-plate is damaged with the '1' missing. The gates are part of the stables (1145023) north of the Old Rectory (1145022) and built in the 18 <sup>th</sup> century. | Fair | Erosion; vehicles | |

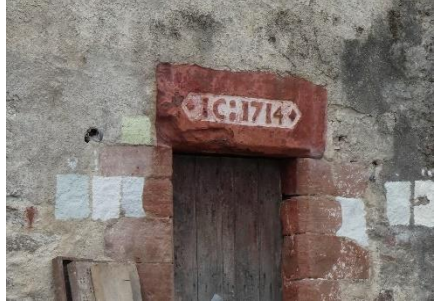
| Feature No. | Feature Type | Description | Condition | Threats | Photograph |
|---|---|---|---|---|---|
| C039 | Date Stone | Large red sandstone lintel with relief carving of letters and date "IC: 1714", with two diamonds on either side. Lintel located over the doorway on the porch entrance to house (MYD66014). Red sandstone quoin jambs. | Fair | Erosion; removal; renovation works | |

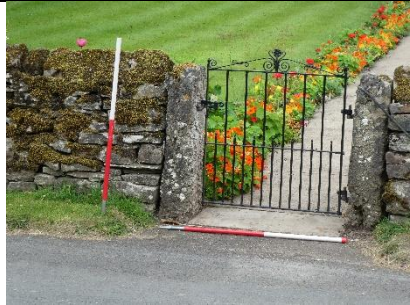
| Feature No. | Feature Type | Description | Condition | Threats | Photograph |
|---|---|---|---|---|---|
| C048 | Gate Stoops (Pair) | Pair of limestone gate stoops with sub-rounded tops outside the old smithy (now a private residence). Left stoop has gate catch, right stoop has two hinges with metal gate attached and metal tie over the top of the stoop connecting it to the wall. Smithy marked on historic 6" and 25" OS maps. | Fair | Vehicles; erosion; neglect | |

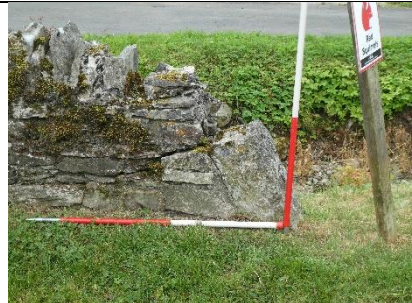
| Feature No. | Feature Type | Description | Condition | Threats | Photograph |
|---|---|---|---|---|---|
| C057 | Gate Stoop (Single) | Single limestone gate stoop on east side of a small section of wall (of unknown use) set at an angle, with a metal hinge on the Beck side. Stoop has been broken about half-way up and has probably been moved from elsewhere. Stoop on opposite side of wall section is C056 (photos of wider location included in folder, nothing shown on historic mapping). | Fair | Vehicles; damage | |

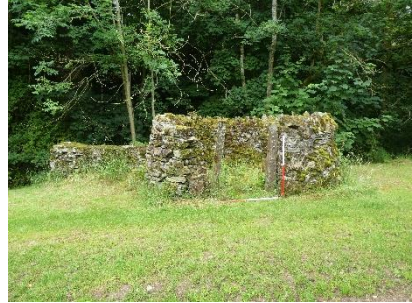
| Feature No. | Feature Type | Description | Condition | Threats | Photograph |
|---|---|---|---|---|---|
| C075 | Well | “Bensson’s Well” is shown on the first edition 6” OS map. The subsequent 6” and 25” OS maps show a dot/circle and P in this location suggesting it had become a pump. The structure is circular with predominantly limestone walls (in the style of sheepfold), with a stoop on either side of the west facing entrance. The left stoop has two hinges on the inside face, the right stoop has a gate catch on the inside face. The internal surface is covered in stone slabs which are covered in moss and vegetation, no evidence of the pump or attachments found. To the north, there is a short section of wall (c.3 metres in length x 0.96 cm high) which ends with a stoop. Possible opening on the north side of the circular structure near the base, adjacent to the wall, now infilled with stone. | Poor | Collapse; vegetation | |

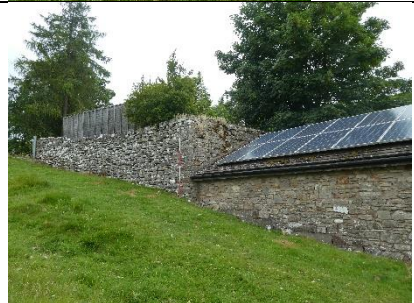
| Feature No. | Feature Type | Description | Condition | Threats | Photograph |
|---|---|---|---|---|---|
| C084 | Lime Kiln | Lime kiln (MYD62744) marked on 25" OS map. Garage built onto the draw/front face of the disused lime kiln. Top of lime kiln landscaped and now part of a garden. | Poor | | |

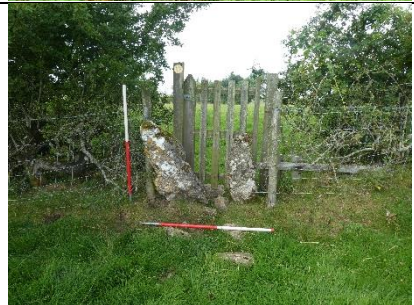
| Feature No. | Feature Type | Description | Condition | Threats | Photograph |
|---|---|---|---|---|---|
| C102 | Squeeze Stile | Pair of limestone stones (probably limestone pavement) creating a squeeze stile, with some associated stones on the floor. One stone leaning badly. Hedgerow on either side, with wooden gate on one side. | Fair | Collapse; erosion; removal; vegetation | |
