# DRY STONE WALL SURVEY – ASBY PARISH

## Summary Report

WESTMORLAND DALES

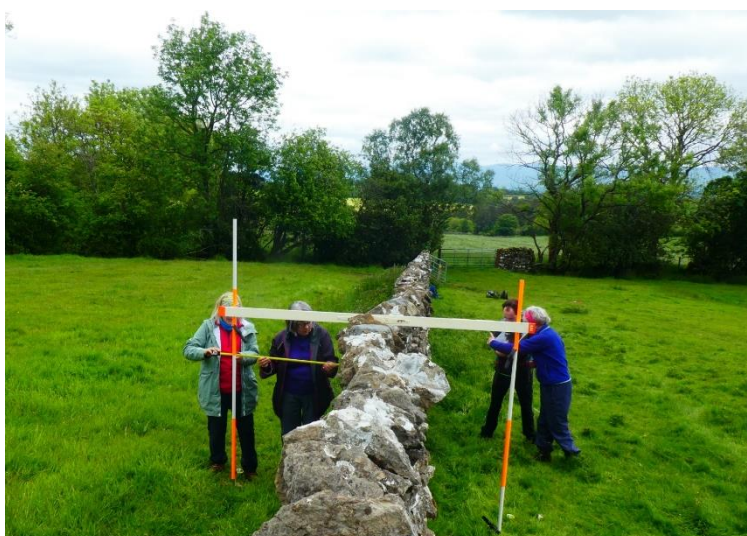
Figure 3 An example of a cross-profile, in this case of a type 2 wall. Supplied by David Johnson
