# Small-Scale Heritage Features Survey

Technical Report: Great Asby and Little Asby  
November 2023

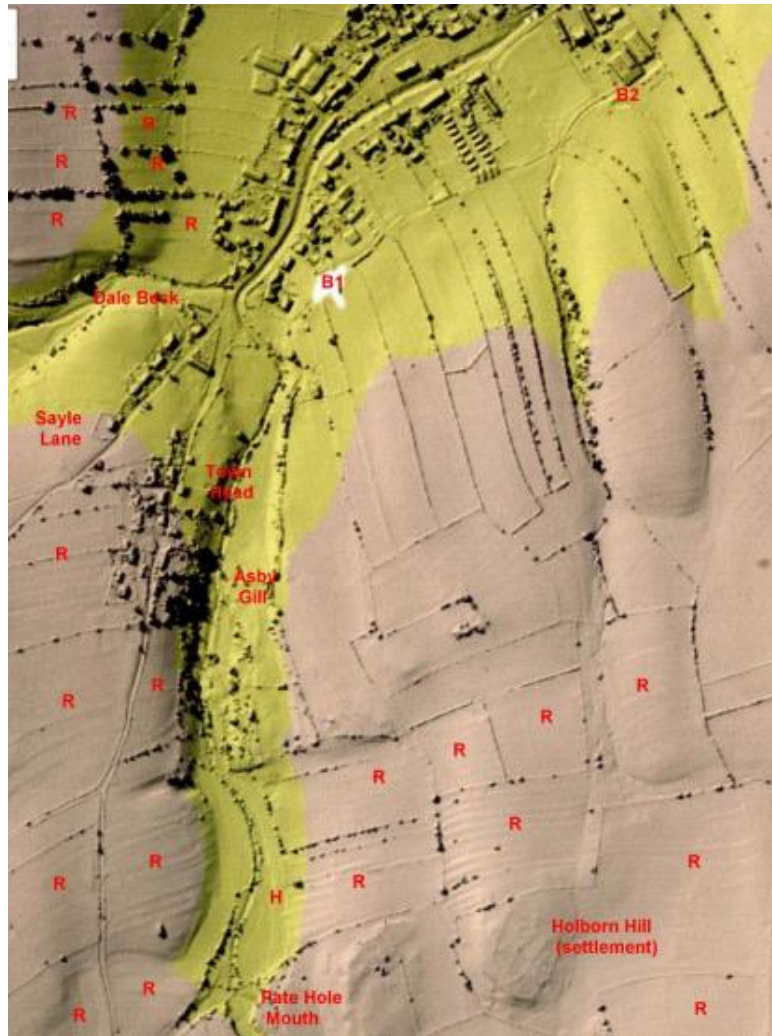
Figure 3 LiDAR image of Great Asby annotated by Dr Johnson (Johnson 2022).

3.19 Figure 3 shows two lines of tofts and crofts facing each other across Asby Beck. As with many linear villages, a back lane was situated at the back of the crofts, separated by a stockproof wall or hedge. The back lane from B1 to B2 shows as a slight linear depression – a Holloway. Extending beyond the Back Lane are long narrow closes defining a reverse-S shape. Over time strips were amalgamated and exchanged. These strips would have originally formed part of open ploughland that was divided (not by any set physical boundary) into individual strips worked by the various tenants using an ox team. Over time, these ploughlands were expanded outwards, away from the Back Lane, as population and demand for food grew, particularly in the late 15th and through the 16th century. Beyond these strips were the open fields. Much of these were also under cultivation, proven today by the ridge and furrow arrangement seen in so many of the present closes (annotated with an R,

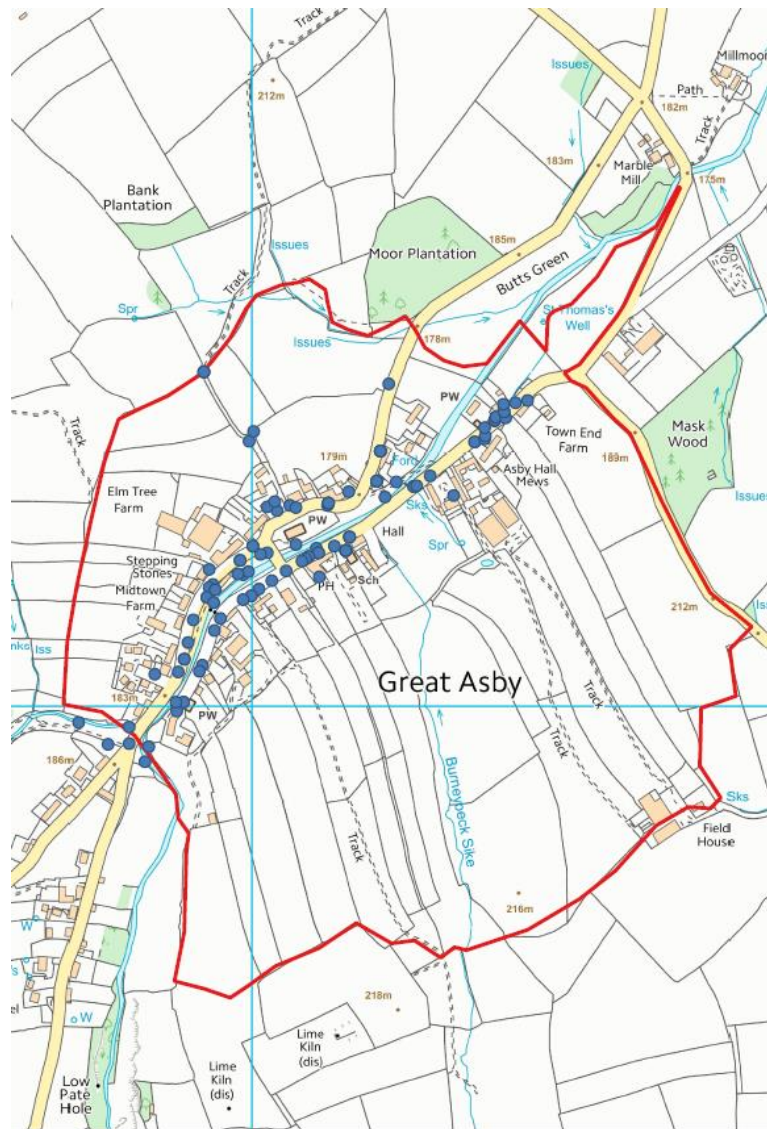
Figure 4 Features surveyed in Great Asby plotted on map.

4.1 The survey of Great Asby took three days to complete and identified 104 features over 80 records (Figure 4, see Appendix B for full gazetteer). The survey of Little Asby took a half day and identified 10 features (Figure 5, see Appendix C for full gazetteer).

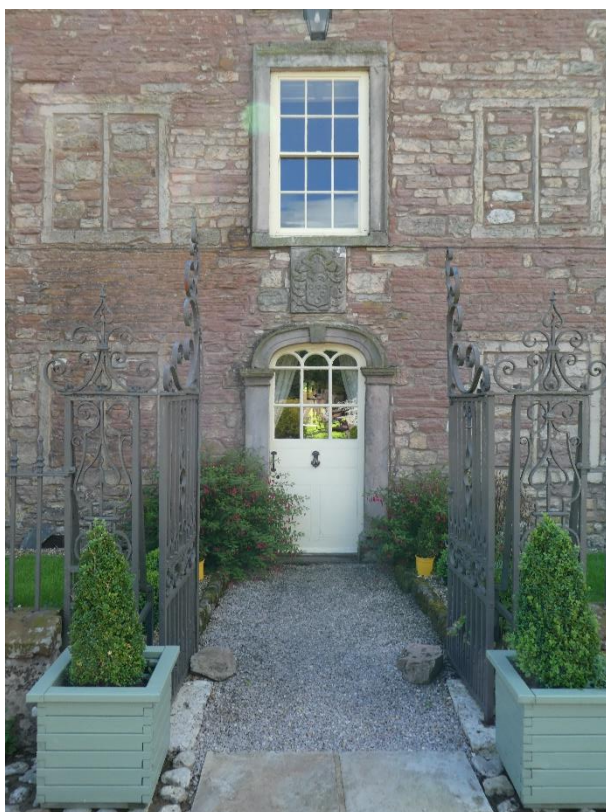
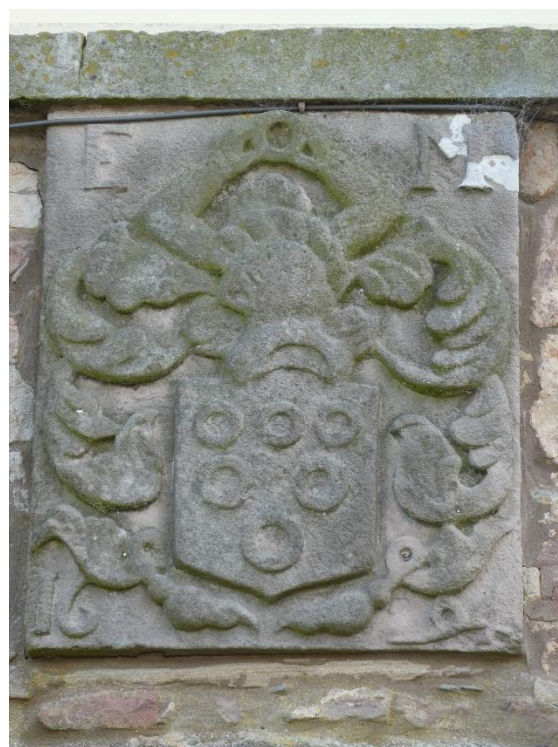
*Figure 6 Date stone (D005) of 1694 located on Asby Hall.*

4.5 Seven date stones were found on domestic buildings. The earliest were D005 and D204a, both dating to 1694. D005 is located on Asby Hall – the date stone also has the initials “E M” (Edward Musgrave) and the Lowther crest. Part of the surviving building dates to this period, however it was enlarged in the 18<sup>th</sup> century; there is also speculation that there was an earlier hall on the site (see 3.29).

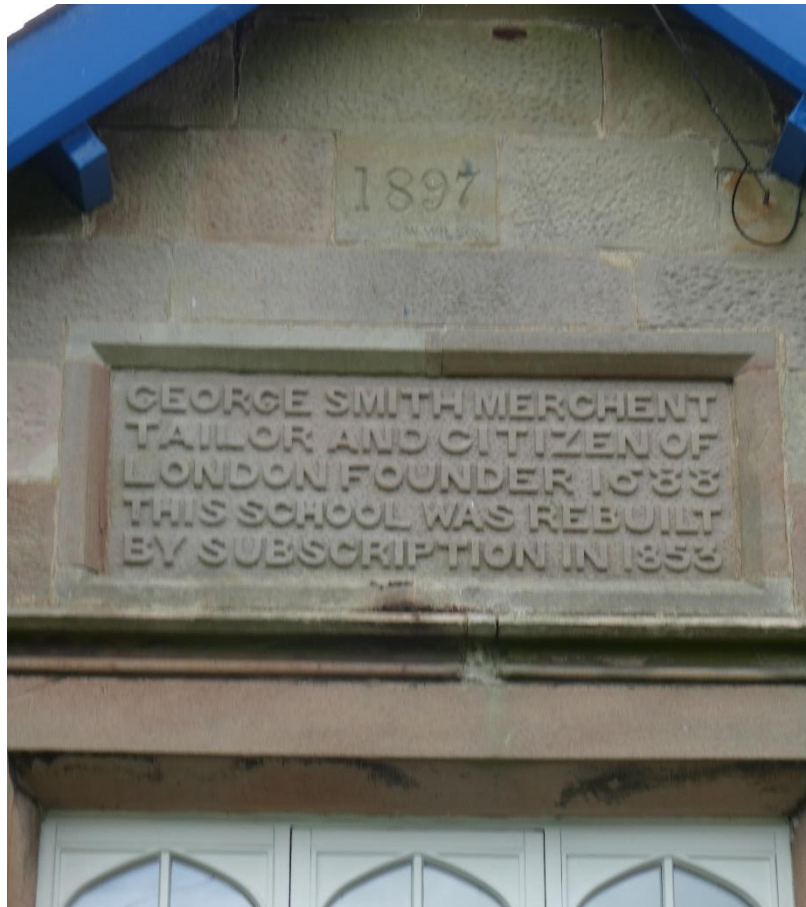
4.9 Unusually, there are three date stones on the Endowed School building (D020a, c and d). The main one being D020a which describes the founding of the school in 1688 by George Smith, a merchant tailor, as well as its rebuilding in 1853 by public subscription. This date stone is positioned above the hoodmould of a window on the building's roadside elevation. Above this is another date stone of 1897 and a smaller engraving of 'W Wilson'. It is unclear what this date refers to – it is possible that it relates to further building work, or it could relate to someone associated with the school like a benefactor or headmaster. The 1891 census lists a

William Wilson as a 'joiner & builder', along with being a 'sub post master' (Ancestry). The third date stone is dated to 1736, again above a window, but it is unclear what its origins are and what the date may relate to.

*Figure 8 Date stones on front elevation of Asby Endowed School. D020d is positioned above D020a.*

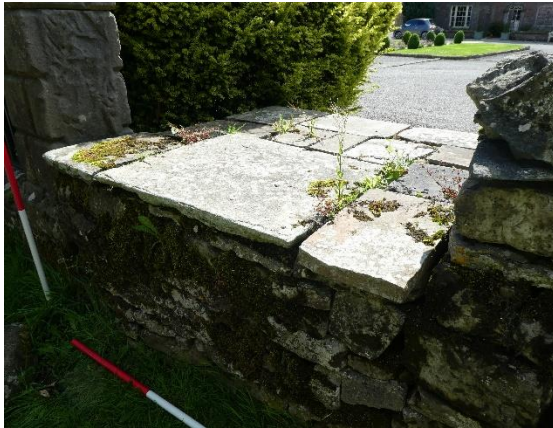
Figure 9 Churn Stand D004

4.14 There are four churn stands in total – two in Great Asby (D004 and D204b) and two in Little Asby (I001 and I007). A churn stand is a platform on which milk churns were placed for collection and were commonly used until the 1970s. Churn stands are particularly vulnerable due to their roadside location, with many being lost following road development schemes and traffic collisions.

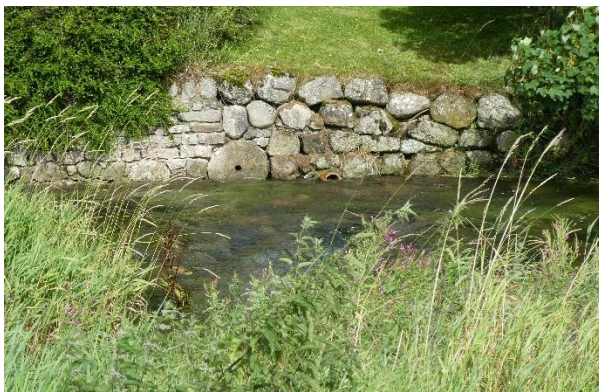
*Figure 13 Quern Stone D032*

4.17 Two rotary quern stones have been repositioned into walls in Great Asby – D032 into the revetment wall for Asby Beck and D038 into a garden boundary wall. Querns themselves have early origins, however these are likely to date to the post-medieval period. Two stones would be laid horizontally and stacked on top of each other. The top stone would rotate around (turned by hand by a handle fixed in its edge), whilst the bottom one would remain stationary, with the grain fed in through the central hole in the top stone. They would have been used to grind wheat, barley and corn etc. to make flour. It is unclear which side of D032 is visible, but it has a circular central hole. D038 shows signs of dressing, although it is very worn; the grinding faces were often dressed (cut with furrows in various patterns) to improve grinding efficiency (CAFG, 2019). The central hole is square in shape, but it appears to narrow.

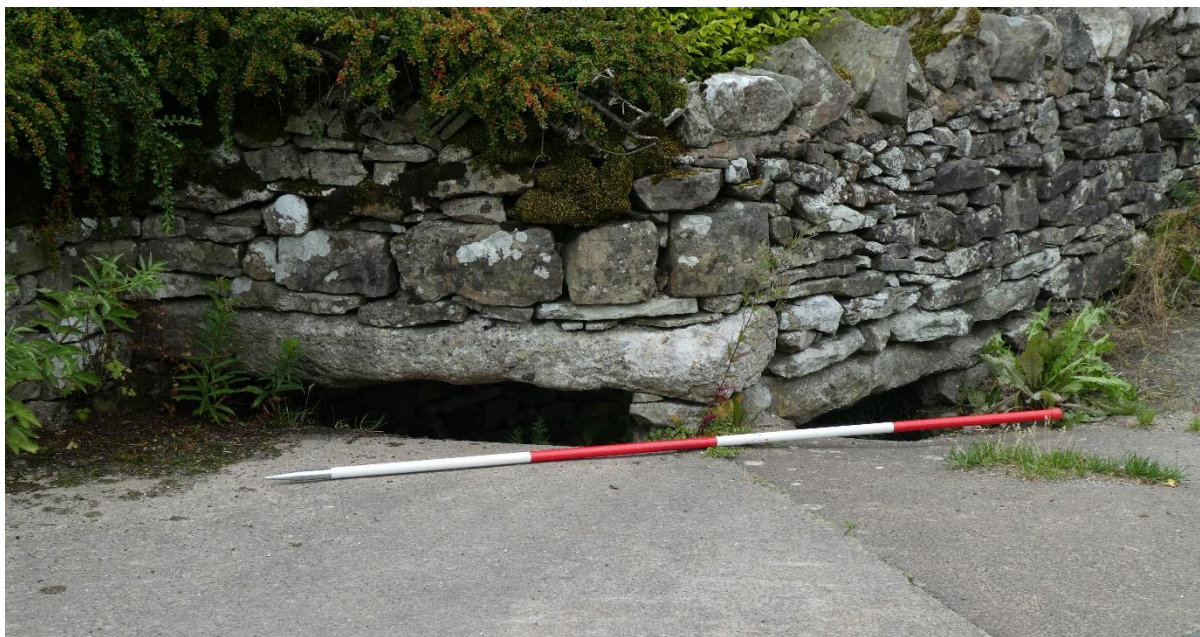
Figure 15 Water Smoot D013

4.19 Five water smoots were recorded in Great Asby, situated in dry stone walls with lintels above the opening (D002a & b, D013, D044 and D060). They all relate to water management, often relating to one or more of the following: fields, road, and Asby Beck. However, it is possible that D013 relates to the former Horizontal Mill discussed in 3.27.

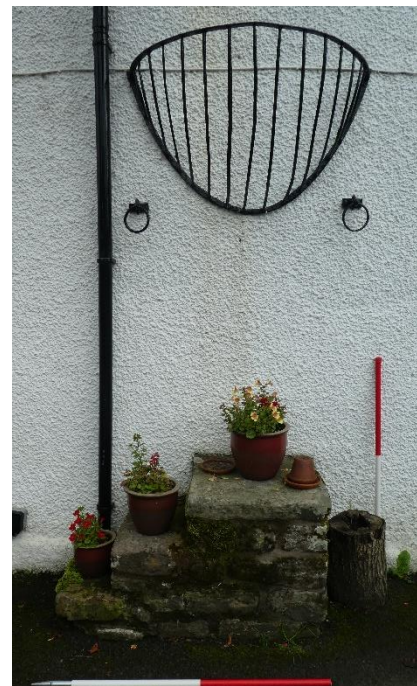
Figure 16 Mounting block (D022) with possible tie rings and hay feeder above for horses.

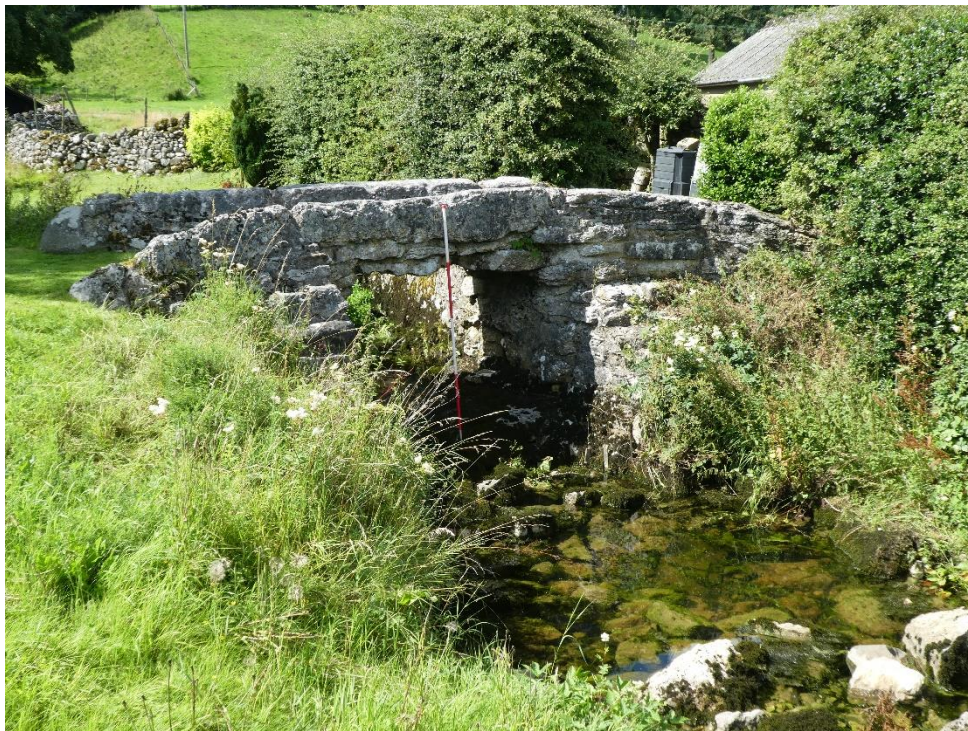
4.29 A stone footbridge is positioned at the western end of the village (D216). It crosses Dale Beck, which runs from the fell to Asby Beck. The bridge is shown on the second edition six- and 25-inch OS maps.<sup>21</sup> It is predominantly constructed from limestone, and has low parapets on either side. It is situated on a right of way, but there is speculation whether it was previously on a packhorse route, and whether it was formerly a packhorse bridge (YDNPA, 2020). The low parapets would have allowed the ponies to pass without catching their panniers on the bridge sides.

*Figure 17 Footbridge crossing Dale Beck (D216)*

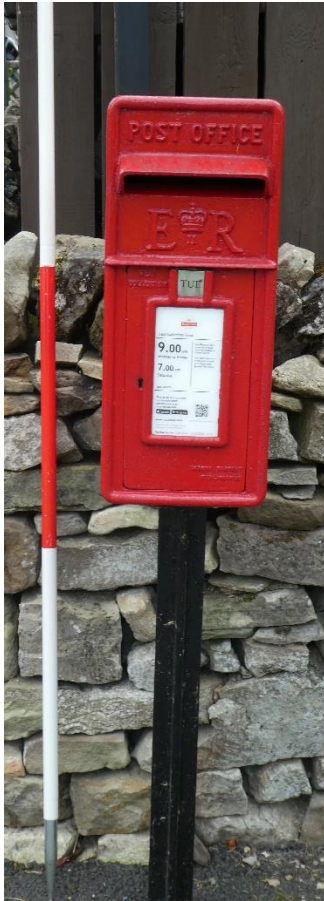
Figure 18 Letter Box D021 (c. 1969-80)

4.32 Three letter boxes were surveyed in Great Asby, with none identified in Little Asby. They all date to the reign of Queen Elizabeth II, with the same EIRR cipher. They are also all of a lamp style, as they were often fitted to a telegraph or lamp post, but could also be on a metal pole, as these examples are (with D021 on a cross post, and D062 and D206 on a circular post). It is unclear who manufactured D021, however it is possible that it was Carron Company based in Stirlingshire, who cast lamp boxes from 1969 to 1982. D062 and D206 were manufactured by "Machan Scotland". Machan Engineering supplied Royal Mail with cast iron letter boxes since the 1980s, but closed in 2015 with the move to stainless steel versions. D062 is the only letter box to be embossed with "ROYAL MAIL" (rather than "POST OFFICE") with appears following the early 1990s when the Post Office Counters Limited and Royal Mail separated as separate companies. Therefore, it is likely that D021 dates to pre-1980 (and possibly post-1969), D206 dates from about 1980 to 1990, and D062 dates from about 1990 to 2015.

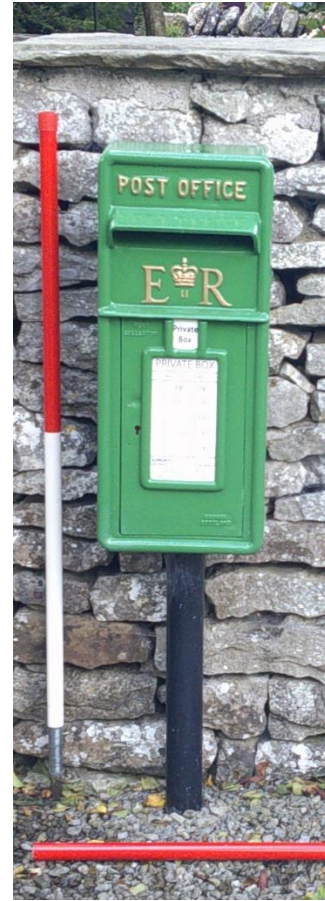
Figure 20 Letter Box D206 (c. 1980-90)

4.33 D206 has been decommissioned and is not painted green, therefore its original location is unknown. Disused boxes are usually painted black, with those that retain the green colour usually representing an early letter box history (i.e. pre-red). However, this example is not that early (dated to the 1980s), though it is similar to the green found on Republic of Ireland letter boxes.

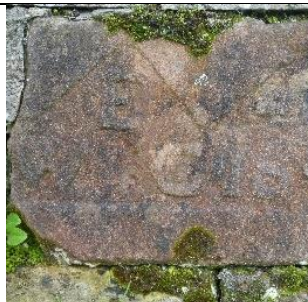
| Feature No. | Feature Type | Description | Condition | Threats | Photo |
|---|---|---|---|---|---|
| D018 | Date Stone | Now irregularly shaped (appears to have once been rectangular, but corners on the left side have chipped off, it is likely that the engraving would have been central) sandstone with carved date, probably reused from elsewhere. The stone is engraved with two triangles, the left point has a carved "E" in it and the right has an unknown shape. The left side has the carved letters "W C" below the "E" and "1694" on the right side. The stone has been damaged and the details are eroding making it difficult to read. The stone is currently being used as a quoin on the corner of a private garden wall. | Poor | Erosion | |

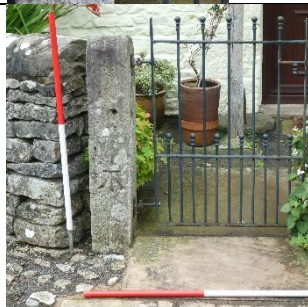
| Feature No. | Feature Type | Description | Condition | Threats | Photo |
|---|---|---|---|---|---|
| D049b | Gate Stoops (Pair) | Pair of sandstone gate stoops outside private house. The left stoop has an OS benchmark (D049a) on the front face and a disused hole above it, two hinge plates on the inside face with gate attached with four small holes in a square formation above this which is probably for a former attachment. The right stoop has a gate catch on the inside face. Left stoop has probably been relocated from elsewhere, unclear about right stoop. | Good | Erosion; removal; vehicles | |

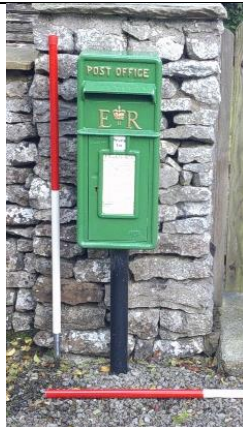
| Feature No. | Feature Type | Description | Condition | Threats | Photo |
|---|---|---|---|---|---|
| D206 | Letter Box | Letter box (now decommissioned for private use) painted green, situated on a black metal pole outside private residence. "POST OFFICE" is embossed above the top opening with "E II R" and crown below the opening, both painted gold. "NEXT COLLECTION" is embossed to the left of where the day token would have been. Markers information "MACHAN SCOTLAND" is embossed at the lower right corner of the box. | Good | Removal | |

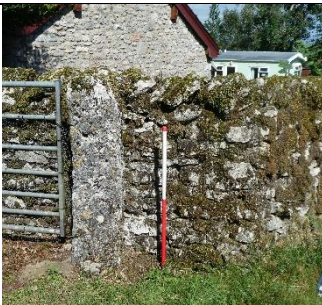
| Feature No. | NGR (NY) | Feature Type | Description | Condition | Threats | No. of Photos | HER No. (MYD) | Photo |
|---|---|---|---|---|---|---|---|---|
| 1005 | 6982309687 | Gate Stoop (Single) | Single limestone gate stoop on the right side of gateway leading to fields. The stoop has one hole on the inside face, with a bolt on outside face near the base which goes through the stone and connects to a hinge on the rear face, a second hinge is located near the top of the rear face. A metal gate is connected to the hinges. | Good | Erosion; vehicles; removal | 5 | | |
