# Small-Scale Heritage Features Survey

Technical Report: Crosby Ravensworth  
November 2023

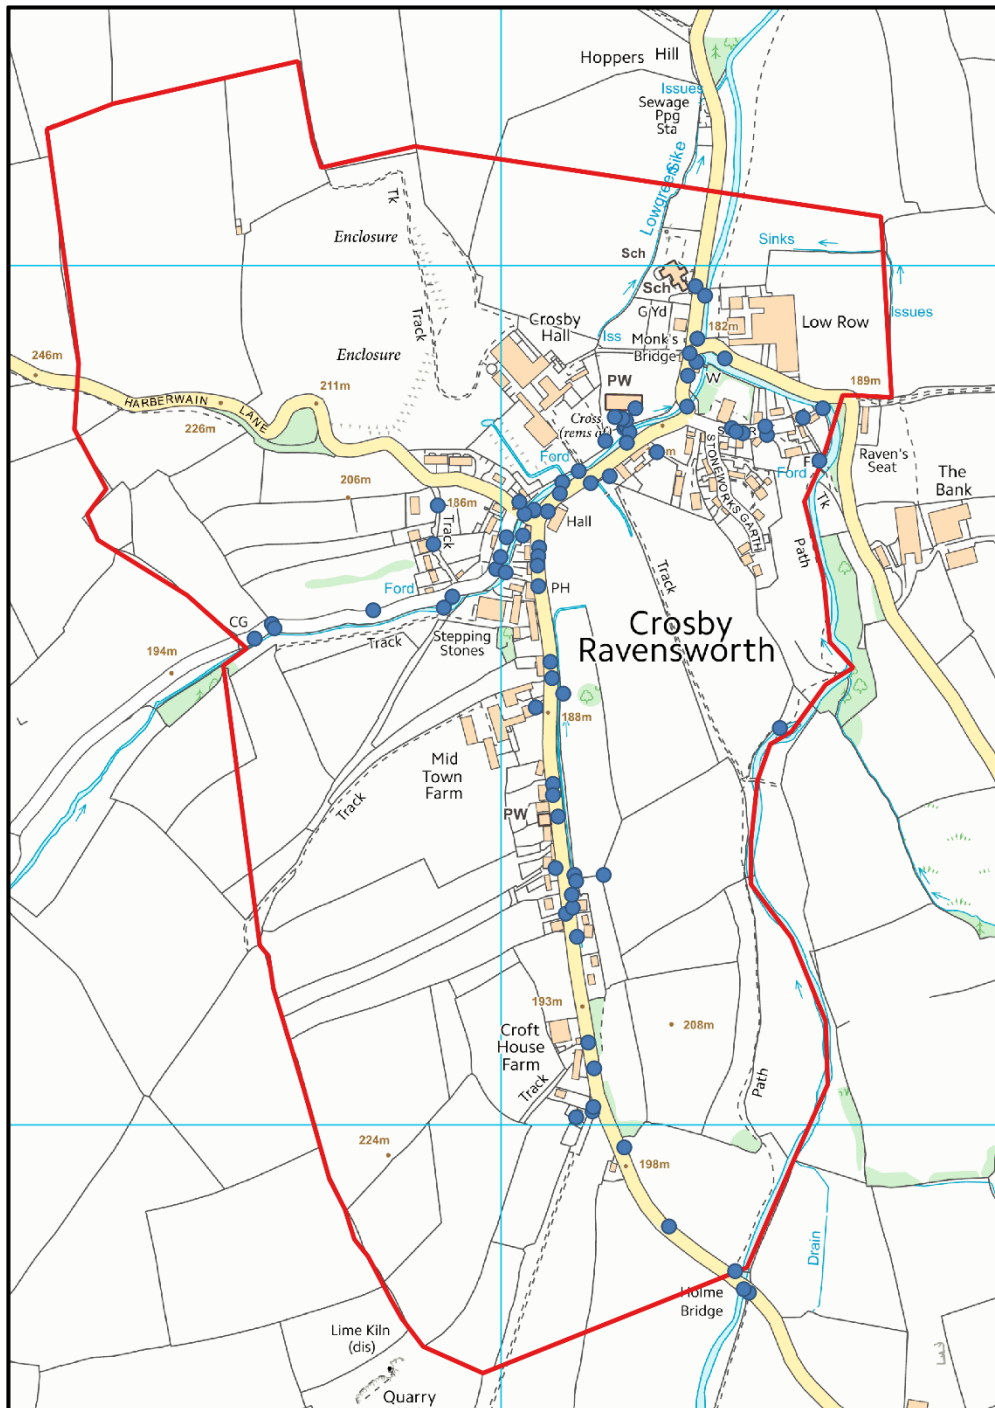
Figure 2: Map showing the location of the features identified during the survey. © Crown copyright and database rights 2022 Ordnance Survey 100023740. Additional information: © Yorkshire Dales National Park Authority.

4.1 The survey of Crosby Ravensworth took three and a half days to complete and identified 96 features over 84 recordings (Figure 2, see Appendix B for the full gazetteer).

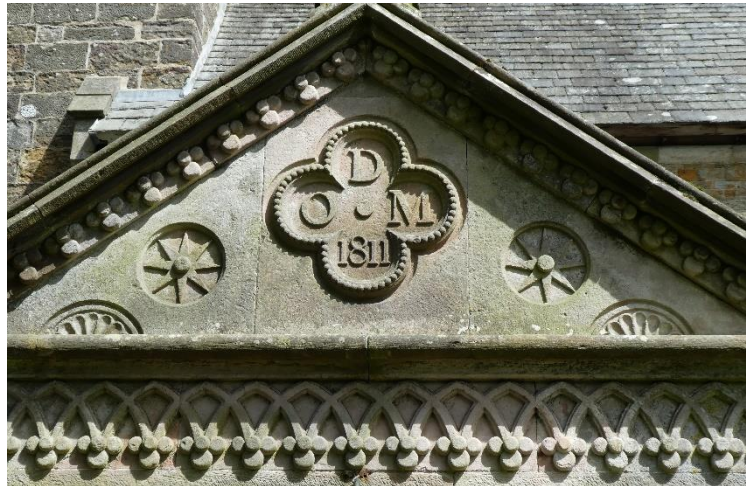
Figure 4: Image showing quatrefoil date stone on the entrance porch to St Lawrence's Church.

4.6 Feature E029 (Figure 4) is a highly stylised quatrefoil date stone located above the entrance porch to St Lawrence's Church (MYD62453). The letters in the top section "O D M" refer to the Latin phrase "*Deo optimo maximo*" which means "to God, most good, most great", with the 1811 date commemorating remodelling works undertaken in the early 19<sup>th</sup> century by George Gibson.

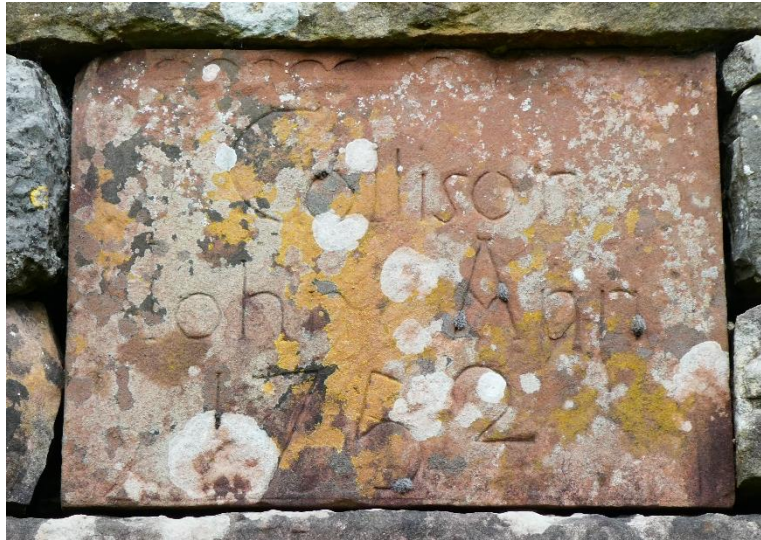
Figure 5: Image showing the date stone (E045) with a scalloped edge around the top and an incised line around the other three edges.

4.8 The oldest date stone recorded during the survey is a rectangular red sandstone block with "Collison Iohn Ann 1752" inscribed over three lines (E045, Figure 5). The stone is unusual as it includes the names of individuals, rather than

just the initials; it is decorated with an incised scallop pattern on the top edge and a plain incised line around the other three sides, however these marks are now very faint. The stone is located on the gable end of a barn (MYD66918), but has probably been repurposed/reused from elsewhere for the barns construction.

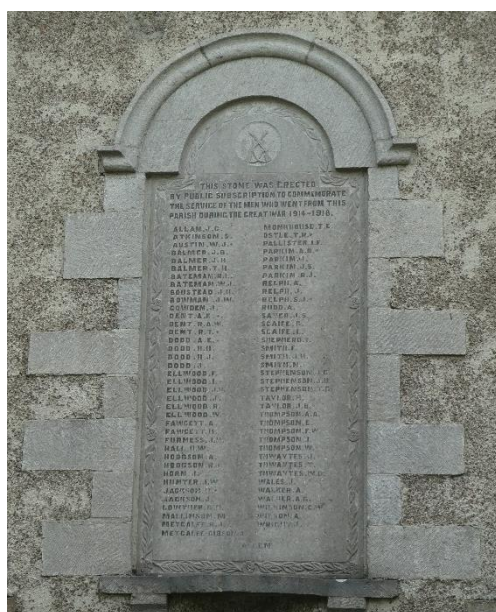
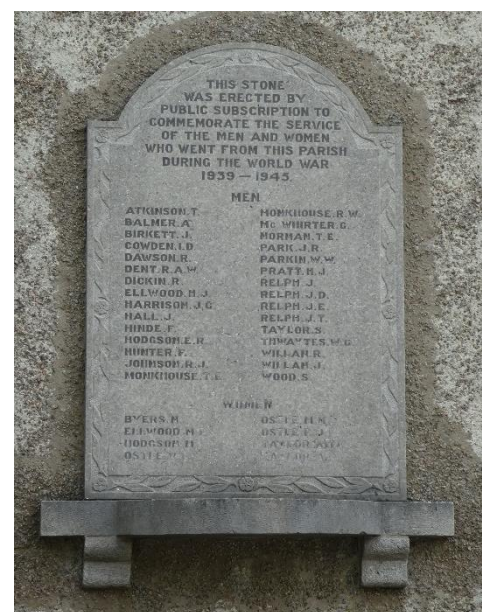
Figure 6: Images showing the memorials on Crosby Ravensworth Village Hall. Left - WWI memorial. Right - WWII memorial.

4.9 Crsoby Ravenworth Village Hall was built in 1927 and has a date stone (E001a) over commemorating its construction over the main enterence. On either side of the doorway on the front elevation of the building is a memorial, both of which were erected by public subscription. The memorial on the left (E001b) is a grey

granite tablet set into the external wall with a shelf at the base that appears to be contemporary with the Hall's construction. The memorial commemorates the men of the parish who left to serve in the First World War and provides a roll of honor (IWM reference 68133). The memorial on the right (E001c) is a grey granite tablet set proud of the wall with a shelf at the bottom that appears to be a later addition to the building. The memorial commemorates the men and women from the parish who served during World War Two, with the stone providing a roll of honour (IWM reference 68134).

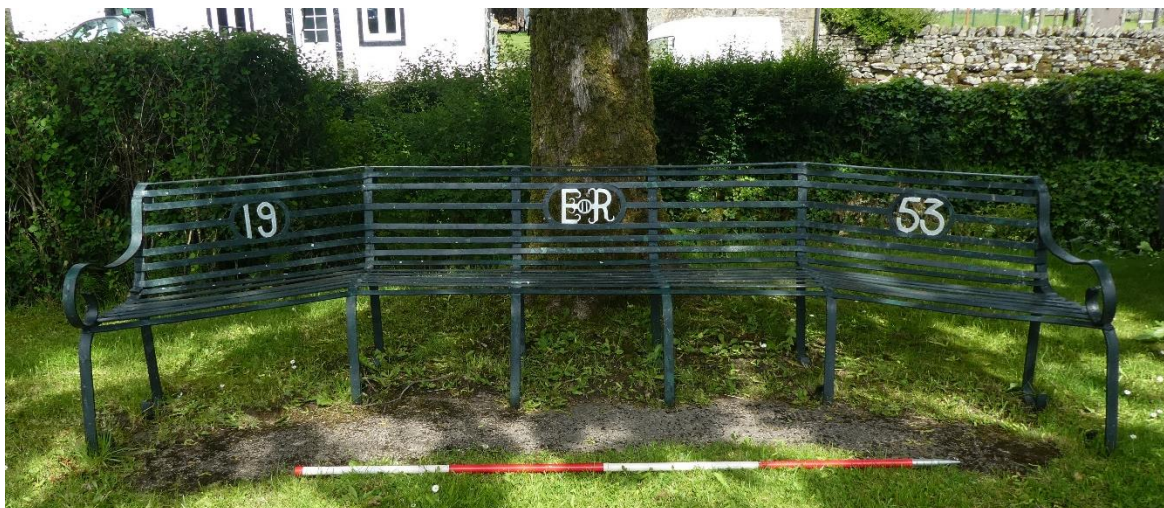
4.11 A semi-curved wrought iron bench (E002, Figure 7) is located opposite the Village Hall and commemorates the coronation of Queen Elizabeth II. The seat is painted black and split between three sections with "19" in the left section, "EIR" in the central section and "53" in the right section. The letters and dates are all located in the centre of each section and painted silver. A similar bench can be found within between Crosby Ravensworth and Maulds Meaburn.

*Figure 7: Image showing a wrought iron seat (E002) commemorating the coronation of Queen Elizabeth II.*

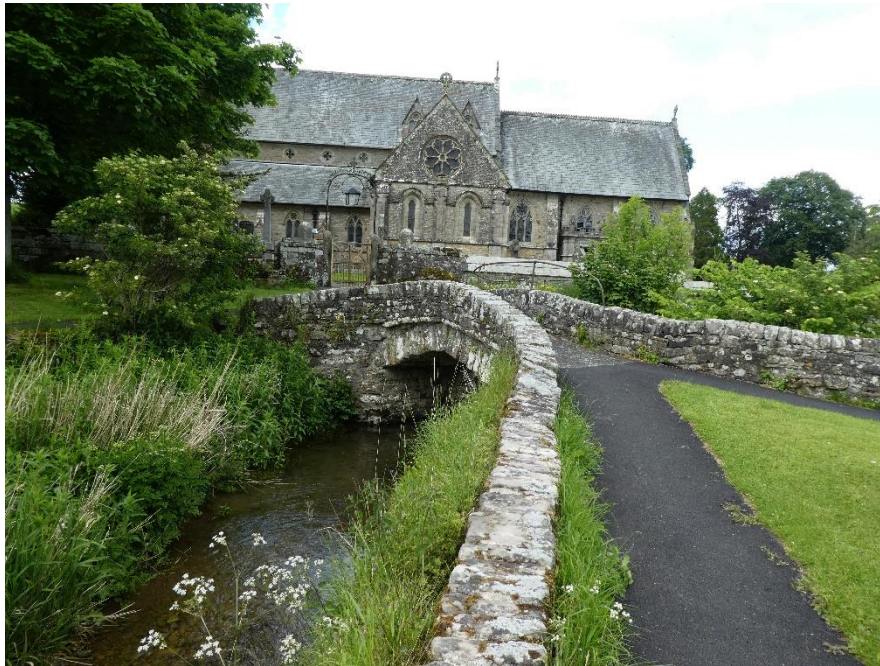
*Figure 8: Image showing a small bridge (E023) leading to St Lawrence's Church.*

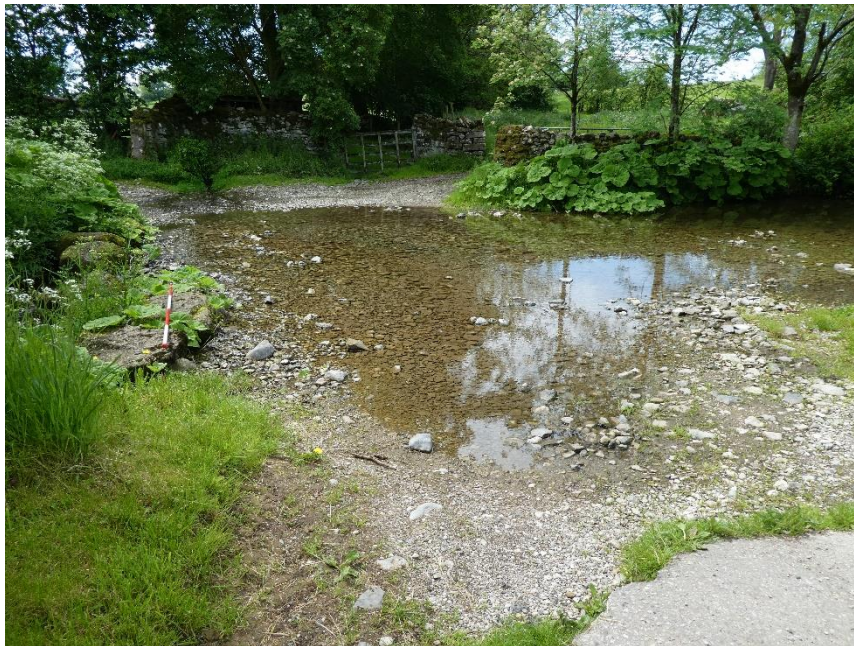
*Figure 9: Image showing the stepping stones (E009a) and ford (E009b) adjacent to Tenter Row.*

4.19 Three lots of stepping stones were recorded during the survey (E009a, E019a and E073). The first, E009a, are located on the east side of the village adjacent to Tenter Row, at a crossing point between several trackways. The stepping stones consist of six large stones and span the breadth of Dalesbank Beck. The stones are shown on the tithe map and the third edition twenty-five-inch OS map. The stepping stones are adjacent to a ford (E009b, Figure 9) which represent the former course of Haberwain Lane going south around Tenter Row, before its current route developed in the late 19<sup>th</sup> century.

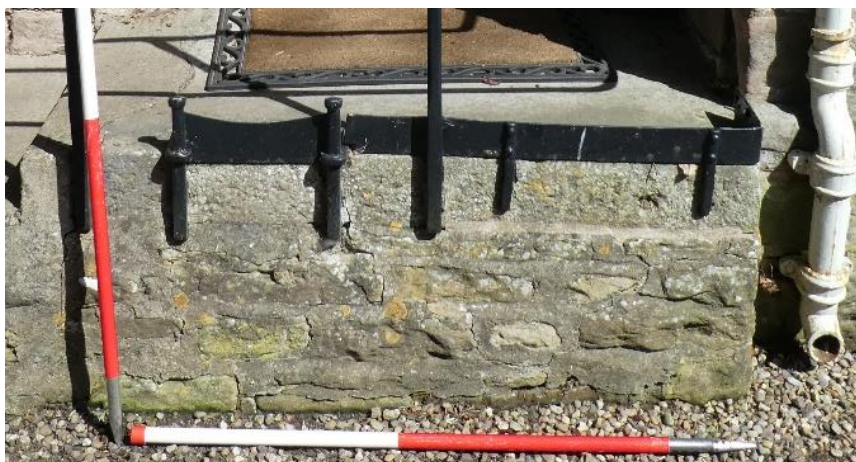
*Figure 10: Image showing a series of boot scrapers (E076c) outside the former school.*

4.24 Two boot scrapers (E076c, Figure 10) were recorded on the rear side of the top step outside the doorway of the former school (now Monks Bridge House). The left most scraper has a finial at either end, while the second scraper is slightly as it is a simple iron bar that is curved around the step on the right side, with both of the scrapers together being about one meter in length. The location of the scrapers suggests that they were probably for the students and staff members of the school, however it is unclear why one of them is more decorative, while the other is purely functional in its design. The age of the scrapers is unclear; however they could be linked to the remodelling work that took place under William Dent in 1784.

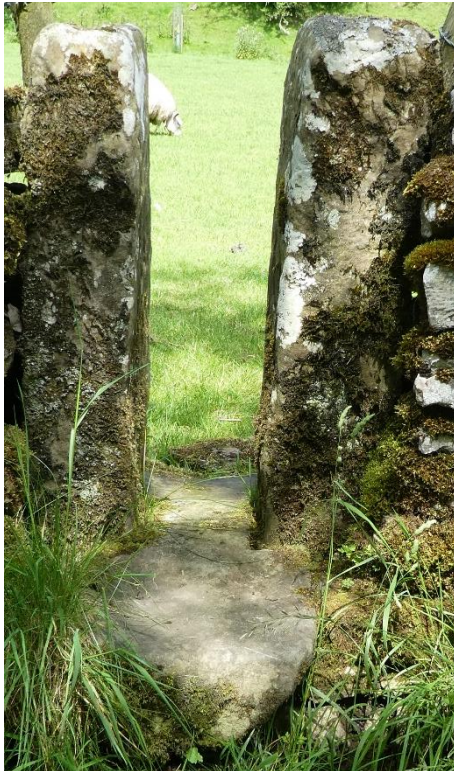
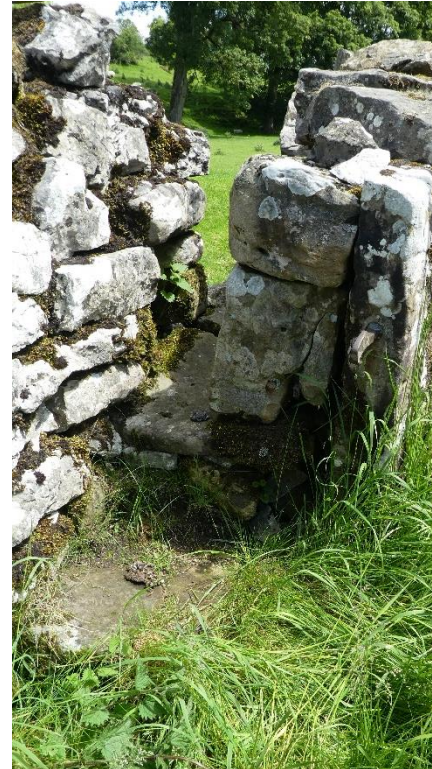
*Figure 11: Left - Image showing how the horizontal stone has been shaped around the vertical stones of squeeze stile E013. Right – Image showing the squeeze stile E011a built into the wall with a gate stoop (E011a) on the right.*

4.28 Stiles E011a and E013 are located to the west, just outside the main village. Stile E013 is a squeeze stile with two steps created using two vertical stones placed to make a "V" shape. A horizontal throughstone has then been placed between them to create a stepping surface. This throughstone has been cut and shaped to fit around the vertical stones (Figure 11) which is unusual. Stile E011a (Figure 11) is located slightly further west on the edge of the survey area and denotes a former public footpath, probably reflecting the route to the village before the formalisation of the current road. The stile has two step with the gap created two sections of wall

being out of alignment. Additionally, the outside of the stile is a gate stoop (E011b) with metal gate attachments, probably marking the former fell gate as shown on the tithe and early OS maps.

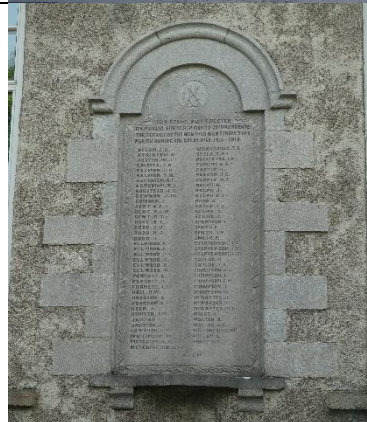
| Feature No. | Feature Type | Description | Condition | Threats | Photograph |
|---|---|---|---|---|---|
| E001b | Memorial | Memorial stone to the left of the main door and was erected by public subscription. The memorial is created from a grey granite tablet set into the external wall with a shelf at the base that appears to be contemporary with the Hall's construction. The memorial commemorate the men at the parish who left to serve in the First World War and provides a roll of honor. | Good | Erosion | |

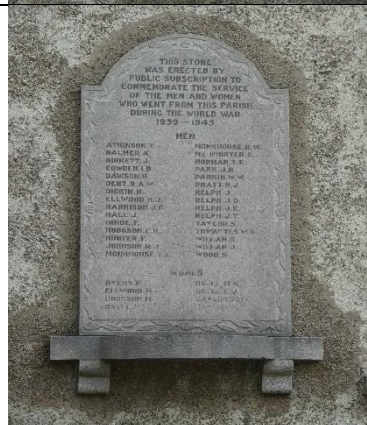
| Feature No. | Feature Type | Description | Condition | Threats | Photograph |
|---|---|---|---|---|---|
| E001c | Memorial | Memorial stone to the right of the main door and was erected by public subscription. The memorial is created from a grey granite tablet set proud of the wall with a shelf at the bottom that appears to be a later addition to the building. The memorial commemorates the men and women from the parish who served during World War Two, with the stone providing a roll of honour. | Good | Erosion | |

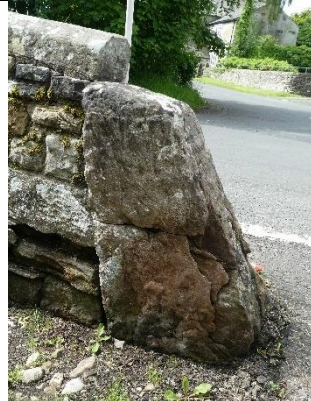
| Feature No. | Feature Type | Description | Condition | Threats | Photograph |
|---|---|---|---|---|---|
| E004 | Cart Stops | Cart stops located on both ends of the bridge's north parapet. The cart stop at the western end is damaged and leaning out of alignment with the parapet. The eastern stop is smaller than the western stop and the parapet wall, however it is in a better condition. | Poor | Vehicles; erosion; collapse | |

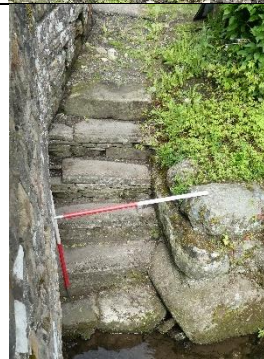
| Feature No. | Feature Type | Description | Condition | Threats | Photograph |
|---|---|---|---|---|---|
| E005 | Steps | Six mixed stone and concrete steps leading to the river on the north-western side of the bridge on the road to Harberwain Lane. Steps for unknown purpose. | Fair | Flood; Wall collapse | |

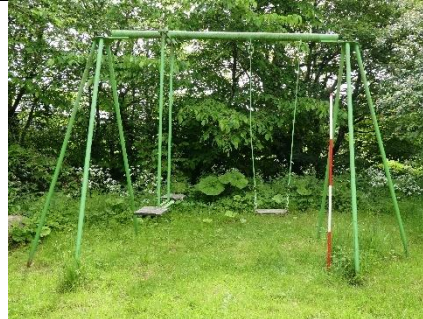
| Feature No. | Feature Type | Description | Condition | Threats | Photograph |
|---|---|---|---|---|---|
| E008 | Swing Set | Swing Set similar to those found in Maulds Meaburn (F002) but without the date. Set consists of a seat glider and swing attached to the horizontal support using long (iron?) rods. | Good | Erosion;<br>Removal | |

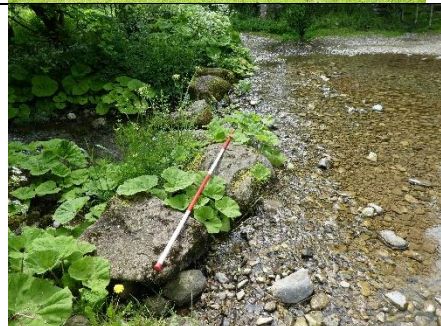
| Feature No. | Feature Type | Description | Condition | Threats | Photograph |
|---|---|---|---|---|---|
| E009a | Stepping stones | Stepping stones located downstream of ford (E009b) on the Dalesbank Beck. Stepping stones only shown on the third edition 25" OS map (Westmorland XIV.16 map. Revised 1913, published 1915). | Good | Flooding | |

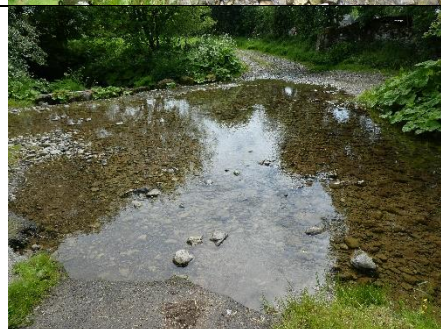
| Feature No. | Feature Type | Description | Condition | Threats | Photograph |
|---|---|---|---|---|---|
| E009b | Ford | Ford to the south of Tenter Row over Dalesbank Beck marked on the 6" and 25" OS maps and leads to a former trackway. | Fair | Flooding | |

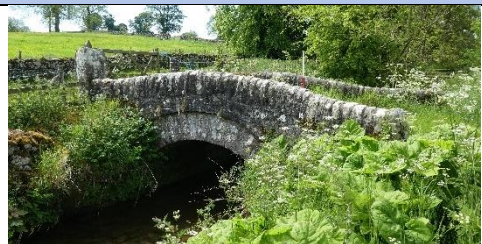
| Feature No. | Feature Type | Description | Condition | Threats | Photograph |
|---|---|---|---|---|---|
| E010a | Bridge | Bridge over Dalesbank Beck with stone parapets and cobbled surface, marked as being on an old trackway on 6" and 25" OS maps. Now provides access from road to field. | Good | Flooding;<br>Vegetation | |

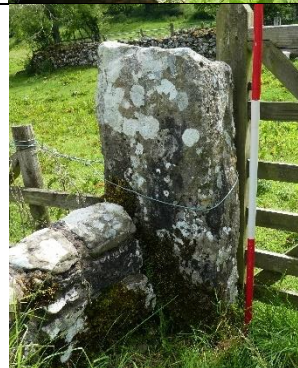
| Feature No. | Feature Type | Description | Condition | Threats | Photograph |
|---|---|---|---|---|---|
| E010b | Gate Stoop (Single) | Single sandstone gate stoop located on the left side of gateway to fields and an old trackway on the south side of the bridge (MYD68531). Two holes on the side of the gate with two leaded hinges and one broken hinge | Fair | Removal;<br>vegetation,<br>flooding | |

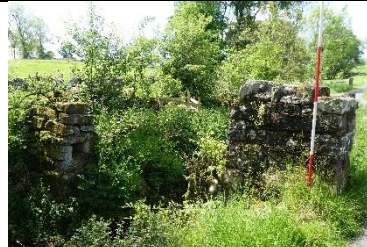
5.6 The inclusion of vegetation as a threat is slightly ambiguous as in some cases damage is possible due to vegetation damaging and degrading stone (such as date stones) or damaging the feature directly (such as the water gate), while for other features vegetation risks obscuring the feature (such as water smooths) and so is a

| Feature No. | Feature Type | Description | Condition | Threats | Photograph |
|---|---|---|---|---|---|
| E012 | Water Gate | Sandstone wall piers over Dalesbank Beck indicating a possible former water gate marking the start of the fell, probably associated with the possible fell gate (E00b) and seen on the 2 <sup>nd</sup> edition 6" and 25" OS maps. | Poor | Flooding; vegetation; | |

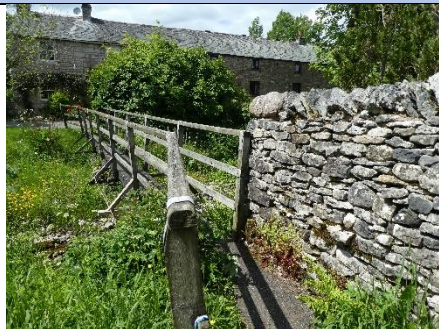
| Feature No. | Feature Type | Description | Condition | Threats | Photograph |
|---|---|---|---|---|---|
| E015 | Footbridge | Wooden footbridge over Dales Beck, footbridge marked on historic OS map. | Good | Flooding; vegetation | |

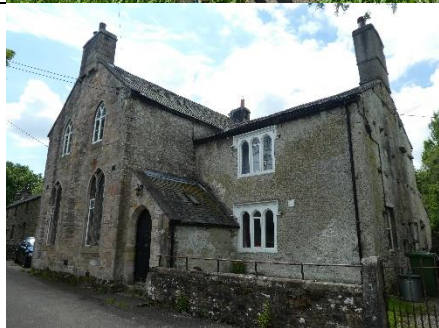
| Feature No. | Feature Type | Description | Condition | Threats | Photograph |
|---|---|---|---|---|---|
| E016 | Dame School | Former Dame School House, marked as "Dame School (endowed)" on the first edition of the 6" OS maps. Building has concrete gate stoops with wrought iron gate at the front. | Good | | |

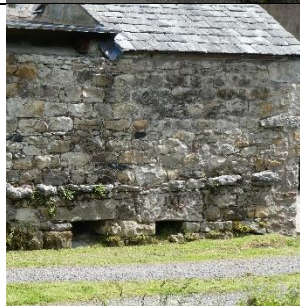
| Feature No. | Feature Type | Description | Condition | Threats | Photograph |
|---|---|---|---|---|---|
| E017 | Privy | Slots in the base of an outside wall facing Dalesbank Beck, probably former privies. Located at the back of Woodbank and Bank Cottage. | Good | Demolition | |

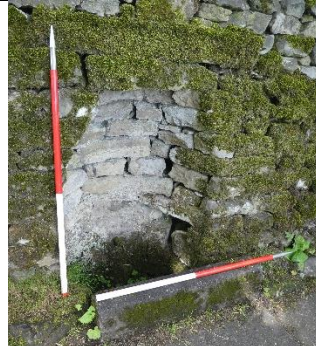
| Feature No. | Feature Type | Description | Condition | Threats | Photograph |
|---|---|---|---|---|---|
| E018a | Spring | Semi-circular recess built into dry stone wall with a metal/lead pipe (no longer working). The recess is below ground level, and leads to a culvert (E018b) which drains into the Dalesbank Beck. Possibly linked to spring "Sp" marked on the third edition 6" map and third edition 25" map. | Fair | Vegetation | |

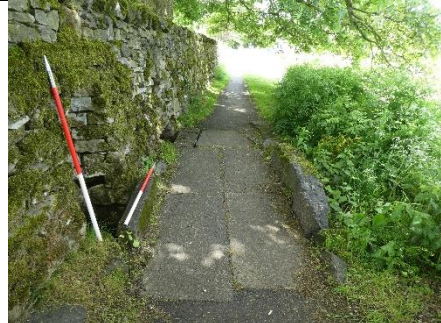
| Feature No. | Feature Type | Description | Condition | Threats | Photograph |
|---|---|---|---|---|---|
| E018b | Culvert | Culvert leading water under the pathway from E018b and E018c to the Dalesbank Beck. Culvert made up of 4 slabs of stone, with stone on the east side being an reused gate stoop. | Fair | Vegetation | |

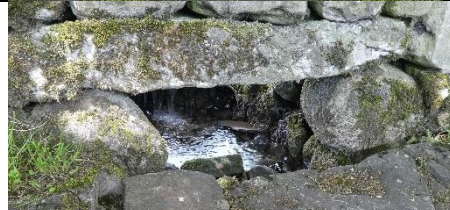
| Feature No. | Feature Type | Description | Condition | Threats | Photograph |
|---|---|---|---|---|---|
| E018c | Smoot | Smoot in dry stone wall with lintel over the top to allow water to pass into a culvert (E018b) under the path before draining into the Dalesbank Beck. Possibly linked to the Crosby Hall Moat. | Fair | Vegetation; removal; flooding | |

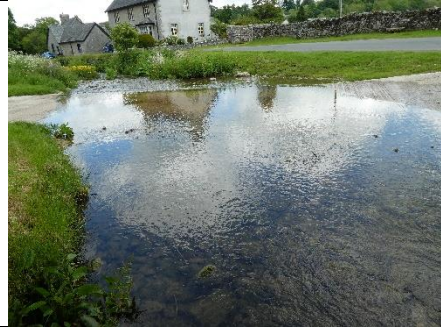
| Feature No. | Feature Type | Description | Condition | Threats | Photograph |
|---|---|---|---|---|---|
| E019b | Ford | Ford over the Dalesbank Beck made with a concrete base, leading to Crosby Hall. Ford labelled on the first edition 6" OS map. | Good | Flooding | |

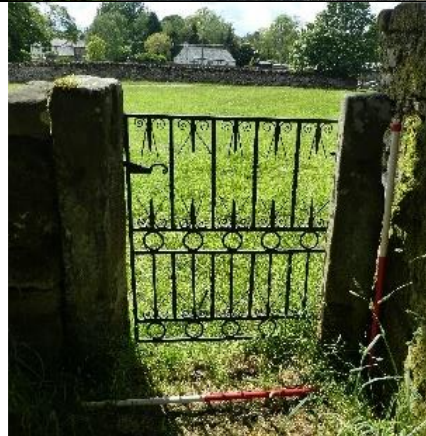
| Feature No. | Feature Type | Description | Condition | Threats | Photograph |
|---|---|---|---|---|---|
| E020 | Gate Stoops (Pair) | Pair of sandstone gate stoops, likely giving access to the church from Crosby Hall. Right stoop has groove in the middle face at the top, with the right stoop having a large rectangular hole on at the top on the centre face. Newer wrought iron gate fixed to the back face of the stoops (gate catch on left stoop, hinges on the right stoop). | Good | Removal | |

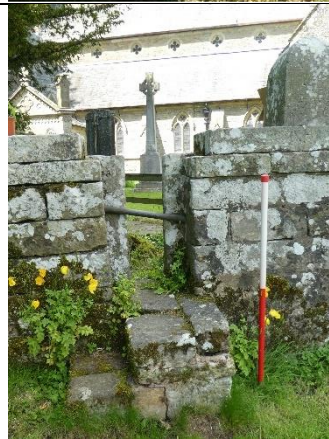
| Feature No. | Feature Type | Description | Condition | Threats | Photograph |
|---|---|---|---|---|---|
| E021 | Squeeze Stile | Sandstone squeeze stile next to a pedestrian gate leading to St Lawrence's Churchyard. Stile has two steps from the ground on the south side and is ground level on the north side, the squeeze is created by two pieces of vertical stone inset into the wall. A metal bar is set across the centre of stile. | Good | Removal | |

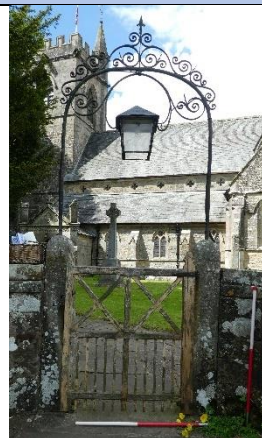
| Feature No. | Feature Type | Description | Condition | Threats | Photograph |
|---|---|---|---|---|---|
| E022 | Gate Stoops (Pair) | Pair of sandstone gate stoops with wooden gate attached at pedestrian entrance to St Lawrence's Churchyard. Tops shaped forming a rounded convex pyramid, with a wrought iron archway coming out of the top. | Good | Removal; erosion | |

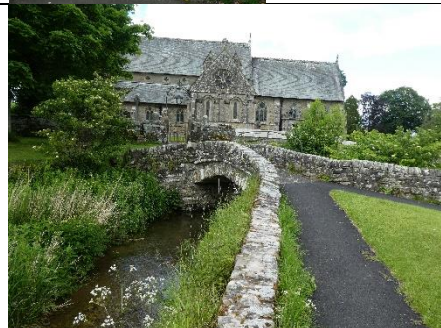
| Feature No. | Feature Type | Description | Condition | Threats | Photograph |
|---|---|---|---|---|---|
| E023 | Bridge | Sandstone footbridge built to give access to the church over Dalesbank Beck. Parapets overhang the bridge slightly. Bridge marked as Church Bridge on the 1 <sup>st</sup> edition 6" OS map. | Good | Erosion; vehicles; Flooding | |

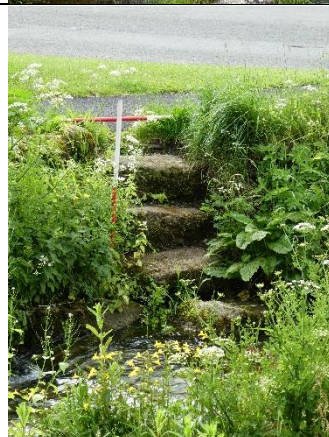
| Feature No. | Feature Type | Description | Condition | Threats | Photograph |
|---|---|---|---|---|---|
| E024 | Steps | Four steps (three sandstone, one granite) down to Dalesbank Beck near the south-eastern end of the bridge. Unknown purpose. | Good | Flooding | |

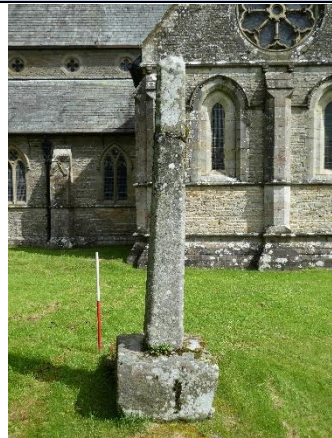
| Feature No. | Feature Type | Description | Condition | Threats | Photograph |
|---|---|---|---|---|---|
| E025 | Cross | Stump of cross, with chamfered edges and a square base, situated on a square stone plinth. Top of cross is extant and the cross has previously been broken into three parts with a step on the north side. Located near the entrance to St Lawrence's Church, Crosby Ravensworth and shown on the historic 6" and 25" OS maps. | Poor | Removal; erosion | |

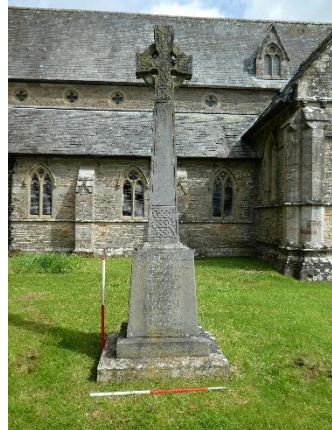
| Feature No. | Feature Type | Description | Condition | Threats | Photograph |
|---|---|---|---|---|---|
| E026 | Memorial | Memorial in the form of a Celtic style sandstone cross for those from Crosby Ravensworth parish who died in WWI, erected in 1920. The memorial includes the names of those who died sorted by the year of death. Located near the entrance to St Lawrence's Church.<br>. | Good | Erosion | |

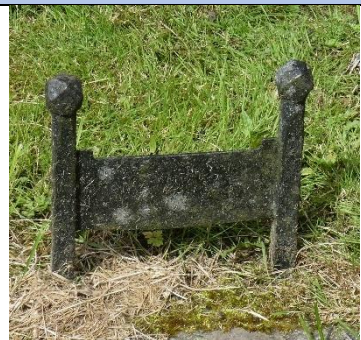
| Feature No. | Feature Type | Description | Condition | Threats | Photograph |
|---|---|---|---|---|---|
| E027 | Boot scrapers | Iron boot scraper with shaped finials by the north-eastern side door to St Lawrence's Church and possibly date from the 18 <sup>th</sup> century based on finials. | Good | Erosion; removal | |

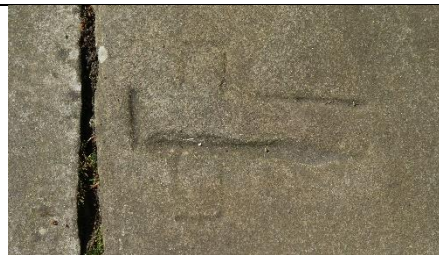
| Feature No. | Feature Type | Description | Condition | Threats | Photograph |
|---|---|---|---|---|---|
| E030 | Graffiti | Crude carving of cross in the same orientation as the St Lawrence's church on a paving stone outside of the church, possible graffiti or reused/rejected grave stone. | Fair | Erosion; removal | |

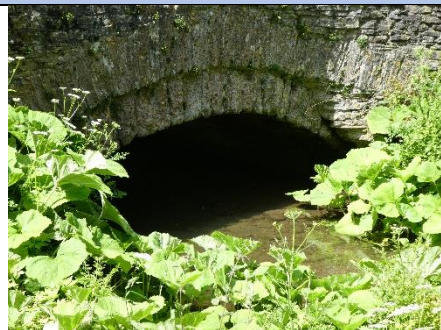
| Feature No. | Feature Type | Description | Condition | Threats | Photograph |
|---|---|---|---|---|---|
| E031 | Bridge | Bride over Dalesbank Beck close to the entrance to St Lawrence's Church. Bridge marked as New Bridge on the 1 <sup>st</sup> edition 6" OS map | Good | Flooding; vehicles | |

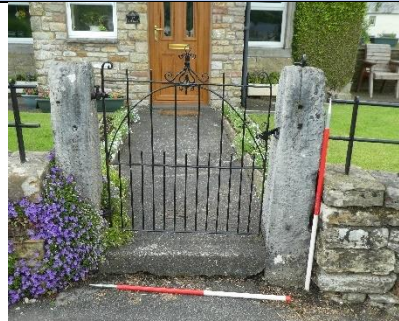
| Feature No. | Feature Type | Description | Condition | Threats | Photograph |
|---|---|---|---|---|---|
| E034 | Gate Stoops (Pair) | Pair of limestone gate stoops with rounded tops leading to private residence. The front face of the right stoop has a hole near the top and an iron and leaded broken hinge at the base. The top of the stoop has a painted metal hook positioned on it (used to tie horses?) and some cracking down the front face from this point. The inside face has a painted metal gate catch that is in use. The inside face of the left stoop has one hole and two metal hinges with gate attached. | Good | Removal; erosion; vegetation | |

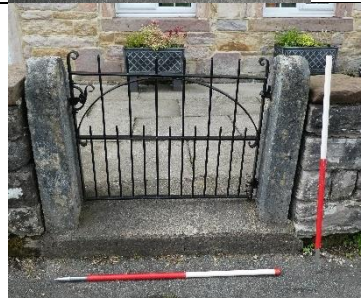
| Feature No. | Feature Type | Description | Condition | Threats | Photograph |
|---|---|---|---|---|---|
| E036 | Gate Stoops (Pair) | Pair of sandstone gate stoops with rounded tops leading to private residence. Left stoop has metal catch for gate on inside face. Right stoop has metal hinges with gate attached. Both stoops are encased in concrete step. | Good | Removal; Erosion | |

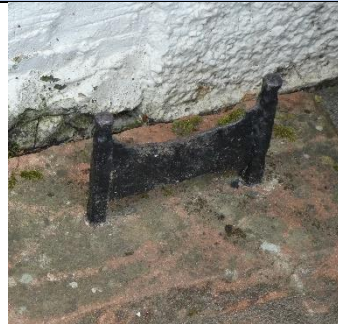
| Feature No. | Feature Type | Description | Condition | Threats | Photograph |
|---|---|---|---|---|---|
| E037a | Boot scraper | Iron boot scraper painted black with finials situated on sandstone block to the right of the main door of The Butchers Arms. Pub marked on the 6" and 25" OS maps under the same name. | Good | Removal;<br>Erosion | |

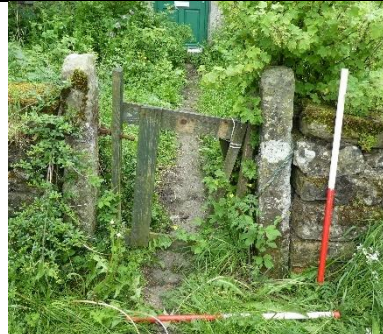
| Feature No. | Feature Type | Description | Condition | Threats | Photograph |
|---|---|---|---|---|---|
| E038 | Gate Stoops (Pair) | Pair of sandstone givate stoops with rounded tops leading to private residence. Left stoop has two rusted metal hinges with gate attached. Right stoop has cut/groove at the top of the inside face. Has old hole (for bolt?) on the inside face. | Good | Vegetation;<br>Erosion;<br>removal | |

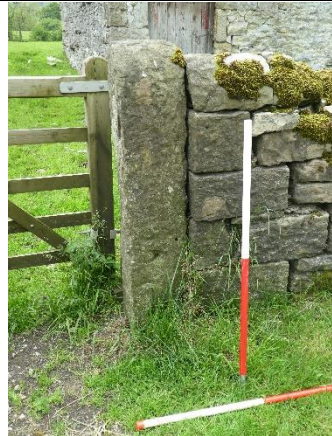
| Feature No. | Feature Type | Description | Condition | Threats | Photograph |
|---|---|---|---|---|---|
| E039 | Gate Stoop (Single) | Single sandstone gate stoop with rounded top on right side of gateway leading to field. Rear inside face of stoop has a cut/groove leading to a hole, with an additional hole below it. Left stoop is concrete. | Good | Removal | |

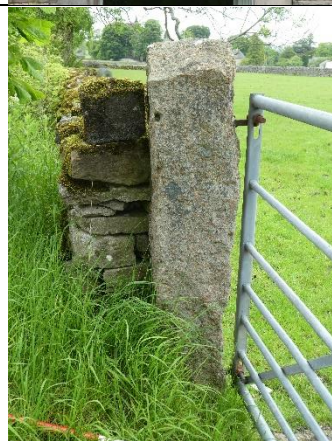
| Feature No. | Feature Type | Description | Condition | Threats | Photograph |
|---|---|---|---|---|---|
| E041 | Gate Stoop (Single) | Single gate stoop made from a rough block of Shap granite on the left side of gateway at the entrance to a field. The front right corner of the stoop has drill marks; the back face has two iron hinges with modern gate attached. | Good | Removal; erosion | |

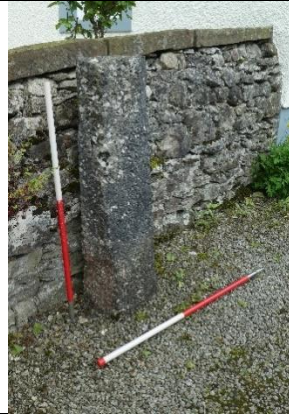
| Feature No. | Feature Type | Description | Condition | Threats | Photograph |
|---|---|---|---|---|---|
| E042 | Gate Stoop (Single) | Single limestone gate stoop with flat top, located on left side of drive-way to private residence. | Good | Erosion | |

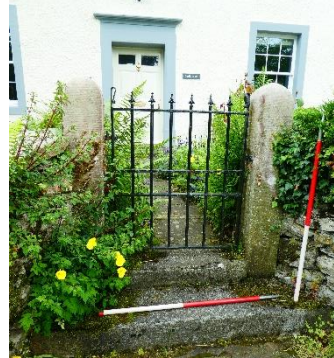
| Feature No. | Feature Type | Description | Condition | Threats | Photograph |
|---|---|---|---|---|---|
| E043 | Gate Stoops (Pair) | Pair of sandstone gate stoops with rounded convex pyramid tops and tool markings on sides. Left stoop has two iron hinges with metal gate attached. Right stoop has cut away section with gate catch. Located outside of private residence. | Good | Erosion | |

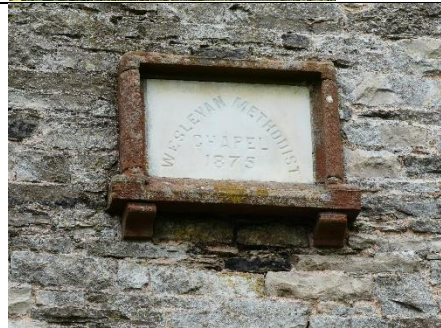
| Feature No. | Feature Type | Description | Condition | Threats | Photograph |
|---|---|---|---|---|---|
| E044 | Date Stone | Stucco/sandstone date stone with a sandstone frame, engraved with "WESLEYAN METHODIST CHAPEL 1875". Located on gable end of the former chapel. | Good | Erosion; removal | |

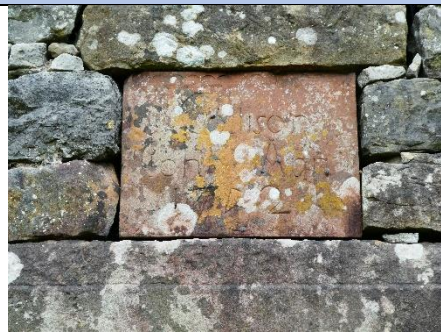
| Feature No. | Feature Type | Description | Condition | Threats | Photograph |
|---|---|---|---|---|---|
| E045 | Date Stone | Red sandstone inscribed with "Collison Iohn Ann 1752". Top of the stone has shallow inscribed scalloped edges with a plain line around the other three sides. Stone located on the gable end of a barn above a doorway, doorway lintel is shaped as an arch. A lintel is situated above date stone. Date stone and door lintel/quoins are probably reused/repurposed from elsewhere (or a substantial rebuild on site). | Fair | Erosion; vegetation; removal | |

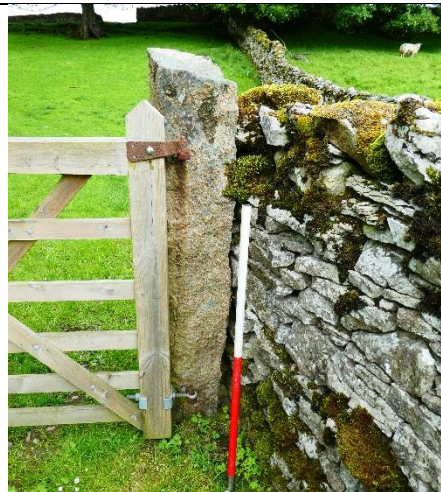
| Feature No. | Feature Type | Description | Condition | Threats | Photograph |
|---|---|---|---|---|---|
| E046 | Gate Stoop (Single) | Single gate stoop made from a rough block of Shap granite on the right side of a gateway leading to a field. Two hinges lead into stone on the front face of the stoop with modern wooden gate attached. Drill marks visible on the back of the middle face. | Good | Removal | |

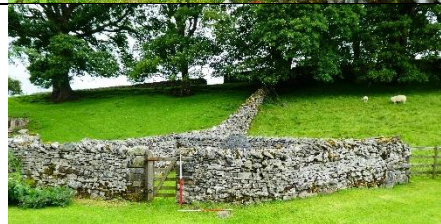
| Feature No. | Feature Type | Description | Condition | Threats | Photograph |
|---|---|---|---|---|---|
| E047 | Pin Fold | Pin fold visible on 6" OS map (but not labelled). Wall at the back of the pinfold possibly rebuilt. An egg shaped sculpture is in centre of the pin fold, added in 2002 by Andy Goldsworthy. | Good | Vehicles | |

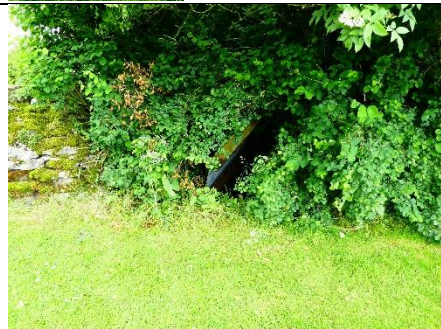
| Feature No. | Feature Type | Description | Condition | Threats | Photograph |
|---|---|---|---|---|---|
| E049 | Well | Former well for the village, possibly had steps down, entrance now covered by a hedge. Marked on 6" OS maps. Now mostly filled with stones but water table still visible. | Poor | Vegetation; neglect | |

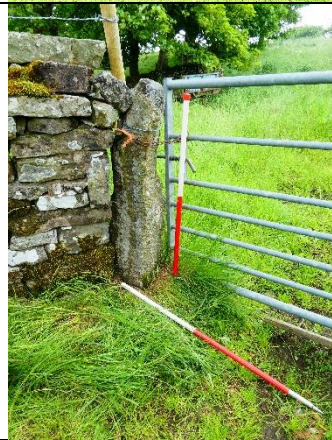
| Feature No. | Feature Type | Description | Condition | Threats | Photograph |
|---|---|---|---|---|---|
| E050 | Gate Stoop (Single) | Single gate stoop on the left side of gateway leading to fields made from a rough block of Shap granite, with a hinge on front face. Stoop triangular in profile with drill marks visible. | Good | Vehicles; removal | |

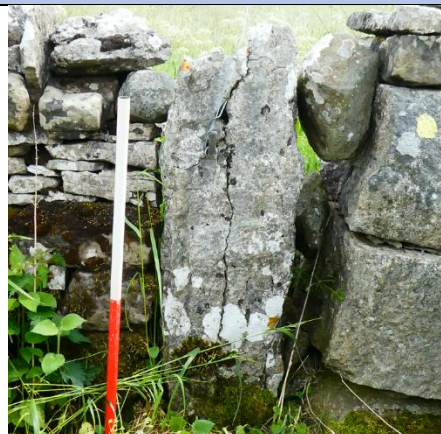
| Feature No. | Feature Type | Description | Condition | Threats | Photograph |
|---|---|---|---|---|---|
| E051 | Gate Stoop (Single) | Single limestone gate stoop with two iron hinges on the front face, with cracks running down its centre. Large quoins forming wall head on the right side. Stoop built into wall for unknown purpose, possibly linked to agricultural improvement or changes to access/land ownership. | Fair | Erosion; removal | |

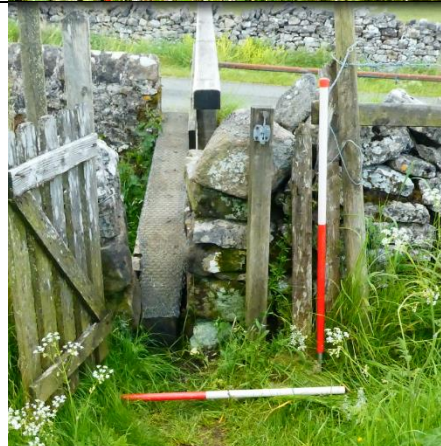
| Feature No. | Feature Type | Description | Condition | Threats | Photograph |
|---|---|---|---|---|---|
| E052 | Squeeze Stile | Squeeze stile in dry stone wall, one step down to ground on north western side. Stile allows access to PROW on the norther west side of the bridge; Wooden footbridge allows crossing of the beck. Footpath marked on historic OS maps. | Good | Wall collapse | |

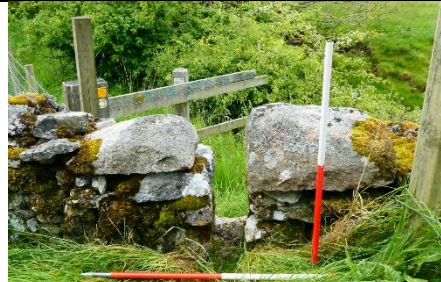
| Feature No. | Feature Type | Description | Condition | Threats | Photograph |
|---|---|---|---|---|---|
| E053 | Squeeze Stile | Squeeze stile in a limestone dry stone wall with two Shap granite cap stones. Stile flares out towards field with three steps down into the field. | Good | Wall collapse | |

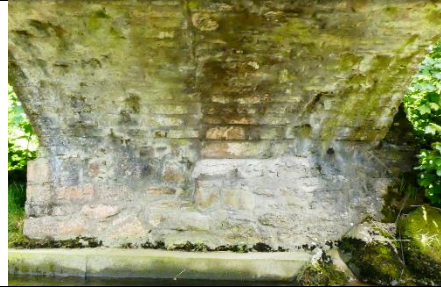
| Feature No. | Feature Type | Description | Condition | Threats | Photograph |
|---|---|---|---|---|---|
| E054 | Bridge | Holme Bridge over the Lyvennet Beck made from sandstone, has previously been widened and has significant foundations at base. Bridge marked and named on 6" and 25" OS maps (although called Woodfoot Bridge on the Westmorland XXI.4 map, surveyed: 1858, published: 1859). | Good | Flooding | |

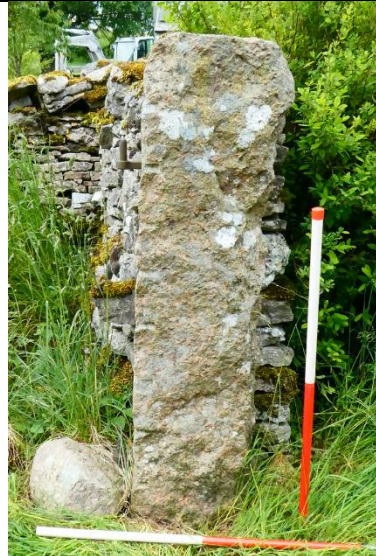
| Feature No. | Feature Type | Description | Condition | Threats | Photograph |
|---|---|---|---|---|---|
| E055 | Gate Stoop (Single) | Single Shap granite gate stoop with flat top and drill marks on the right side of gateway. Stoop has two iron hinges on the centre face. Wooden gate-post on opposite side of gateway, probably former fell gateway to Crosby Ravensworth Fell shown on 25" OS maps. | Good | Removal | |

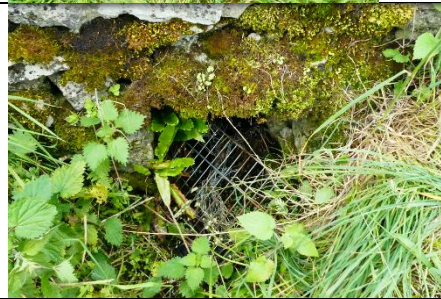
| Feature No. | Feature Type | Description | Condition | Threats | Photograph |
|---|---|---|---|---|---|
| E056 | Culvert | Two culverts located on either side of the original fell gateway to Crosby Ravensworth Fell. Culvert openings are on fell side of the gateway before going under the dry stone wall. North west culvert has square opening. South east culvert has a number of circular openings (pipes?). Metal grills over each. | Fair | Vegetation; sediment; flooding | |

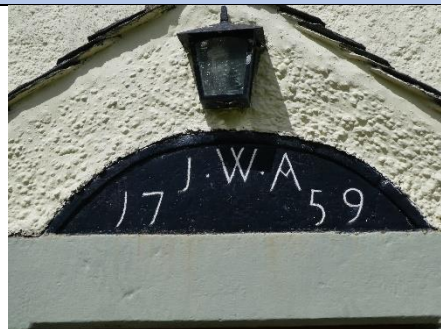
| Feature No. | Feature Type | Description | Condition | Threats | Photograph |
|---|---|---|---|---|---|
| E057 | Date stone | Semi-circular date stone painted black inscribed with "17 J. W. A 59", inscription painted white. Stone located on porch of Fell Gate house. | Good | Removal; erosion | |

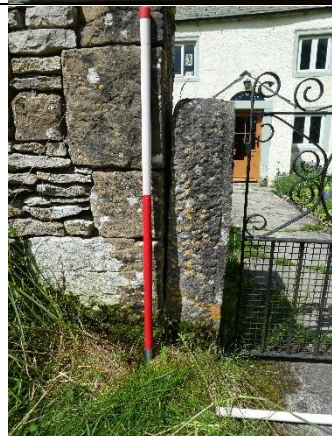
| Feature No. | Feature Type | Description | Condition | Threats | Photograph |
|---|---|---|---|---|---|
| E058 | Gate Stoop (Single) | Single limestone gate stoop with rounded top, rusticated detailing and tool marks located on left side of gateway to private residence. Right stoop is concrete. | Good | Erosion; removal | |

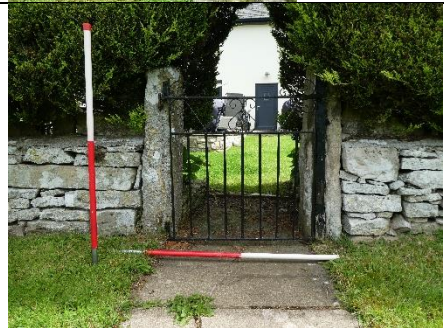
| Feature No. | Feature Type | Description | Condition | Threats | Photograph |
|---|---|---|---|---|---|
| E061 | Gate Stoops (Pair) | Pair of gate stoops leading to private residence. Left stoop is limestone with two iron hinges and modern gate attached. Right stoop is sandstone(?) with gate catch attached. | Fair | Erosion; removal | |

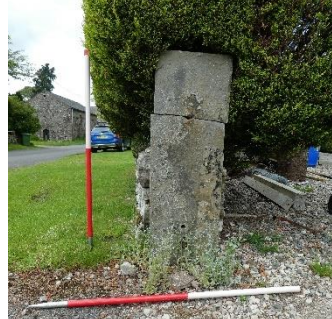
| Feature No. | Feature Type | Description | Condition | Threats | Photograph |
|---|---|---|---|---|---|
| E062 | Gate Stoop (Single) | Single mudstone(?) gate stoop leading to driveway. Square top with rusted iron hinge. Hole above hinge probably from previous hinge/ fixing and second hole near the top of the stoop. Top third of stoop cracked, probably due to previous fixing. | Poor | Erosion; removal | |

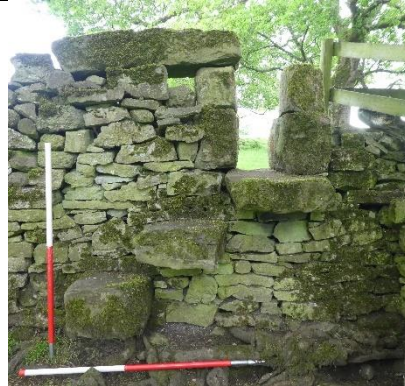
| Feature No. | Feature Type | Description | Condition | Threats | Photograph |
|---|---|---|---|---|---|
| E063 | Step Stile | Step stile in limestone dry stone wall. West side of stile has three steps; east side of stile has two (third on ground) steps. Steps made up of large blocks of sandstone. | Good | Wall collapse | |

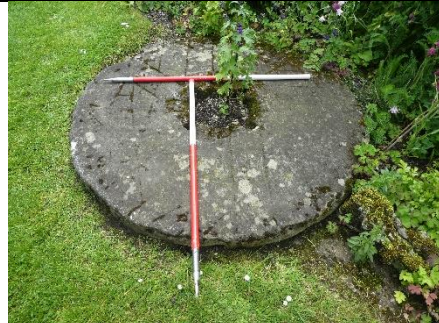
| Feature No. | Feature Type | Description | Condition | Threats | Photograph |
|---|---|---|---|---|---|
| E065 | Mill stone | Round stone with grooves in top and hole in the centre, possibly a former mill stone or used in the smithy. Metal capping around the edges recently removed (informed by occupant). Located to the left of the old smithy shown on the 6" and 25" OS maps, currently used as garden feature. | Fair | Erosion; removal; vehicles | |

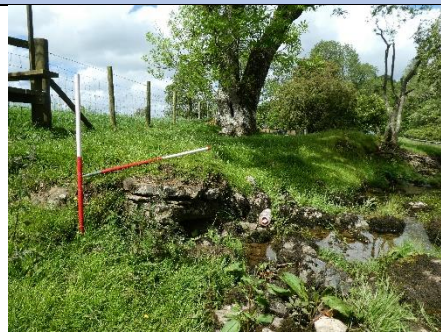
| Feature No. | Feature Type | Description | Condition | Threats | Photograph |
|---|---|---|---|---|---|
| E066 | Mill Race | Mill race and weir visible on the 1841 tithe map for Crosby Ravensworth parish, with the mill race and former Corn Mill marked on the first edition 6" OS map. With the weir and part of the race shown on some of the subsequent maps. Remains of the weir is no longer visible except a few large stones, the start point of the race is now only visible as a partial earth work. The course of the race travelled to a former mill (building demolished) before discharging into the Dalesbank Beck just north of the old vicarage. The remains of the race can be seen in the garden of the former vicarage (NY6223714817), but it is now mostly used as a storm drain and covered by iron railings. | Poor | Vegetation; flooding; sediment | |

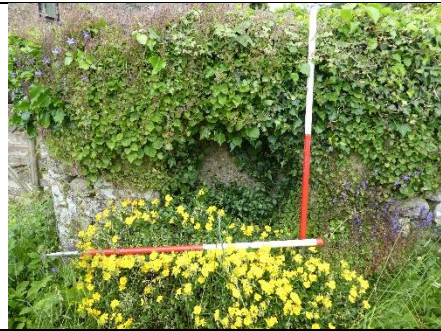
| Feature No. | Feature Type | Description | Condition | Threats | Photograph |
|---|---|---|---|---|---|
| E067 | Trough | Arched alcove in stone wall of Glebe House (former vicarage). Long stone protruding at the base. Possible drinking trough but now used as planter and very overgrown. Labelled on the third edition 25" OS map (Westmorland XIV.16 revised: 1913, published: 1915b). | Poor | Vegetation; vehicles | |

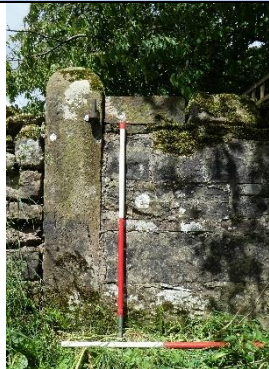
| Feature No. | Feature Type | Description | Condition | Threats | Photograph |
|---|---|---|---|---|---|
| E068 | Gate Stoops (Pair) | Pair of sandstone gate stoops with rounded pointed convex pyramid shaped tops. Both stoops have visible tool marks and two iron and leaded hinges on the front face, suggesting a double gate (gateway now blocked, located in wall around former vicarage) with cracks radiating from the hinges on both sides (left stoop worse than right). | Fair | Vegetation; erosion | |

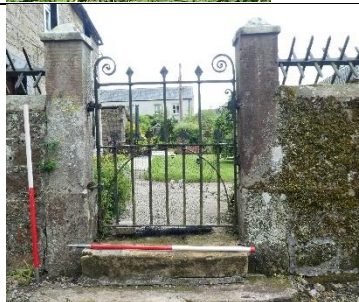
| Feature No. | Feature Type | Description | Condition | Threats | Photograph |
|---|---|---|---|---|---|
| E069 | Gate Stoops (Pair) | Pair of square-cut sandstone gate stoops with visible tool marks and decorative pointed caps outside private residence. Left stoop has gate catch, right stoop has double hinge and metal gate attached. Right stoop has slight crack radiating from gate catch. | Good | Vegetation; erosion | |

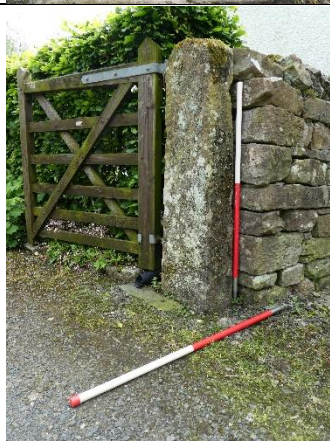
| Feature No. | Feature Type | Description | Condition | Threats | Photograph |
|---|---|---|---|---|---|
| E070 | Gate Stoop (Single) | Single sandstone gate stoop with rounded top, tool marks and unused hole (probably for former hinge). Modern metal hinges attached to rear face with gate attached. Located on right side of gateway entrance to farmyard, left side has a wooden gatepost. | Good | Erosion | |

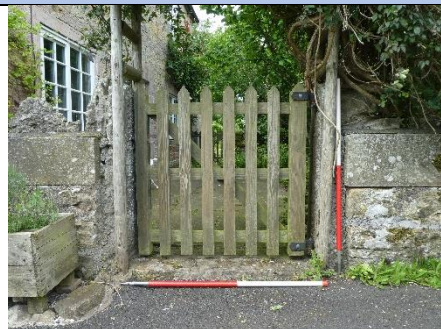
| Feature No. | Feature Type | Description | Condition | Threats | Photograph |
|---|---|---|---|---|---|
| E071 | Gate Stoops (Pair) | Pair of sandstone gate stoops with rusticated detail and rounded tops. Left stoop has a hole for a former fixing on the inside face and a modern gate catch. Right stoop has metal hinges with wooden gate attached. Located at entrance to private residence. Both stoops concreted into wall. | Fair | Erosion | |

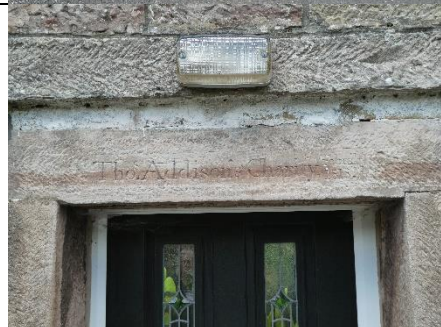
| Feature No. | Feature Type | Description | Condition | Threats | Photograph |
|---|---|---|---|---|---|
| E072 | Date Stone | Tooled sandstone lintel on front elevation of house (including door lintel and jambs). Lintel inscribed with "Tho <sup>s</sup> . [Thomas] Addison's Charity rebuilt 1818.". | Good | Erosion | |

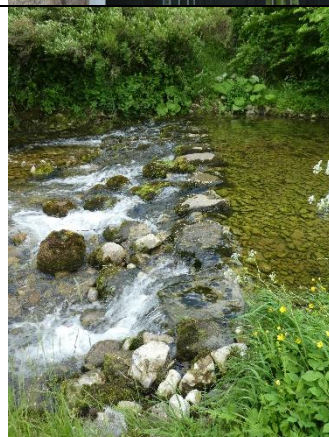
| Feature No. | Feature Type | Description | Condition | Threats | Photograph |
|---|---|---|---|---|---|
| E073 | Stepping Stones | Mixture of 10 large stones (limestone, sandstone, Shap granite?), some below water creating a small weir. Apparently restored in the early 2000s. Stepping stones shown on the third edition of the 25" OS map (Westmorland XIV.16 revised: 1913, published: 1915). | Fair | Flooding; vegetation | |
