# Small-Scale Heritage Features Survey

Technical Report: Crosby Ravensworth  
November 2023

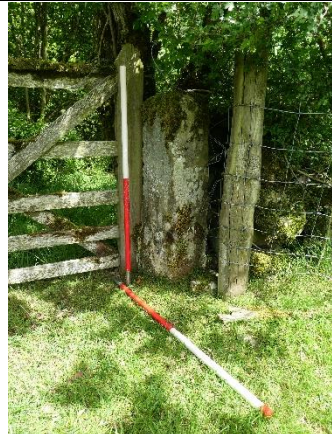
| Feature No. | Feature Type | Description | Condition | Threats | Photograph |
|---|---|---|---|---|---|
| E074 | Gate Stoop (Single) | Single sandstone gate stoop in dry stone wall, on the right side of gateway leading to field. | Good | Erosion; removal | |

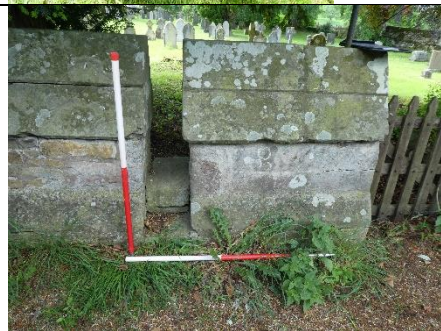
| Feature No. | Feature Type | Description | Condition | Threats | Photograph |
|---|---|---|---|---|---|
| E075 | Squeeze Stile | Sandstone squeeze stile located in boundary wall of St Lawrence's Church. Wall is stylised, with the top designed in a triangular profile. | Good | Vegetation; erosion | |

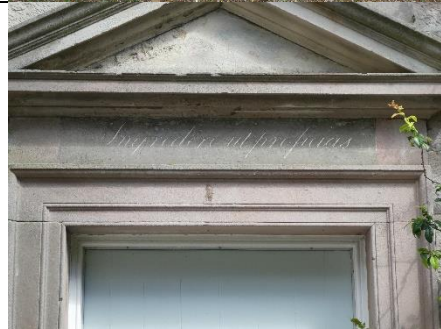
| Feature No. | Feature Type | Description | Condition | Threats | Photograph |
|---|---|---|---|---|---|
| E076a | Date Stone | Former school building with inscription below pediment on front door which reads "Ingredere Ut Proficias" (enter to profit). Inscription running around the west face of the building, below gutter which reads "THIS SCHOOL was rebuilt by a private benefactor in the year of our LORD 1784". School shown in this location from the second edition 6" OS map onwards (Westmorland Sheet XIV.SE revised: 1897, published: 1899) | Good | Erosion | |

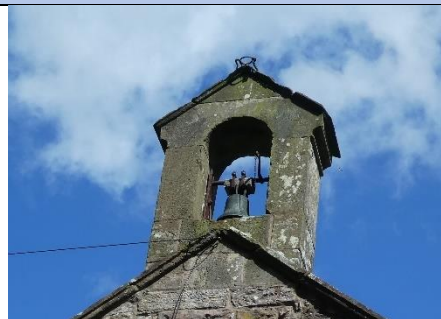
| Feature No. | Feature Type | Description | Condition | Threats | Photograph |
|---|---|---|---|---|---|
| E076b | Bell | Bell in-situ in a small bell tower (bell-cote) built onto the gable end of the former school building. | Good | Erosion; removal | |

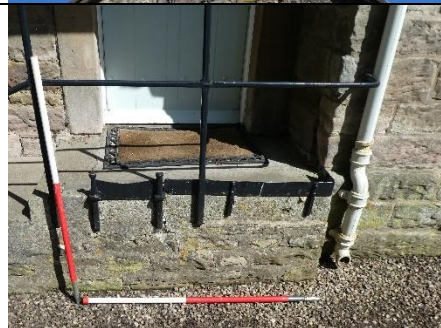
| Feature No. | Feature Type | Description | Condition | Threats | Photograph |
|---|---|---|---|---|---|
| E076c | Boot scraper | Boot scraper opposite left door on front elevation, one scraper is designed piece of iron with finials, other scraper is a long strip of iron, both painted black. | Good | Erosion; removal | |

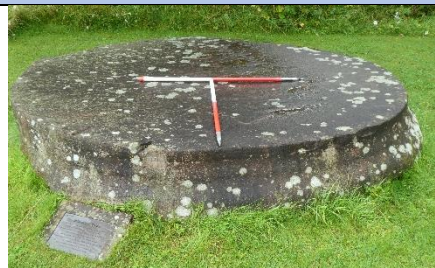
| Feature No. | Feature Type | Description | Condition | Threats | Photograph |
|---|---|---|---|---|---|
| E079 | Memorial | Sandstone taken from the Plumpton quarry in 1996 and placed in Crosby Ravenworth in May 2000 to mark the millennium. The stone has some chipping around the edges and visible quarry marks. | Good | Vegetation; erosion | |

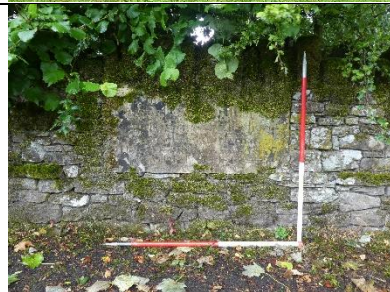
| Feature No. | Feature Type | Description | Condition | Threats | Photograph |
|---|---|---|---|---|---|
| E080 | Date Stone | Three large sandstone blocks in wall around part of the school grounds. Inscriptions on all three stones, but not particularly visible due to vegetation. Left block probably had a bible quote "Teach me thy way O Lord and I will walk in thy [?] truth". Words "Crosby" and "1700" also visible. | Poor | Vegetation; deterioration; erosion | |
