# Small-Scale Heritage Features Survey

Technical Report: Maulds Meaburn

November 2023

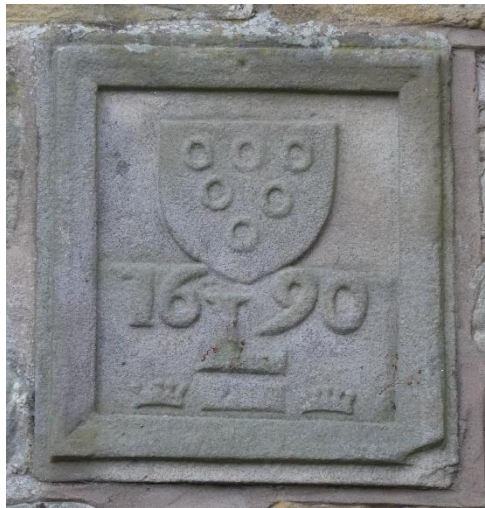
*Figure 4: Image showing date stone.  
Lowther crest above the cart door on the  
old mill.*

4.6 Feature F032 (**Error! Reference source not found.**) is a square sandstone block located above the doorway of the former corn mill. The stone has a boarder with the Lowther family crest carved above the 1690 date which itself is separated into two sections by an 'L' initial (referring to the Lowthers) in the centre. Below this are two crowns on either side and reflects the mill's manorial status.

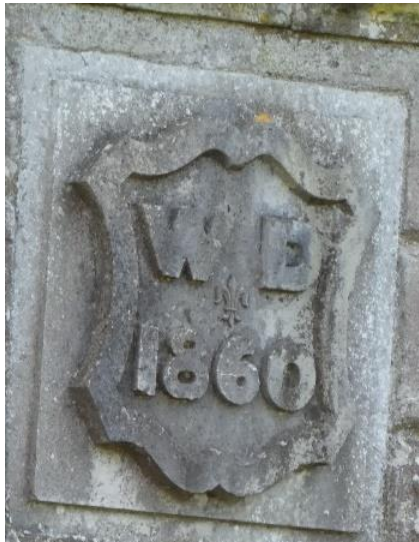
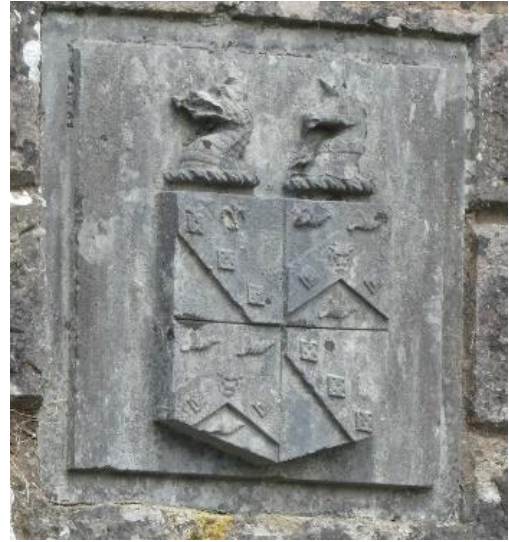
*Figure 5: Image showing feature F052 the date stone (left) and Dent family crest (right) located on the bridge to the south of the village.*

4.8 Another crest and date stone (F052, Figure 5: Image showing feature F052 the date stone (left) and Dent family crest (right) located on the bridge to the south of the village.) can be found on the bridge to the south of the village, adjacent to The

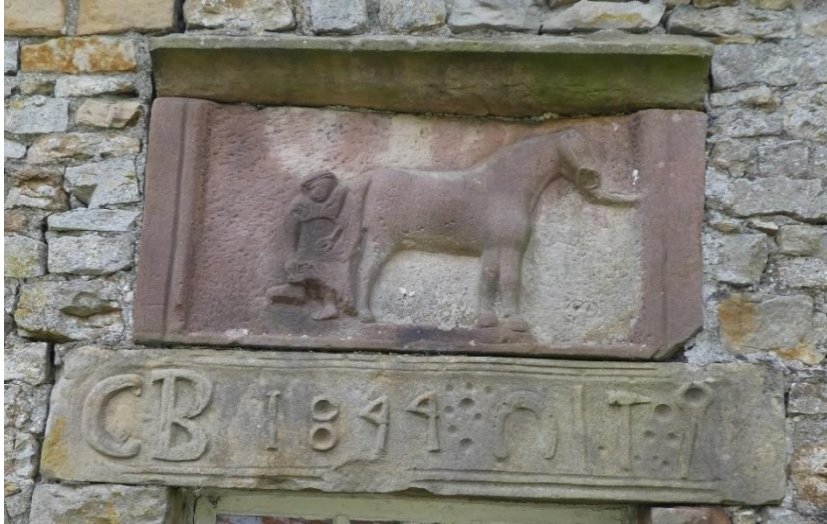
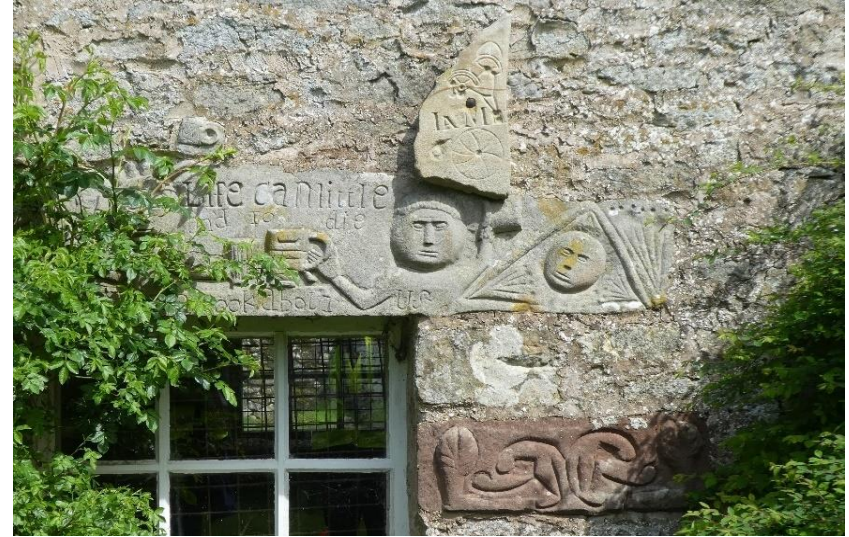
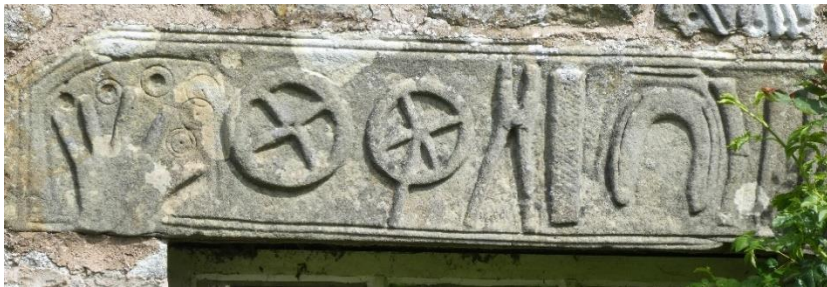
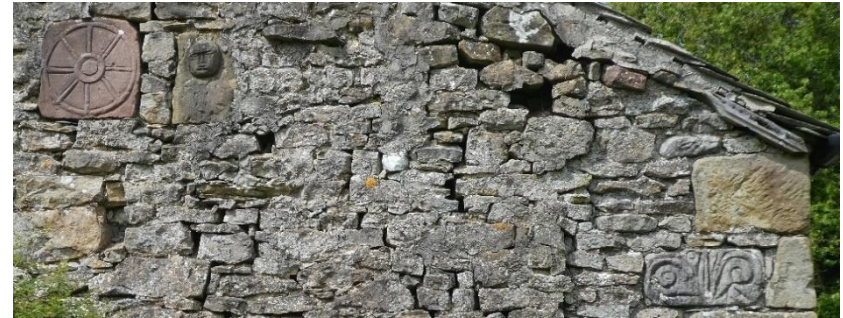
Figure 6: Images showing a series of carvings on the Old Smithy

4.9 As mentioned earlier (paragraph 3.27), the smithy to the south-east of the village has a date stone (F056) along with a large number of carvings on different elevations of the building (**Error! Reference source not found.**). The window lintel on the east elevation low relief carvings of the initials 'CB' followed by '1844' and a selection of blacksmithing tools relief. The letters refer to Christopher Bowman, a noted local poet, as well as the village blacksmith. Above the date stone is a relief carving of someone shoeing a horse, with a number of additional carvings on the rear of the building, which suggest an experimentation of carving styles.

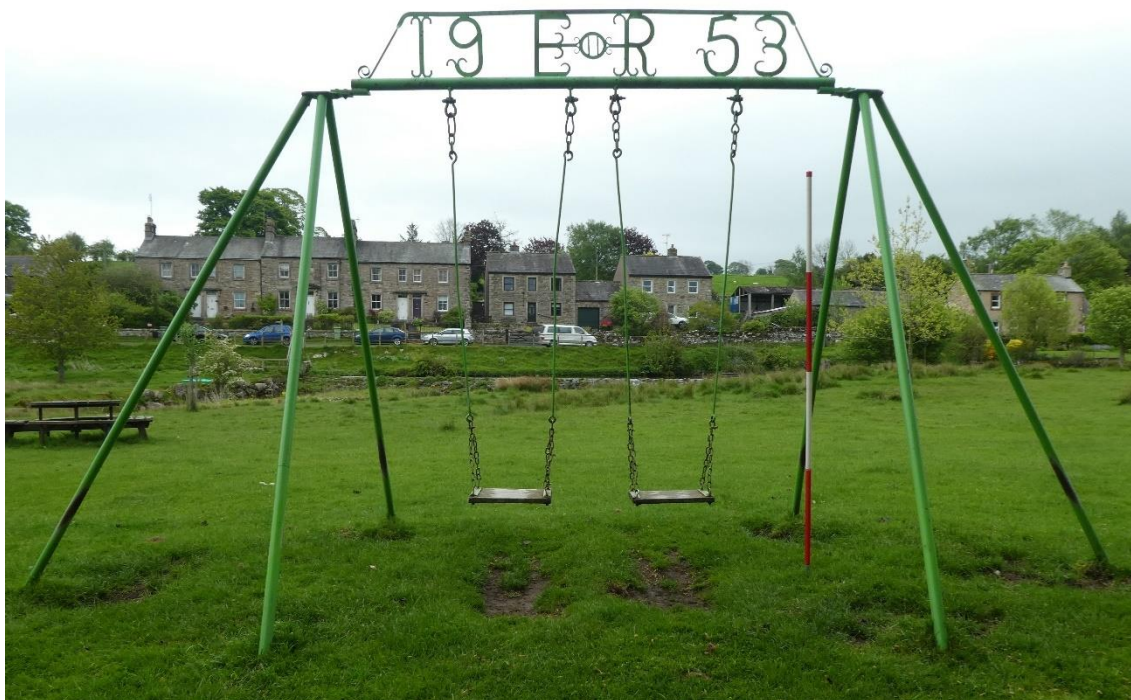
4.12 A swing set (F002) is located north of The Green and has the date “19 E II R 53” on the top horizontal support commemorating the coronation of Queen Elizabeth II. The swing set is an unusual feature in the area, however a similar swing set is located within Crosby Ravensworth village (E008, see Crosby Ravensworth Report), with a near identical swing set in Reagill (c 1.5 miles north and within Crosby Ravensworth Parish) and Sleagill (c. 2.5 miles north, within Sleagil Parish which

*Figure 7: Image showing the swing set at Maulds Meaburn.*

boarders Crosby Ravensworth). This swing set was reportedly made by a Mr Pigney, the last blacksmith in the area (Relph 1999).

- d. In addition to the above, further research into the coronation swing sets and crown finials found within the village and wider area would provide a clearer picture of their provenance and history, thereby contributing to their future management and preservation.

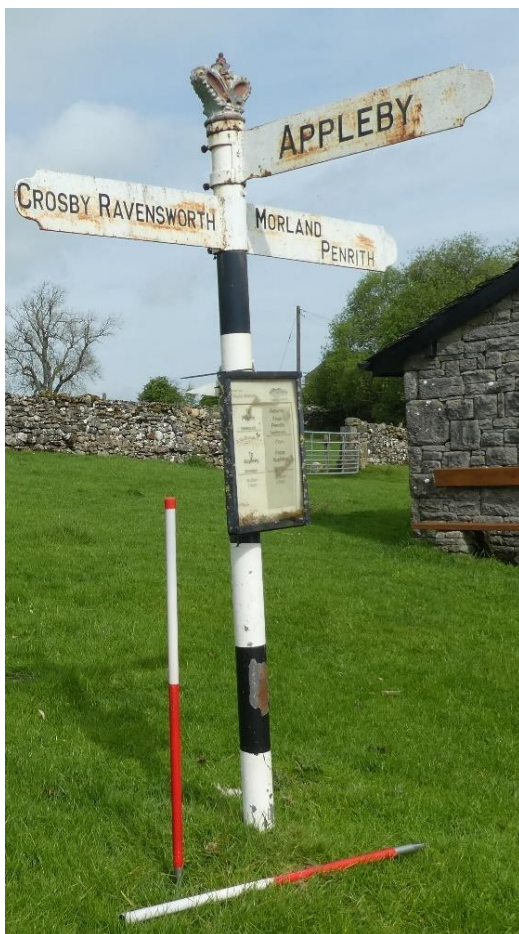
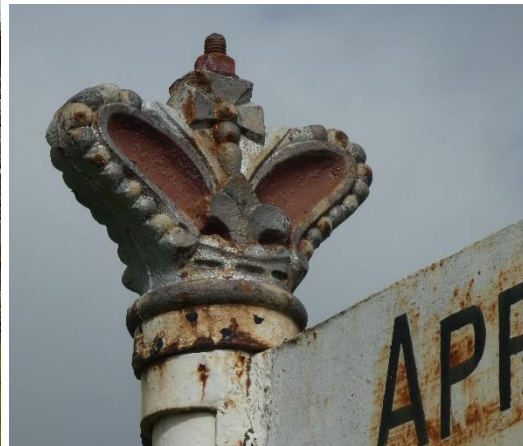
*Figure 8: Finger post (F021) located at the south end of Maulds Meaburn with a decorative crown final.*

4.15 Maulds Meaburn has several finger posts within the village. The first of these (F021) is located on the west side of the villages' southern bridge, next to the former bus shelter and is possibly the same guide post referred to in this location on the OS maps. The pole is circular and painted black and white, with three arms at the top, each of which have button shaped ends pointing towards Cosby Ravensworth, Appleby, Morland and Penrith (**Error! Reference source not found.**). An unusual crown finial sits on the top of the pole. This type of finial is unique to the fingerposts of the West Ward of Westmorland, however, their origin and purpose is unknown. It has been suggested that they are possibly associated with Queen Victoria's 1987 Diamond Jubilee, with later ones marking the Coronation of George V (Hill 2019), alternatively they may be associated with the Lowther family (Cumbria Industrial History Society 2009). No others finger posts with crown finials were recorded as part of this project.

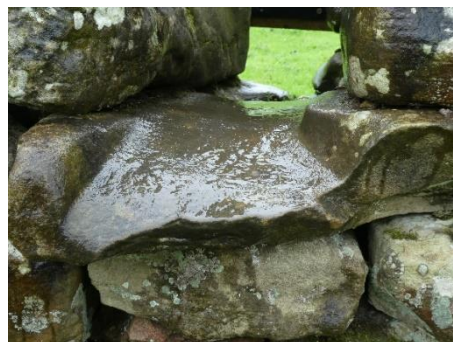
*Figure 9: Image showing squeeze stile F009 with the shaped stone in the centre of the stile being used as stepping surface.*

4.27 Stile F009 is built into a dry stone wall, the east side has at least four stones on the ground leading to the stile, with only one stone on the ground on the west side. The stone in the centre of the stile (creating the stepping surface) has probably been repurposed from elsewhere as it has been shaped (**Error! Reference source not found.**).

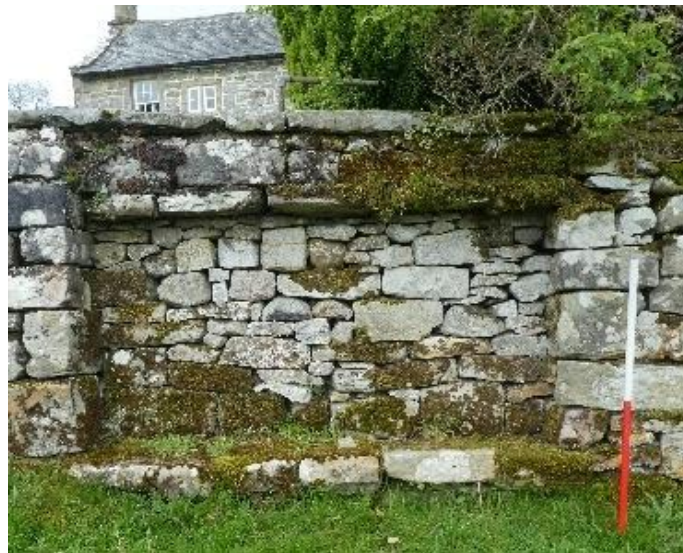
*Figure 10: An unknown east-facing recess in the wall outside of Meaburn Hill (possibly a bee bole).*

boundary wall of Meaburn Hill to the south of the village. The recess is reportedly a bee bole, with other bee boles also being present within the garden (Kingsbury 2022 *pers. comm.*). While the size of the recess is larger than many bee boles, its orientation and location close to the front door is more common.

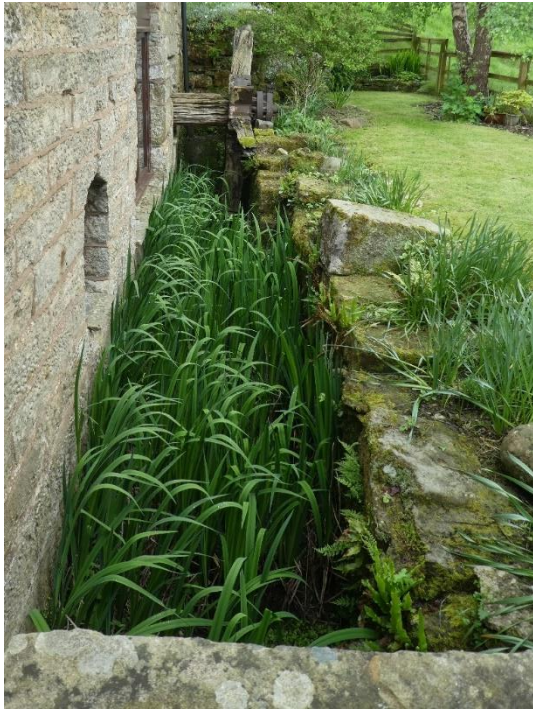
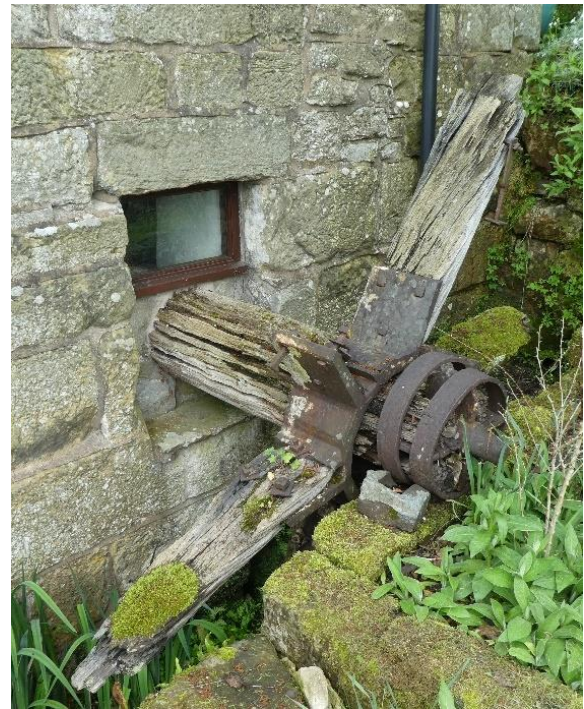
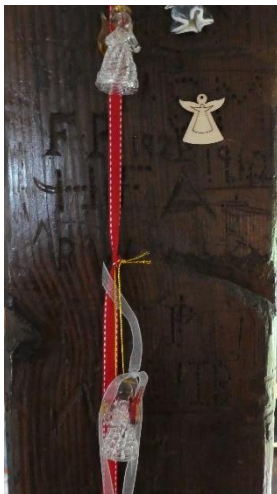
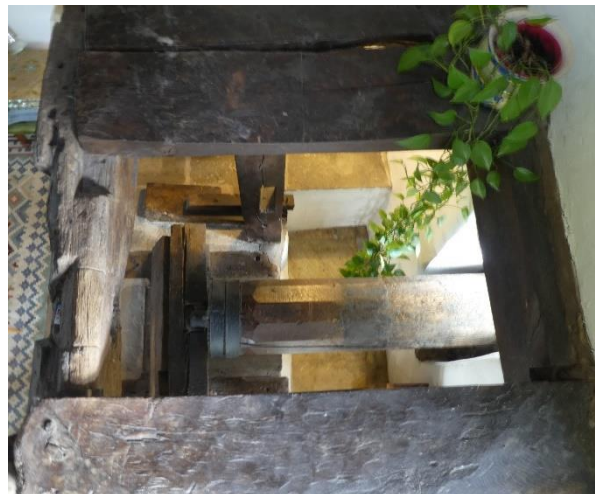
*Figure 11: Images from the Corn and Saw Mill*

*Top left – Mill race*

Figure 11) which is still visible on the outside of the property (although in very poor condition). The mill wheel is situated in the former mill race (F032d, Figure 11) that is part of the wider scheduled monument. The internal section of the mill wheel is still present inside the property, along with other bits of surviving woodwork some of which have engraved initials on them, believed to be from former mill workers.

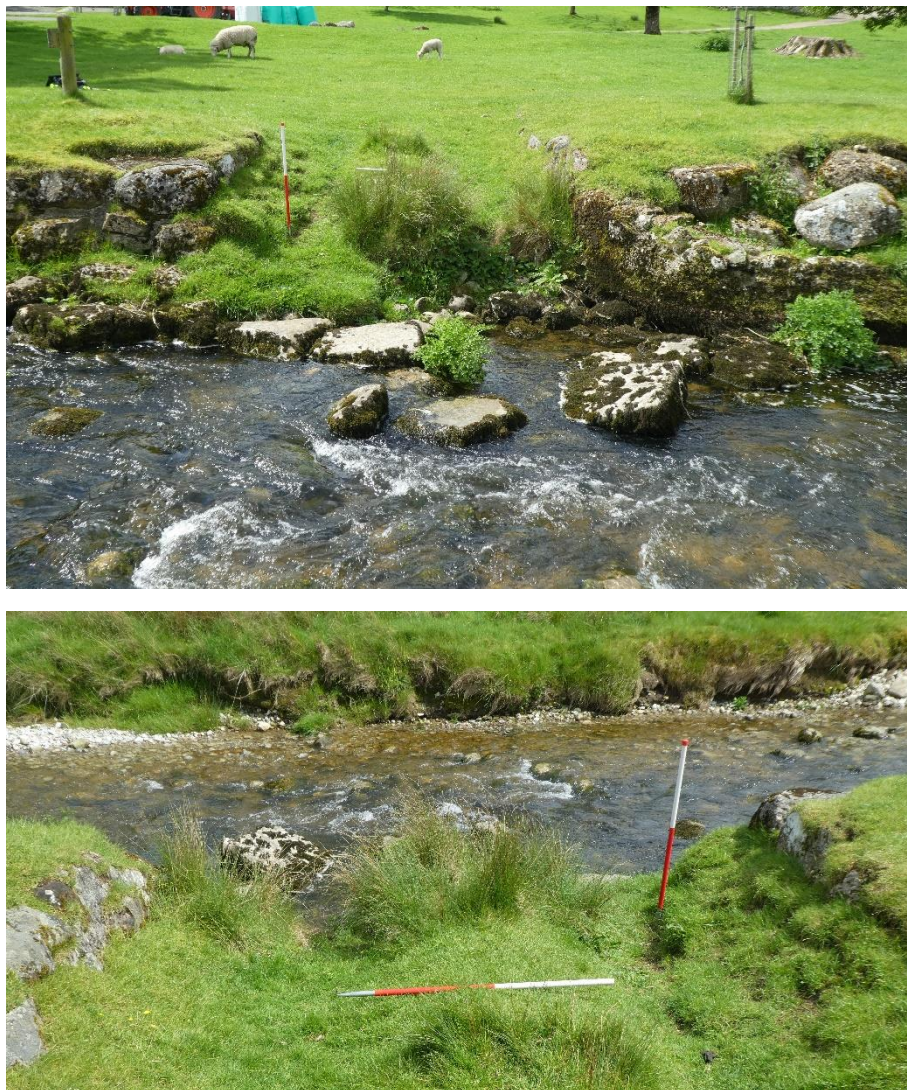
4.35 An unknown feature (F029, Figure 12) to the south of the former school (now School House) was recorded during the survey. The feature comprises a ramp cut

into the river bank. Blocks on either side of the ramp are visible and form a curved revetment, with some additional stones creating an 'arm' into the water. While the

*Figure 12: Image showing unknown feature F029.*

feature is shown on the twenty-five-inch map as two parallel lines on the edge of the river bank, it is not labelled. It is unclear what the purpose of this feature was, it may possibly have been agricultural in nature and represent a former ford or water access point for a sheep wash; alternatively, it could have been more domestic and represent a laundry spot.

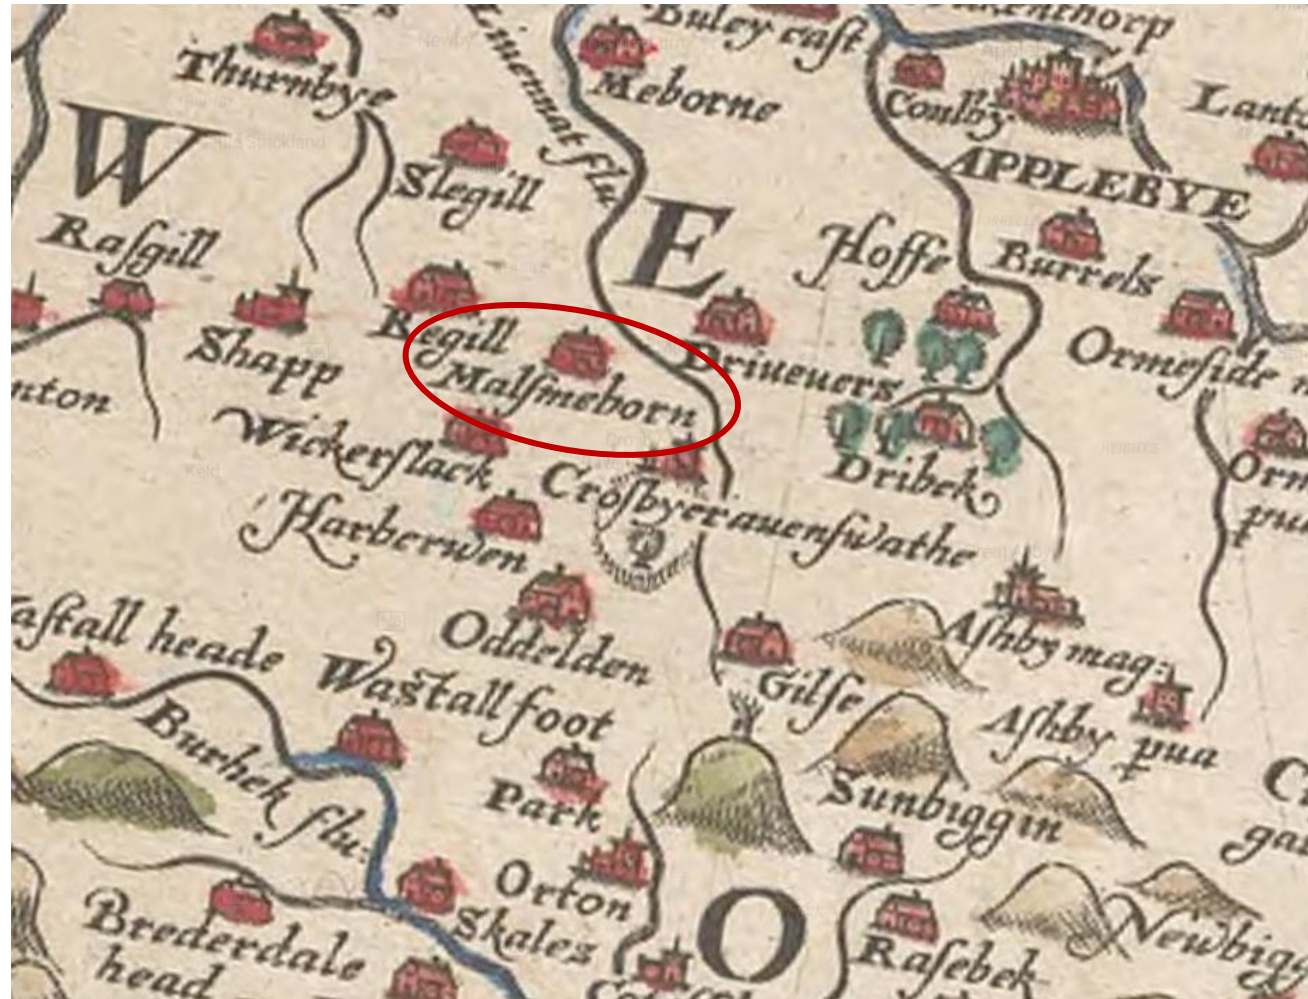
10.1 The 1583 edition of the Saxton Atlas of England and Wales (**Error! Reference source not found.**) shows the location of 'Malsmeborn' (circled). The icon of a house next to village name suggests there was a small settlement in the area (University of Glasgow 2022).

Figure 14: The map of Westmorland and Cumbria from the 1583 edition of the Saxton atlas of England and Wales (Old Maps Online 2022) showing the village of Malsmeborn circled in red.

3.19 A deer park is shown at Maulds Meaburn on the 1695 Morden map and the 1760 Bowen and Kitchin map (Lakes Guide 2022). The park's absence from the 1583 edition of the Saxton Atlas of England and Wales (Figure 14) and the 1662 map by Joan Blaeu, suggests it was created between 1662 and 1695. However the park is not shown on Jeffery's 1778 map (Figure 16), rather a plantation of trees is shown either side of Meaburn Hall. This could suggest the deer park had gone out of use by this time or the area had become a landscaped park. The first edition six-inch OS map, along with the one-inch OS map<sup>2</sup> label Meaburn Park, although it is not included on subsequent maps. There is reference to a 'high-walled' park that rings

3.29 The spelling of Maulds Meaburn changes dramatically over a 200-year period. It was first recorded as “Malsmeborn” on the 1583 edition of the Saxton Atlas of England and Wales (Figure 14) with a slight change to “Malmesborne” on the 1662 map by Joan Blaeu (**Error! Reference source not found.**). However, the Jeffery’s 1778 map (Figure 16) shows the village as Maulds Meaburn which is significantly different. This has continued in use until the present day and is shown on the Tithe map and later OS maps.

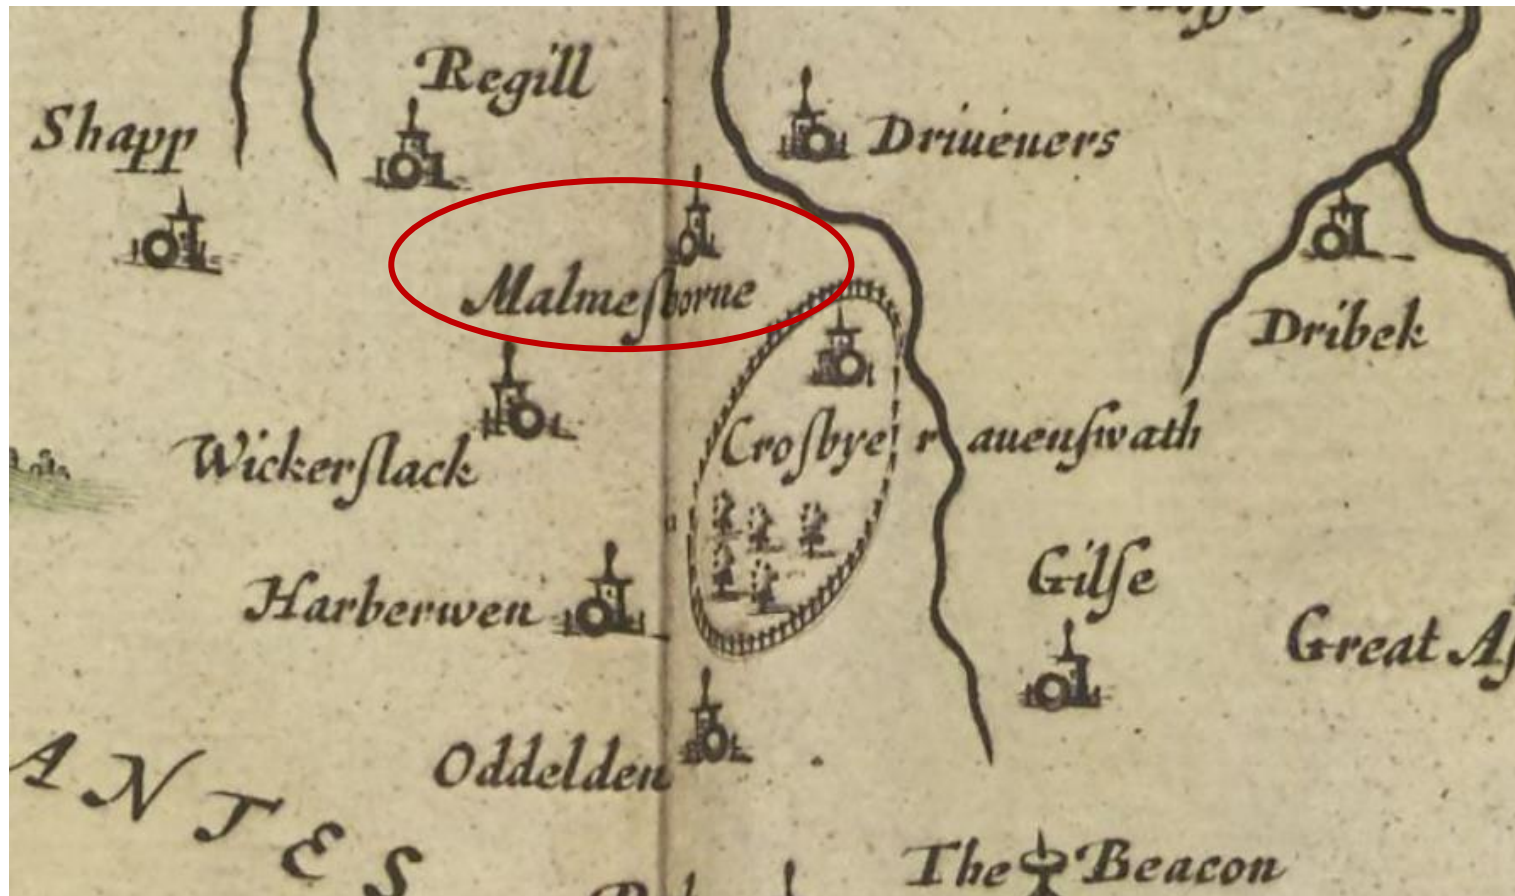
10.2 The 1662 map by Joan Blaeu (**Error! Reference source not found.**) shows the village of Malmesborne (circled). The symbol next to the village name is possibly a church, but it's unclear what this would refer to as the parish church is St Lawrence in Crosby Ravensworth.

Figure 15: The map of Westmorland by Joan Blaeu, printed in 1662 (National Library of Scotland 2022) showing the village of Malmesborne circled in red.

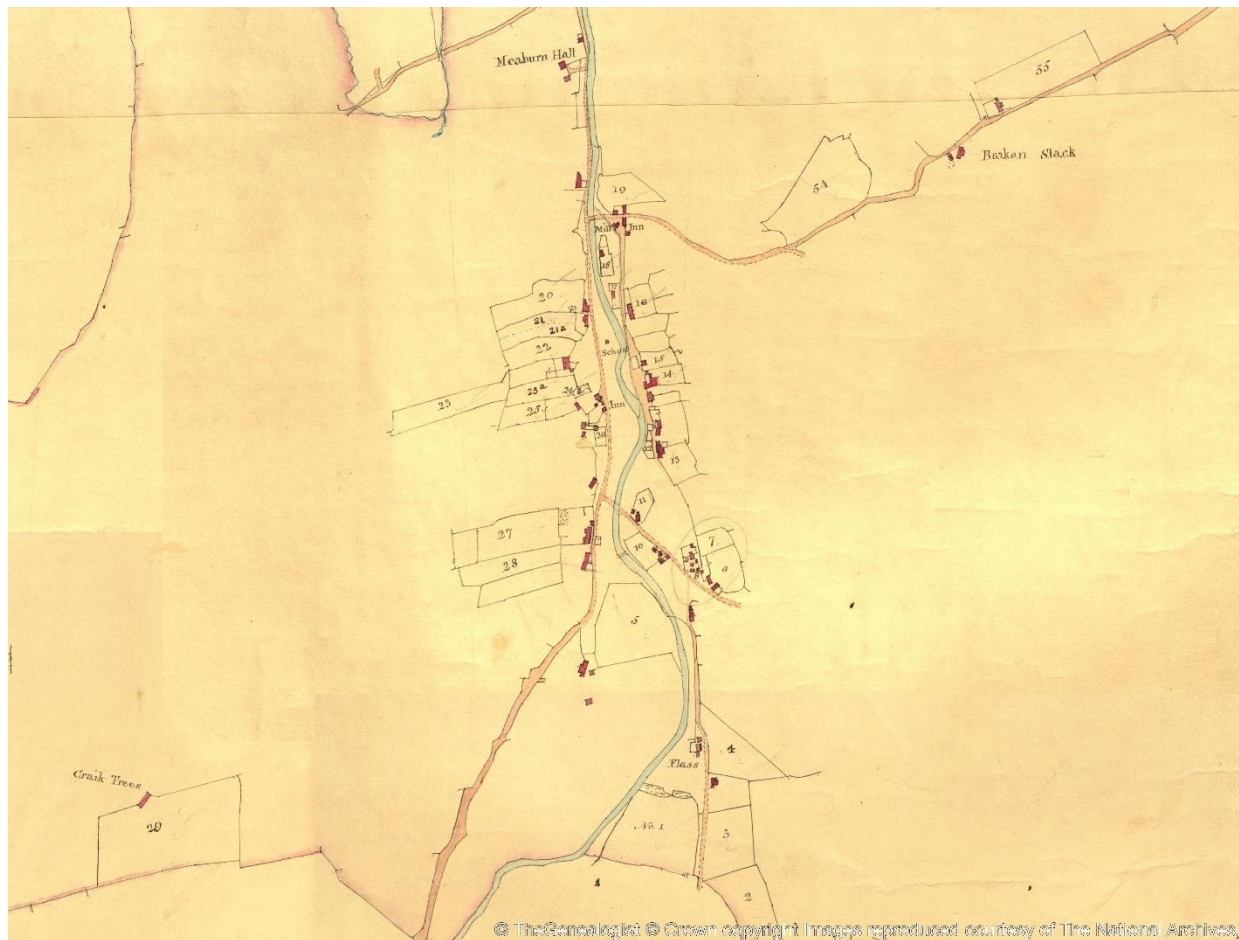
10.4 The 1844 Tithe map (Figure 17) provides the first detailed layout of Maulds Meaburn. It shows the types of buildings within the village, as well as the layout of some of the fields immediately behind the houses. No back lane or further field systems are shown on this map.

Figure 17: The 1843 Tithe map for Maulds Meaburn (The Genealogist 2022).

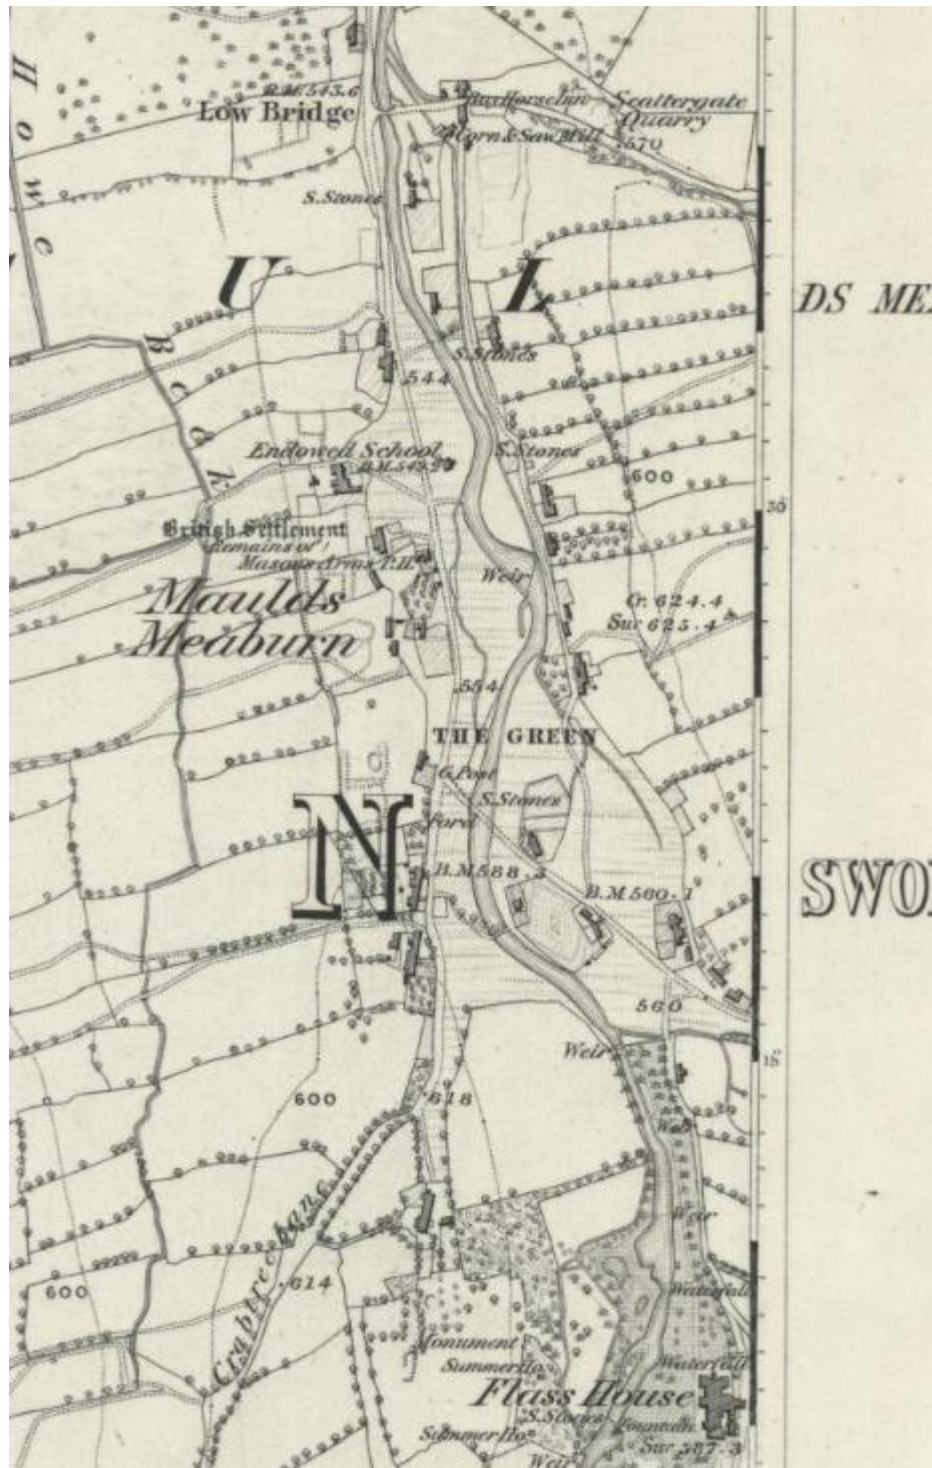
10.5 The first edition six-inch OS map (Figure 18) provides quite a lot of information on the village, labelling Scattergate quarry, the Bay Horse Inn and the Corn and Saw Mill to the north. A variety of stepping stones shown going across the river, along with the endowed school and the Mason Arms P.H. A guide post is shown close to the green along with a ford.

Figure 18: The first edition six-inch OS map for Maulds Meaburn (Westmorland Sheet XIV. Surveyed: 1858 to 1859, Published: 1863 National Library of Scotland 2022).

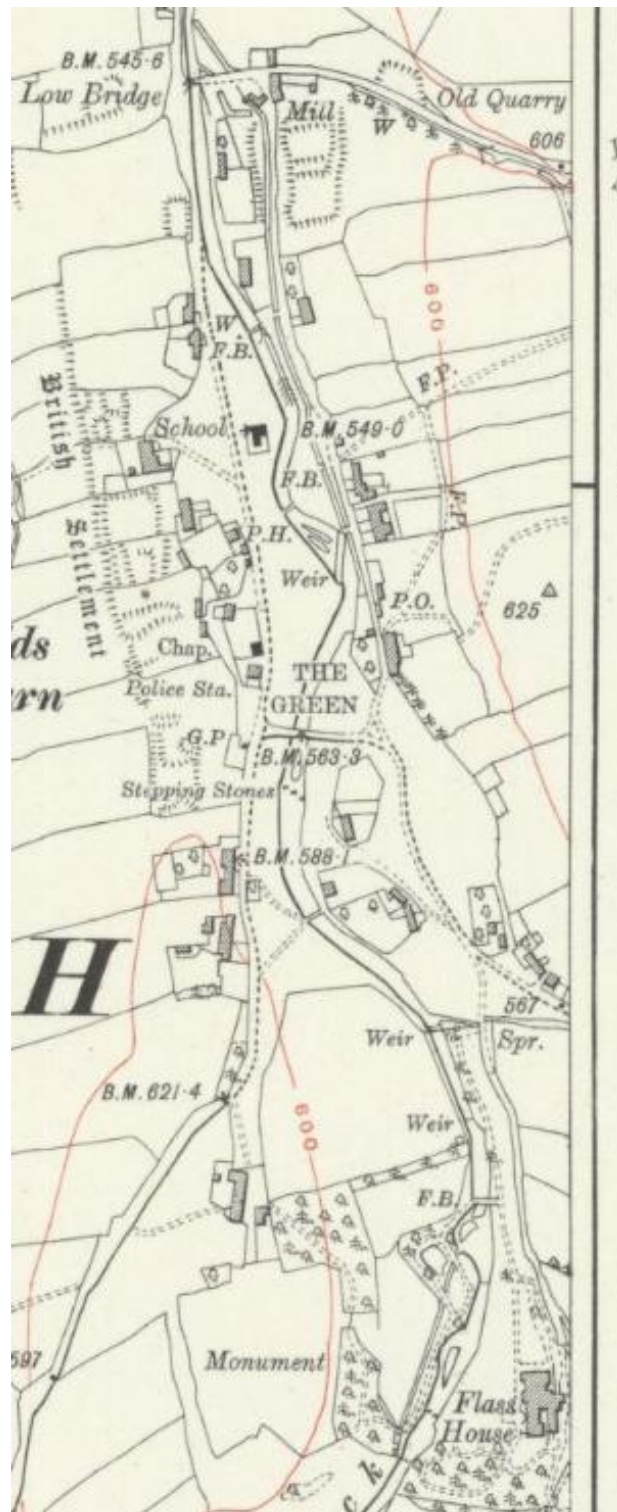
10.7 The third edition six-inch OS map (Figure 20) shows a chapel and police station located to the west of the green, along with a well to the north.

Figure 20: The third edition six-inch OS map of Maulds Meaburn (Westmorland Sheet XIV.SE. Revised: 1913, Published: 1920 (National Library of Scotland 2022).

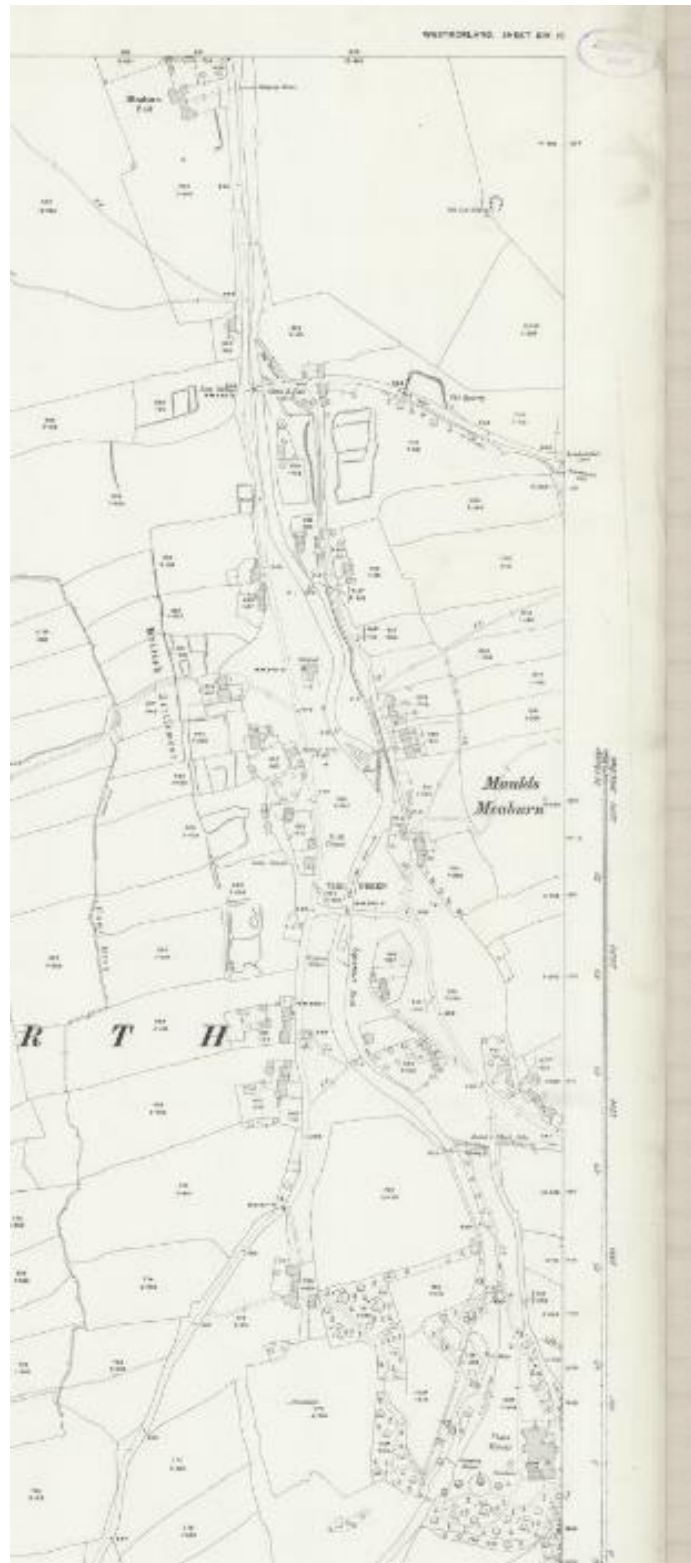
10.8 The third edition twenty-five-inch OS map shows quite a lot of detail about the buildings within the village, with the mill race and mill steam both being labelled for the first time.

Figure 21: The third edition twenty-five-inch OS map of Maulds Meaburn (Westmorland XIV.12. Revised: 1913, Published: 1916. National Library of Scotland 2022).

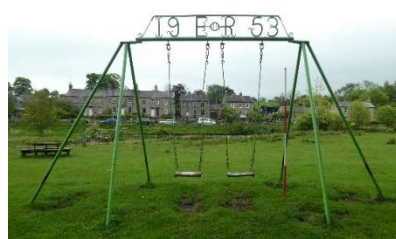
| Feature No. | Feature Type | Description | Condition | Threats | Photograph |
|---|---|---|---|---|---|
| F002 | Swing Set | Metal swing set painted green with "19 ER 53" on the top and three legs either side of the structure. Two swings present and attached to the horizontal support with long fixed (iron?) rods before connecting to links and the wooden seats. Date (1953) commemorates the coronation of Queen Elizabeth II. | Good | Vandalism, disuse, erosion | |

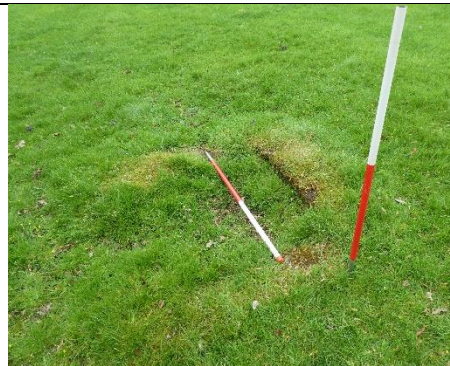
| Feature No. | Feature Type | Description | Condition | Threats | Photograph |
|---|---|---|---|---|---|
| F003 | Well | Well shown on the on the 6" and 25" OS maps. Remains of well can be seen outlined in the grass by sandstone(?) blocks. | Poor | Removal, vegetation | |

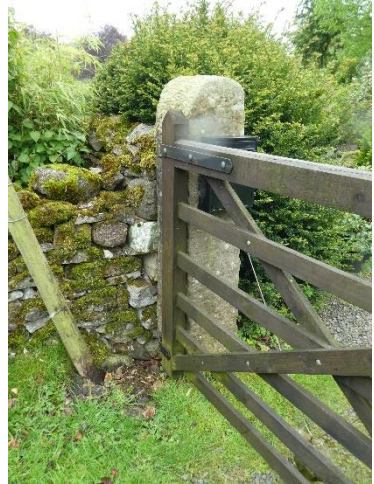
| Feature No. | Feature Type | Description | Condition | Threats | Photograph |
|---|---|---|---|---|---|
| F004a | Gate Stoop (single) | Single sandstone gate stoop with rounded top located on the left side of a vehicle gateway leading to a converted private residence. Two hinges on the outside face with modern gate attached, letter box attached to the inside face. | Good | Erosion, removal | |

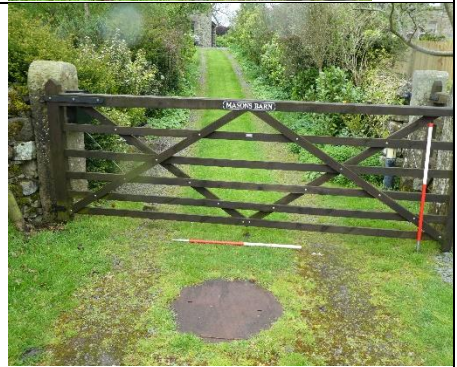
| Feature No. | Feature Type | Description | Condition | Threats | Photograph |
|---|---|---|---|---|---|
| F004b | Gate Stoop (single) | Single sandstone gate stoop with rounded top. Stoop used as the central post for a vehicle gateway (left side) and pedestrian gateway (right side) leading to private residence. Stoop has two gate latches, the one on the front face if for the vehicles gateway and the one on the outside face for the pedestrian gateway. | | | |

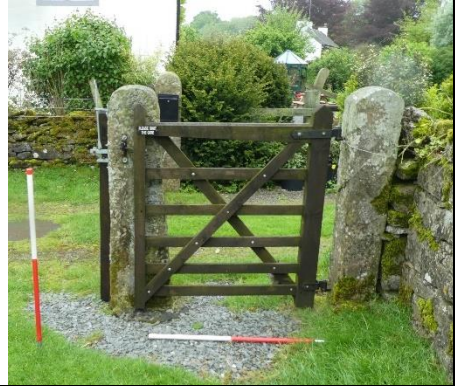
| Feature No. | Feature Type | Description | Condition | Threats | Photograph |
|---|---|---|---|---|---|
| F004c | Gate Stoop (single) | Single sandstone gate stoop with rounded top. Stoop located on right side of pedestrian gateway leading to private residence. Stoop has two hinges on the inside face with modern gate attached. | | | |

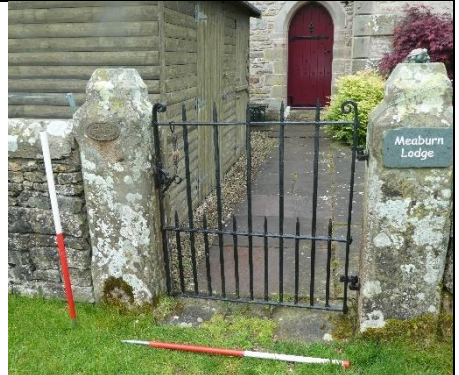
| Feature No. | Feature Type | Description | Condition | Threats | Photograph |
|---|---|---|---|---|---|
| F005 | Gate Stoops (Pair) | Pair of sandstone gate stoops, sides are chamfered with tool marks, top of stoop is squared with shoulders. Stoops located on Meaburn Lodge (the Old School, MYD66240). Left stoop has metal latch and old hole on the inside face, with metal sign screwed to the front. Right stoop has two metal hinges on the inside face with modern gate attached and slate sign screwed to the front. | Good | N/A | |

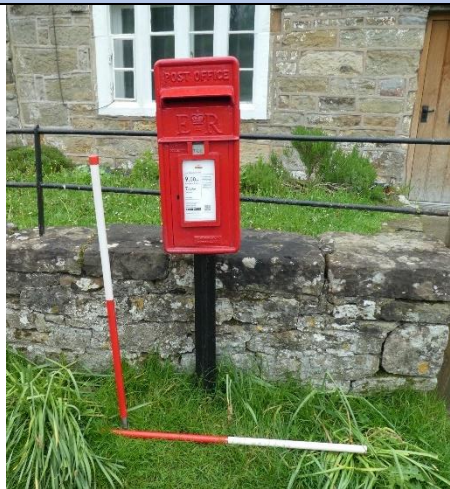
| Feature No. | Feature Type | Description | Condition | Threats | Photograph |
|---|---|---|---|---|---|
| F006 | Letter Box | Red metal letter box on a cross-shaped pole painted black. The words "POST OFFICE" are embossed on the top of the front face above the opening. "E II R" with a crown embossed below opening. "NEXT COLLECTION" embossed to the left of the changeable day token. Words embossed on right side of box base but not readable. | Good | Disuse | |

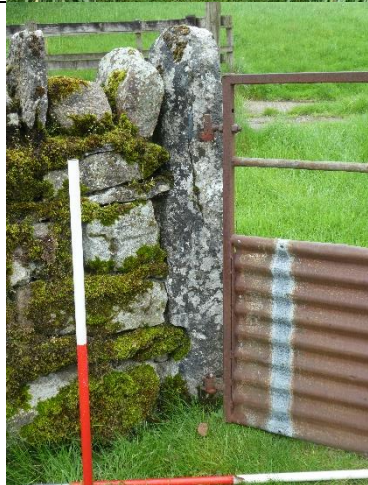
| Feature No. | Feature Type | Description | Condition | Threats | Photograph |
|---|---|---|---|---|---|
| F007 | Gate Stoop (Single) | Single limestone gate stoop on the left side of gateway leading to fields. Stoop built/shaped to fit adjacent drystone wall. Stoop tapers slightly, with two iron hinges on the front face with modern gate attached. Slight crack next to the top hinge, partly filled with lead connected to hinge. | Fair | Erosion, removal | |

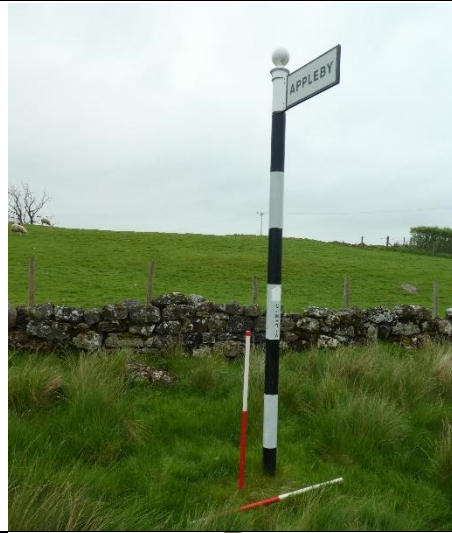
| Feature No. | Feature Type | Description | Condition | Threats | Photograph |
|---|---|---|---|---|---|
| F008 | Finger post | Finger post with pole painted black and white, "CUMBRIA" painted/printed vertically halfway up the pole (now starting to fade). The pole has a round finial on the top. Finger sign is rectangular in shape with black edges and "APPLEBY" printed in black on a white background. | Good | Erosion, removal | |

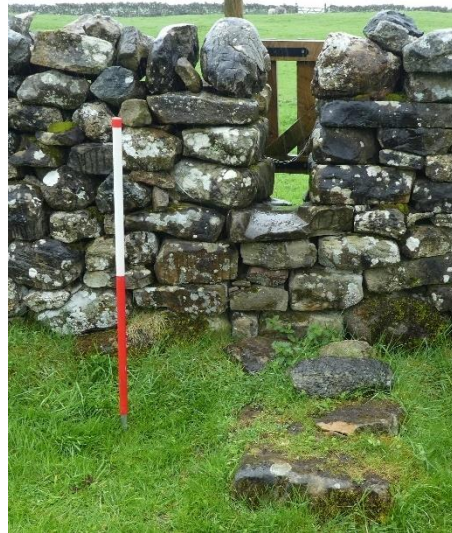
| Feature No. | Feature Type | Description | Condition | Threats | Photograph |
|---|---|---|---|---|---|
| F009 | Squeeze Stile | Squeeze stile in mixed limestone, sandstone and Shap granite drystone wall. The east side has at least four stones on the floor leading to the stile, with one stone on the floor on the west side. The stone in the middle of the stile (stepping surface) has probably been repurposed from elsewhere as it is shaped and broken on either end. | Good – but loose stones on top | Erosion, removal | |

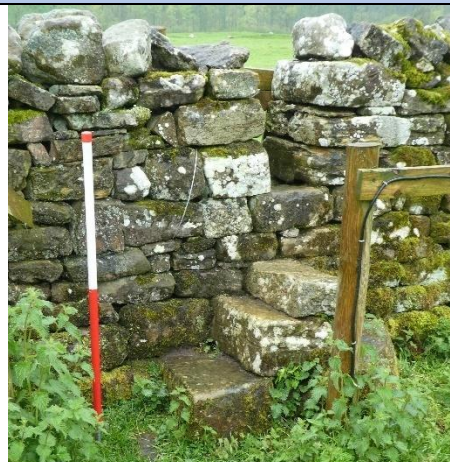
| Feature No. | Feature Type | Description | Condition | Threats | Photograph |
|---|---|---|---|---|---|
| F010 | Step Stile | Sandstone step stile with four steps on the east side - one on floor and three built into dry stone wall. Three of the steps are through that extend on the opposite side of the. | Good | Vegetation, removal | |

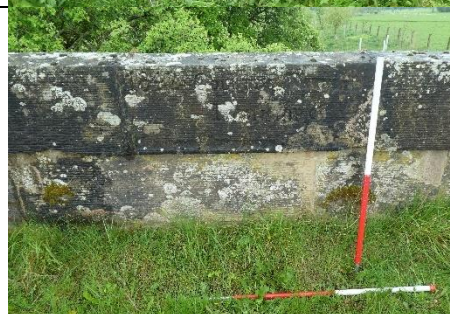
| Feature No. | Feature Type | Description | Condition | Threats | Photograph |
|---|---|---|---|---|---|
| F011a | Date Stone | Howebeck Bridge over the Howe Beck. The internal parapet stones have tool marks, while the external faces are rusticated. The parapets end in a scroll shape. There is a date stone in middle of bridge on south side inscribed with "1842 County of [unknown] ", "Township of [unknown]". Parts of the inscription have been deliberately removed. | Poor | Erosion; vehicles | |

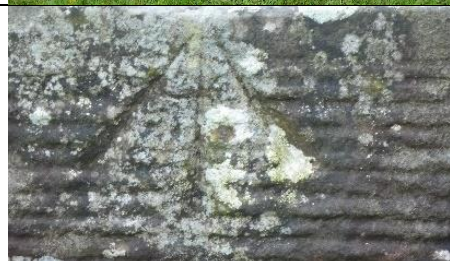
| Feature No. | Feature Type | Description | Condition | Threats | Photograph |
|---|---|---|---|---|---|
| F011b | OS Bench Mark | OS Bench mark shown on 6" and 25" OS maps. Bench mark is located on the north side of Howebeck Bridge an OS Bench Mark in the middle, with top edge of bridge used as straight line. | Good | Erosion; vehicles | |

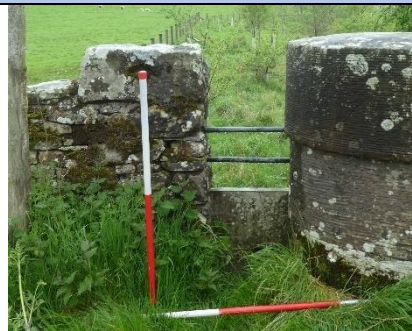
| Feature No. | Feature Type | Description | Condition | Threats | Photograph |
|---|---|---|---|---|---|
| F012 | Step Stile | Step stile on the east side of Howebeck Bridge, wing wall of bridge making up one side of stile, with wall head on the other. A vertical concrete slab is situated at base of stile with two metal iron bars above it. Five steps on the other side of the stile leading to ground level. | Good | Erosion | |

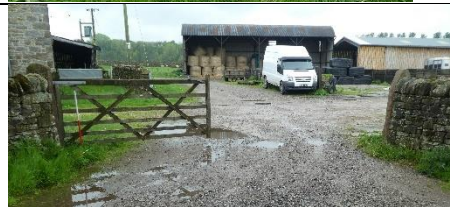
| Feature No. | Feature Type | Description | Condition | Threats | Photograph |
|---|---|---|---|---|---|
| F013 | Gate Stoops (Pair) | Pair of sandstone gate stoops with rounded tops, located at the gateway to a farm. Left stoop has faint tool marks on the side, right stoop is broken at the top with two holes. Modern metal gate attachments on back of stoops. | Good | Erosion, replacement | |

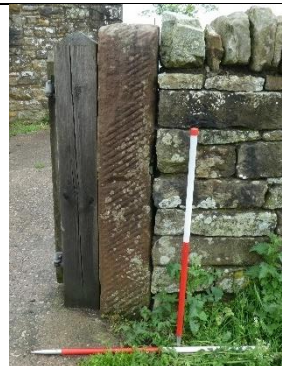
| Feature No. | Feature Type | Description | Condition | Threats | Photograph |
|---|---|---|---|---|---|
| F014 | Gate Stoops (Pair) | Pair of sandstone gate stoops with rounded tops leading to a farm, right stoop has tool marks. | Good | Erosion, replacement | |

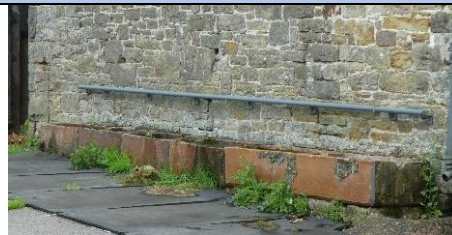
| Feature No. | Feature Type | Description | Condition | Threats | Photograph |
|---|---|---|---|---|---|
| F015 | Drinking troughs | Five drinking troughs (one larger, four smaller) located in farmyard next to farm building (byre?), metal pole above troughs (used to tie animals?). | Fair | Damage; replacement | |

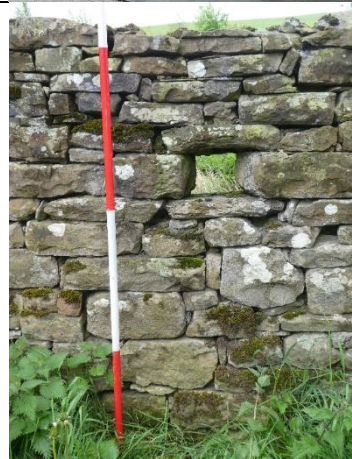
| Feature No. | Feature Type | Description | Condition | Threats | Photograph |
|---|---|---|---|---|---|
| F016 | Unknown | Hole about 1m from ground level in drystone wall with lintel and sill located opposite Meaburn Hall. Unknown purpose, but possibly related to the former deer park. | Good | Wall collapse | |

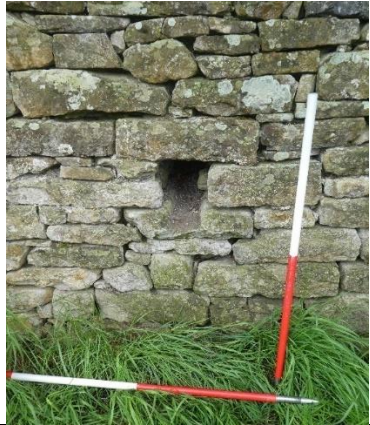
| Feature No. | Feature Type | Description | Condition | Threats | Photograph |
|---|---|---|---|---|---|
| F017 | Water Smoot | Hole in west side of wall around farmyard, with the sill shaped as a channel, similarly to F009. Hole partially blocked, seems to lead to farmyard/garden which is on a higher ground level – was possibly a water smoot. | Good | Vegetation | |

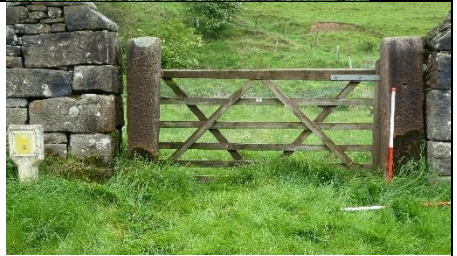
| Feature No. | Feature Type | Description | Condition | Threats | Photograph |
|---|---|---|---|---|---|
| F018 | Gate Stoops (Pair) | Pair of sandstone gate stoops with rounded tops and tool marks on front and back faces, located at gateway to fields. The left stoop is leaning backwards away from road and has a small hole and wear marks on the inside face. Right stoop has use marks on the inside face and a metal screw going through the stone and attaching to a wooden gate on the rear face. | Good | Erosion | |

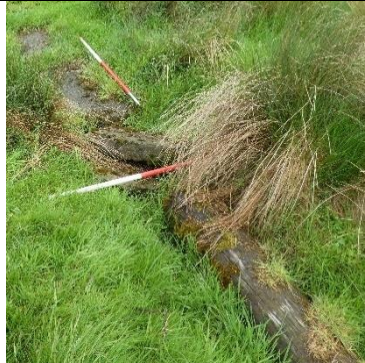
| Feature No. | Feature Type | Description | Condition | Threats | Photograph |
|---|---|---|---|---|---|
| F019 | Culvert | Culvert for road and associated trackway drainage to help vehicle access. Partially broken/uncovered. Starting to fill with vegetation. | Poor | Vegetation; vehicle damage | |

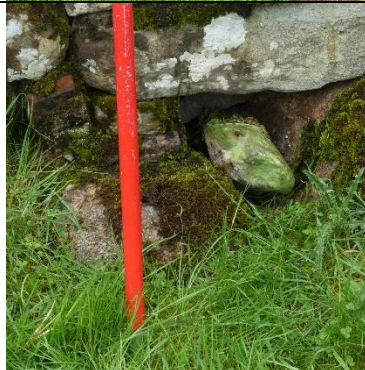
| Feature No. | Feature Type | Description | Condition | Threats | Photograph |
|---|---|---|---|---|---|
| F020 | Water smoot | Possible Water Smoot in base of dry stone wall located next to stile (F009). Boulders on either side and possible lintel at the top. Now partially blocked. | Good | Vegetation | |

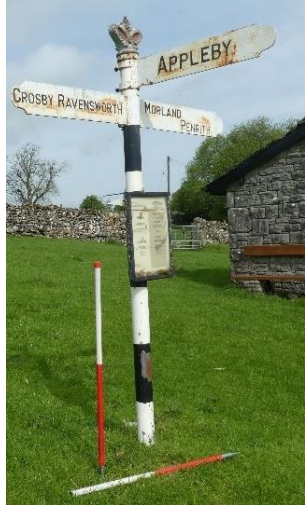
| Feature No. | Feature Type | Description | Condition | Threats | Photograph |
|---|---|---|---|---|---|
| F021 | Finger Post | Steel tube painted black and white, steel fingers with curved ends at the top of the post painted white with black lettering. Finial on top of post is a cast crown which is painted silver and red, with a bolt coming through the top holding it in place. Fingers give directions to "CROSBY RAVENSWORTH", "MOORLAND", "PENTRITH" and "APPLEBY". A modern bus timetable is fitted to the post. Paintwork is damaged and rusted in places. | Fair | Erosion; removal/replacement | |

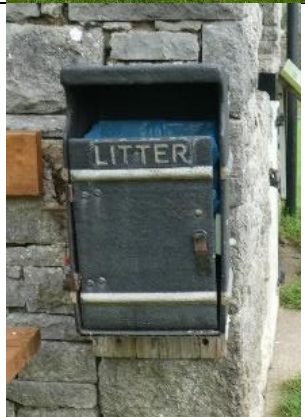
| Feature No. | Feature Type | Description | Condition | Threats | Photograph |
|---|---|---|---|---|---|
| F022 | Litter Bin | Glass Reinforced Plastic (GRP) litter bin fixed to the south side of Bus Shelter. The GRP is painted black with 2x silver bands round three sides. The word "LITTER" is in raised text. The box is tapered down from the top with an opening to the front. An access door on the front as a swing latch and is hinged on the left. The manufacturing label is fitted on the right, made by Wybone Ltd. Serial no. 174185 | Good | Removal | |
