# Small-Scale Heritage Features Survey

Technical Report: Maulds Meaburn

November 2023

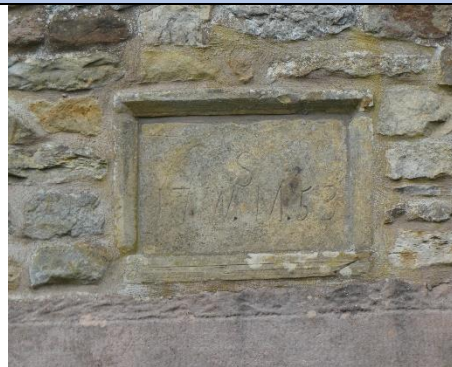
| Feature No. | Feature Type | Description | Condition | Threats | Photograph |
|---|---|---|---|---|---|
| F023 | Date Stone | Date and letters inscribed on sandstone block located above the door on the eastern side of 'Chestnuts' house (converted barn). Has inscription "17. W. <sup>S</sup> M. 53" (referring to William and Mary Salkeld). Block surrounded by four pieces of dressed/chamfered sandstone. | Fair | Erosion | |

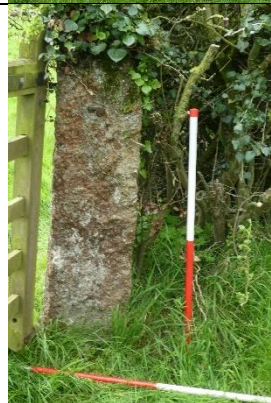
| Feature No. | Feature Type | Description | Condition | Threats | Photograph |
|---|---|---|---|---|---|
| F025 | Gate Stoop (Single) | Single sandstone gate stoop located on the right side of gateway to fields. Stoop has tooling marks and a broken leaded gate catch/hinge on the inside face. Top of stoop covered in ivy. | Fair | Vegetation; removal | |

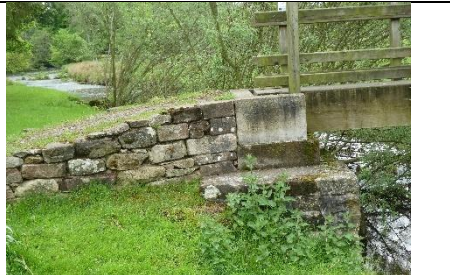
| Feature No. | Feature Type | Description | Condition | Threats | Photograph |
|---|---|---|---|---|---|
| F027 | Bridge | Footbridge and track marked on 6" OS map. Stone footing of an older bridge is visible on each bank, with the west bank also having stones located on the river's edge indicating a possible older bridge (photos F027.1 & F027.2). PROW runs over bridge, with earlier Holloway leading to bridge on the west side. Modern wooden footbridge replaced following Storm Desmond in 2015 (EEC funded). | Fair | Flooding/removal (accessibility) | |

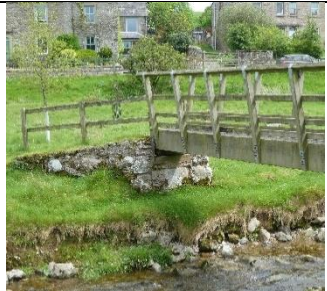
| Feature No. | Feature Type | Description | Condition | Threats | Photograph |
|---|---|---|---|---|---|
| F028 | Bridge | Foot bridge labelled on the third edition 6" and 25" OS maps. Modern footbridge now in this place with the stone footings of an older bridge still visible (although unclear on age). Eastern side has large sandstone(?) block foundations with rubble side supports. Relief drain undercuts the support on eastern side. Modern wooden footbridge now in place. | Fair | Vegetation; flooding; removal. | |

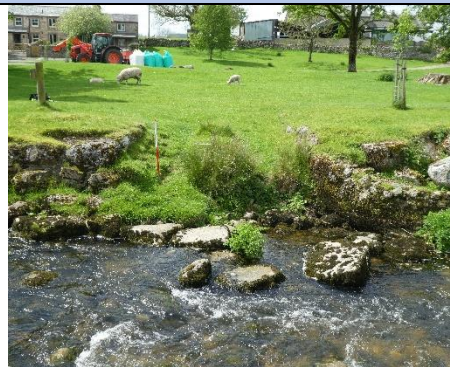
| Feature No. | Feature Type | Description | Condition | Threats | Photograph |
|---|---|---|---|---|---|
| F029 | Unknown | Trackway shown on the 1 <sup>st</sup> edition OS map, this is then show as two parallel lines on the third edition 25" OS maps. The ramp is cut into riverbank down from The Green to the river's edge with rutting visible. Blocks on either edge of the ramp form a curved revetment. Stone blocks in river, creating an arm to slow(?) the water/create a pool. Possibly used as a sheep wash/dub, laundry spot, ford or water access point for livestock. | Fair | Flooding; vegetation | |

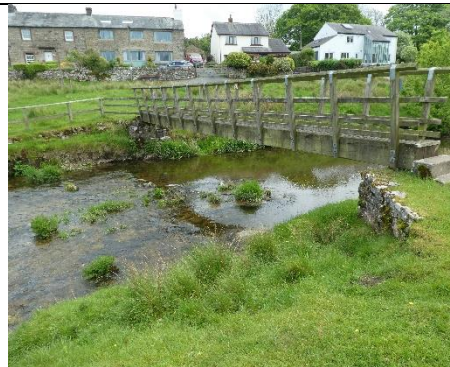
| Feature No. | Feature Type | Description | Condition | Threats | Photograph |
|---|---|---|---|---|---|
| F030 | Bridge | Footbridge shown on the 6" and 25" OS maps. Stone footings of an older bridge are visible. The western support and foundation has large sandstone and limestone blocks with an upper concrete support and stone revetting. Eastern support consists of smaller stone blocks and revetting. Modern wooden footbridge now in place. | Fair | Flooding | |

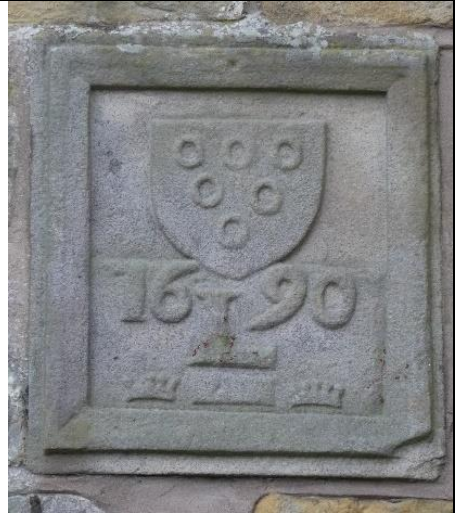
| Feature No. | Feature Type | Description | Condition | Threats | Photograph |
|---|---|---|---|---|---|
| F032a | Date Stone | Mill marked on the 1" Outline and Hill Shade OS maps. The Mill House has a decorated date stone located above the cart door. The date stone has the Lowther shield with 6 rings above date reading "16 L 90" (L = Lowther). | Good | Erosion. | |

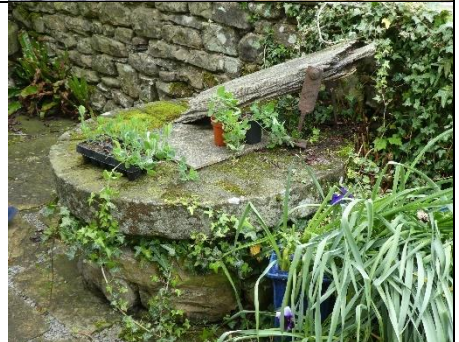
| Feature No. | Feature Type | Description | Condition | Threats | Photograph |
|---|---|---|---|---|---|
| F032b | Mill Stones | Old mill stones are reused from the mill, and are now used as features both internally and externally. | Fair | Removal | |

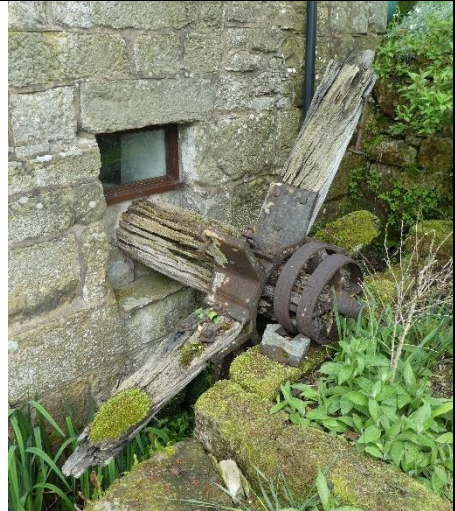
| Feature No. | Feature Type | Description | Condition | Threats | Photograph |
|---|---|---|---|---|---|
| F032c | Mill Wheel | The mill wheel is visible externally and in very poor condition, with only a few inner spokes and shaft remaining along with rusted iron work. Internally, the wheel shaft is in good condition, but the gearing has been removed. The grinding stone framework is present and in good condition, with the date 1815 embossed on a horizontal beam. Graffiti on vertical wooden post has names and initials inscribed (believed to be millworkers). | Poor | Erosion; flooding; vegetation | |

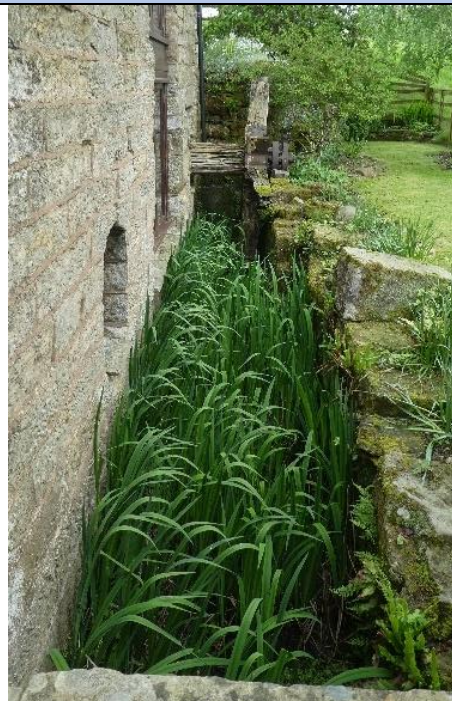
| Feature No. | Feature Type | Description | Condition | Threats | Photograph |
|---|---|---|---|---|---|
| F032d | Mill Race | Mill race is part of the wider scheduled monument that includes the mill race which runs through the village. This section is no longer connected to the main race but is still visible in garden at Mill House and as an earthwork in the village. . | Fair | Flooding; vegetation | |

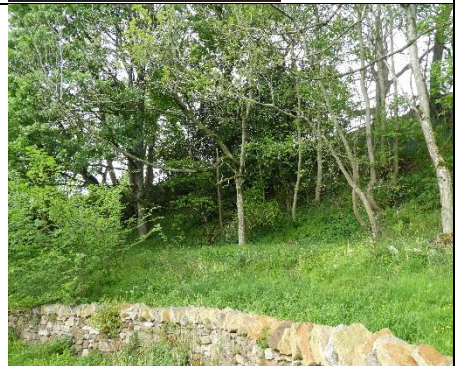
| Feature No. | Feature Type | Description | Condition | Threats | Photograph |
|---|---|---|---|---|---|
| F035 | Quarry | Scattergate Quarry marked on the first edition 6" OS map. Quarry now covered in trees, drystone wall surrounds the area with new field gate for access. | Good | | |

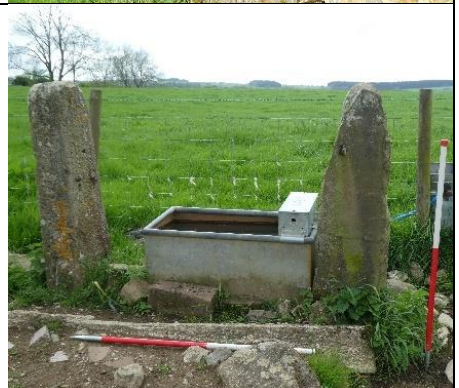
| Feature No. | Feature Type | Description | Condition | Threats | Photograph |
|---|---|---|---|---|---|
| F036a | Gate Stoops (Pair) | Pair of unmatched sandstone gate stoops. Left stoop has a rounded top and possible gate catch attachments on the inside face; right stoop has a roughly shaped top and hinge near the top on the front face (stoop orientation changed). Stoops located on an old field boundary with a possible hollow way (see 6" OS map). | Fair | Removal | |

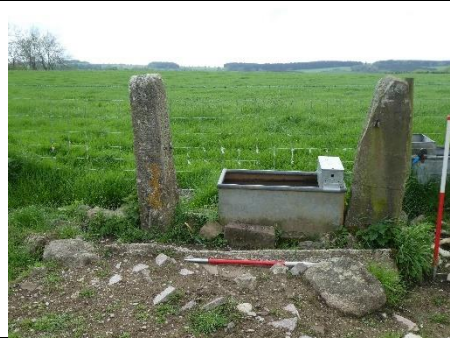
| Feature No. | Feature Type | Description | Condition | Threats | Photograph |
|---|---|---|---|---|---|
| F036b | Gate Stoop (single) | Single limestone gate stoop on the ground and mostly buried, possibly had a rounded top. Purpose of this stoop is unclear. Although it is located on an old field boundary with a possible hollow way (see 6" OS map). | Fair | Removal | |

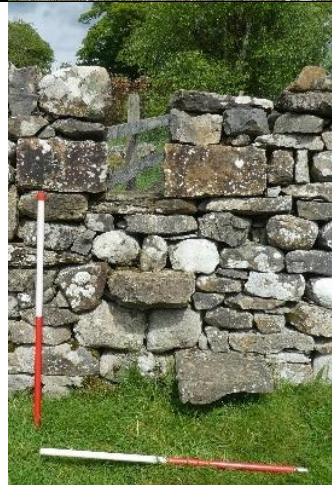
| Feature No. | Feature Type | Description | Condition | Threats | Photograph |
|---|---|---|---|---|---|
| F037 | Step stile | Sandstone step stile located in drystone wall. No steps (except gap) on west side as the ground is higher, two steps down to ground level on east side. | Good | Removal | |

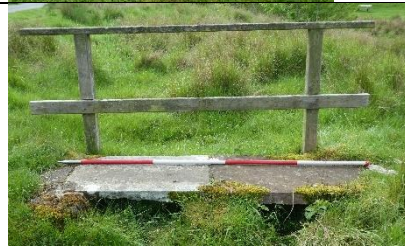
| Feature No. | Feature Type | Description | Condition | Threats | Photograph |
|---|---|---|---|---|---|
| F038 | Clapper Bridge | Footbridge shown on 25" OS map. Clapper bridge over the mill race and made from one slab of limestone (east), one of sandstone (west) and concrete (east end). Three sandstone(?) blocks supporting the bridge, one block on either side of the bridge and one in the centre. Wooden handrail on one side. | Good | Vegetation; removal | |

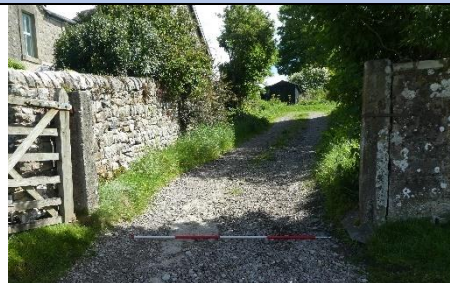
| Feature No. | Feature Type | Description | Condition | Threats | Photograph |
|---|---|---|---|---|---|
| F039 | Gate Stoop (Single) | Single sandstone gate stoop with rounded top, on the right side of gateway. There is an iron bracket going around the stoop tying it to the wall with metal gate catch attached, stoop is cemented at base. Left stoop is concrete. | Good | Erosion; vehicles | |

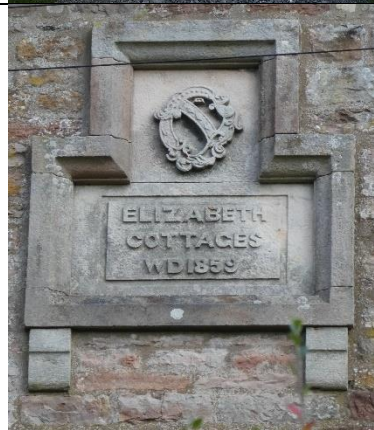
| Feature No. | Feature Type | Description | Condition | Threats | Photograph |
|---|---|---|---|---|---|
| F040 | Date Stone | Row of five cottages with date stone commemorating their construction. Central house with pair of cottage on either side. Not a completely linear form as the central house stands proud. Central house has a pediment over the door and date stone above this. The date stone (an inverted "T" shape) with an unknown carving above it. "ELIZABETH COTTAGES WD 1859" over three lines, WD is probably Wilkinson Dent. | Good | Erosion | |

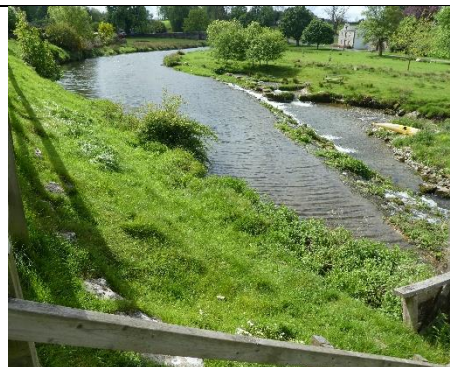
| Feature No. | Feature Type | Description | Condition | Threats | Photograph |
|---|---|---|---|---|---|
| F041 | Weir | Weir shown on the 6" OS map and labelled on the 25" map. Weir with later salmon leap ladder added. The mill race leaves the top of the weir at a water gate on west side of the waterway and is shown on the 25" OS map. | Good | Vegetation; flooding | |

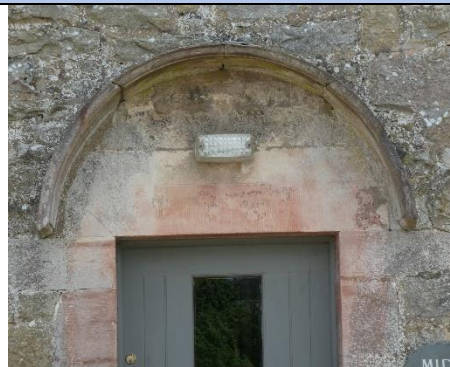
| Feature No. | Feature Type | Description | Condition | Threats | Photograph |
|---|---|---|---|---|---|
| F042 | Canopy Porch | Shaped sandstone canopy over door of farmhouse (private residence). North side has some slight damage | Good | Erosion | |

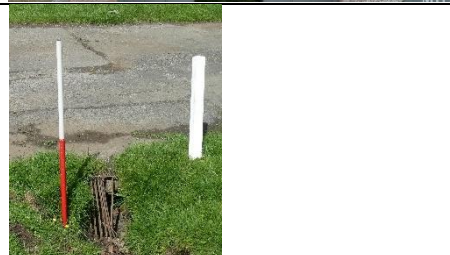
| Feature No. | Feature Type | Description | Condition | Threats | Photograph |
|---|---|---|---|---|---|
| F043 | Culvert | Culvert for watercourse under road. Metal grate on east side with pipe with stone lintel visible on west side. | Good | Vegetation; flooding | |

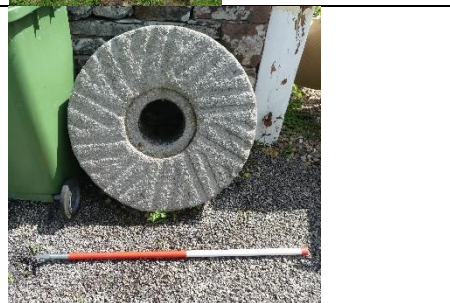
| Feature No. | Feature Type | Description | Condition | Threats | Photograph |
|---|---|---|---|---|---|
| F044 | Mill Stones | Two former mill stones moved from Keld Bank Farm, Kings Meaburn – provenance from house owner who moved the stones. Stones now situated either side of gateway. Both stones grooved – Right has notches on either side of central hole, left has depression around central hole - possibly used for grinding animal feed. | Good | Erosion; vehicles; removal | |

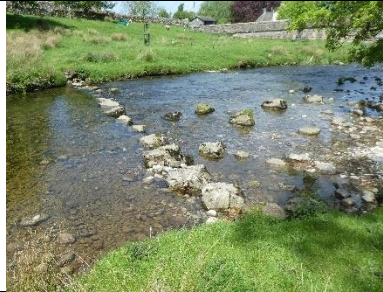
| Feature No. | Feature Type | Description | Condition | Threats | Photograph |
|---|---|---|---|---|---|
| F045 | Stepping Stones | Stepping stones marked on 6" and 25" OS maps, Tithe map shows a ford. 13 limestone stepping stones crossing east-west on the River Lyvennet. Stones are of different sizes and are of different heights. | Good | Vegetation; flooding | |

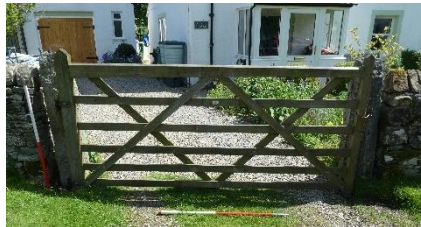
| Feature No. | Feature Type | Description | Condition | Threats | Photograph |
|---|---|---|---|---|---|
| F046 | Gate Stoops (Pair) | Pair of gate stoops, tapered from the base with slight points at the top on driveway to private residence. The right stoop is limestone with two iron hinges on the front face, left stoop is Shap granite with two hinges – top one now used as gate catch – on the front face. Left stoop also has grooves down the side possibly from quarrying activity. | Good | Vehicles; erosion | 1<br> |

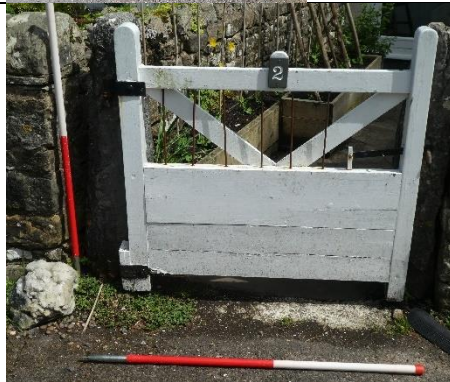
| Feature No. | Feature Type | Description | Condition | Threats | Photograph |
|---|---|---|---|---|---|
| F049 | Gate Stoops (Pair) | Pair of limestone gate stoops leading to private garden. Left has two hinges on the front face with wooden gate attached; right stoop has a metal catch on the front face. | Good | Erosion | |

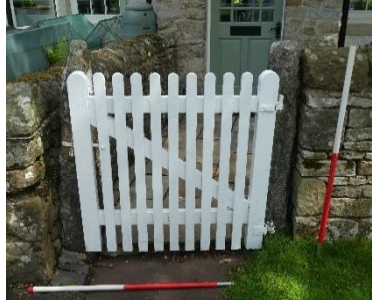
| Feature No. | Feature Type | Description | Condition | Threats | Photograph |
|---|---|---|---|---|---|
| F050 | Gate Stoops (Pair) | Pair of limestone gate stoops leading to private garden. Left stoop has a catch on the front face concreted in place and small hook which is no longer in use. Right stoop has two hinges on the front face with gate attached. | Good | Erosion | |

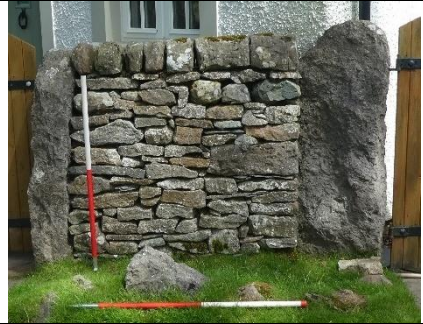
| Feature No. | Feature Type | Description | Condition | Threats | Photograph |
|---|---|---|---|---|---|
| F051a | Gate Stoop (Single) | Single gritstone(?) gate stoops on the left side of a short section of wall marking the right side of a gateway. The stoop has probably been reused/moved. The stoop has two hinges on the inside face with gate attached. | Good | Erosion | |

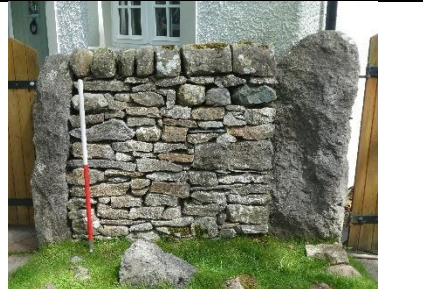
| Feature No. | Feature Type | Description | Condition | Threats | Photograph |
|---|---|---|---|---|---|
| F051b | Gate Stoop (Single) | Single gritstone(?) gate stoop with a roughly rounded top, on the right side of a short section of wall marking the left side of a gateway. The stoop has probably been reused/moved. The stoop has a former gate catch and two hinges, it has been realigned at an angle. | Good | Erosion | |

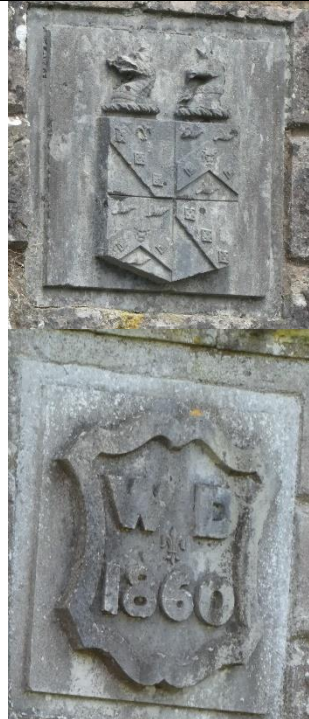
| Feature No. | Feature Type | Description | Condition | Threats | Photograph |
|---|---|---|---|---|---|
| F052 | Date Stone | Concrete(?) crest with the head of a dragon and a unicorn on south facing side of bridge – relates to the Dent family. North side was a shield with “WD 1860” on it – probably denoting Wilkinson Dent. | Good | Erosion | |

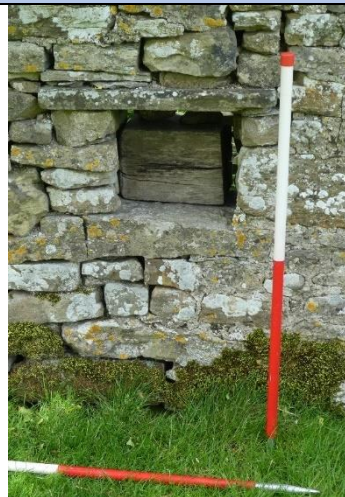
| Feature No. | Feature Type | Description | Condition | Threats | Photograph |
|---|---|---|---|---|---|
| F053 | Unknown | Hole in wall about 50 cm from the ground with lintel at the top. The hole leads into a private garden. Purpose unknown. | Good | | |

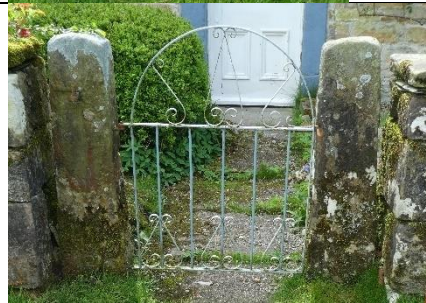
| Feature No. | Feature Type | Description | Condition | Threats | Photograph |
|---|---|---|---|---|---|
| F054 | Gate Stoops (Pair) | Pair of sandstone gate stoops with sub-rounded tops leading to a private garden. Left stoop has disused hinges on the front face and two in use hinges on the inside face with gate attached. Right stoop has a disused gate catch on the front face, with a recess cut into the stone for a second gate catch that is in use. The top of right stoop damaged, repaired with concrete. | Good | Erosion | |

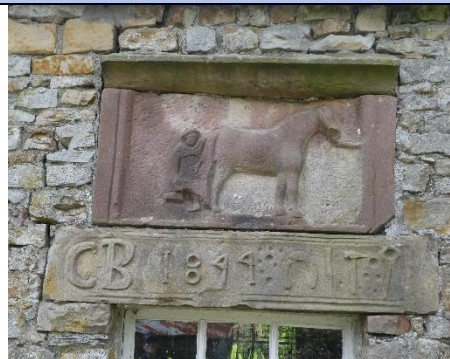
| Feature No. | Feature Type | Description | Condition | Threats | Photograph |
|---|---|---|---|---|---|
| F056 | Carvings | Smithy marked on the 1" outline and hillside map but shown on later maps. Series of carvings on the Old Smithy (MYD66524) including a horse and farrier, date stone showing "CB 1844" with tools relating to farriering on the front. A decorated stone, wheel, person, tools and hand, faces and writing are on the rear and side of the property. | Good | Erosion; barn collapse | |

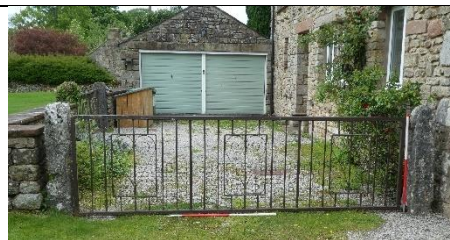
| Feature No. | Feature Type | Description | Condition | Threats | Photograph |
|---|---|---|---|---|---|
| F057b | Gate Stoops (Pair) | Pair of limestone gate stoops, rougher in design than F057a with roughly rounded tops. Leading to private garden. Left has notch on the outside face; right stoop has two hinges on the inside face and possible broken former attachment on the front face. | Good | Cracking/erosion | |

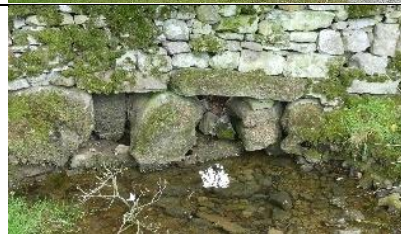
| Feature No. | Feature Type | Description | Condition | Threats | Photograph |
|---|---|---|---|---|---|
| F058 | Water Smoot | Water smoot in the base of the dry stone wall. There were possibly two openings on the north side - 2 lintels visible, divided by an erratic. On the south side of the wall, reused gate stoops and large stones are placed on floor to create a channel to guide water though the smoot | Good | Vegetation; wall collapse; flood event | |

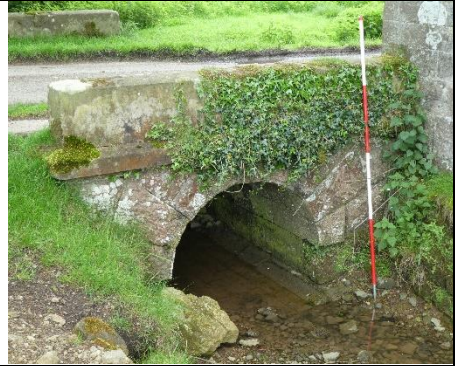
| Feature No. | Feature Type | Description | Condition | Threats | Photograph |
|---|---|---|---|---|---|
| F059 | Bridge | Bridge leading to Flass House, arched with keystones; 'parapet' created using 2 dressed stones on east side and 3 dressed stones on west side. Stones also laid under bridge. Culvert associated with bridge, with two pipes and water coming out to south side. | Good | Vegetation; vehicles | |

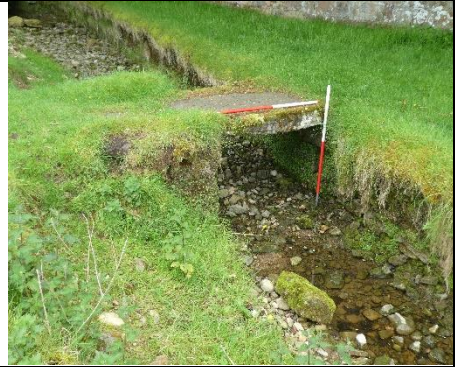
| Feature No. | Feature Type | Description | Condition | Threats | Photograph |
|---|---|---|---|---|---|
| F060 | Clapper Bridge | Bridge possibly shown on the 6" and 25" OS maps. Clapper bridge made from a sandstone slab over the water course. Pier next to bank on north side with revetted bank on south side. | Good | Vegetation; erosion | |

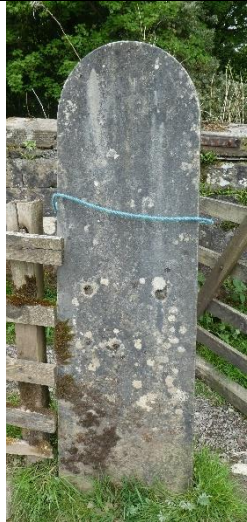
| Feature No. | Feature Type | Description | Condition | Threats | Photograph |
|---|---|---|---|---|---|
| F061b | Gate Stoop (Single) | Concrete(?) gate stoop in the middle of three stoops, on the right side of driveway with cattle grid, and ide of pedestrian gateway all leading to Flass House. The stoop has a rounded top and tapers, with casting marks showing an arch and trapeze. | Good | Vehicles | |

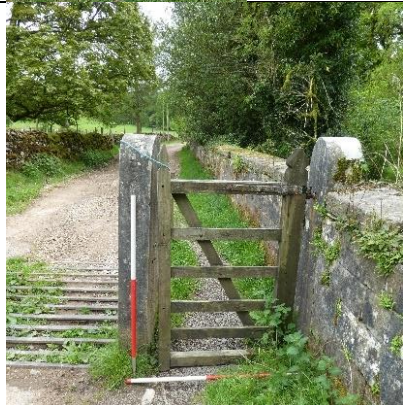
| Feature No. | Feature Type | Description | Condition | Threats | Photograph |
|---|---|---|---|---|---|
| F061c | Gate Stoop (Single) | Concrete(?) gate stoop on the right side of pedestrian gateway leading to Flass House. Stoop has a rounded top and is built into the estate wall. casting marks showing an arch and trapeze are visible | Good | Vehicles | |

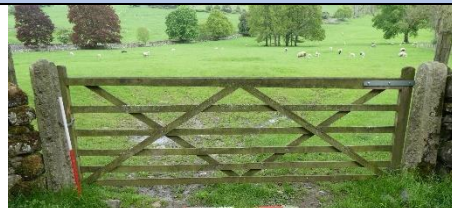
| Feature No. | Feature Type | Description | Condition | Threats | Photograph |
|---|---|---|---|---|---|
| F062 | Gate Stoops (Pair) | Pair of Shap granite gate stoops with rounded tops and rusticated detail leading to fields. | Good | Erosion; vegetation; vehicles | |

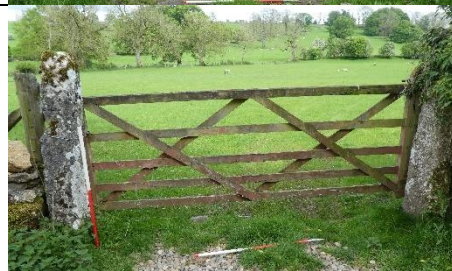
| Feature No. | Feature Type | Description | Condition | Threats | Photograph |
|---|---|---|---|---|---|
| F063 | Gate Stoops (Pair) | Pair of gate stoops leading to fields. Left is limestone and right is Shap granite. Left stoop has roughly rounded top, right stoop top is covered in vegetation, possibly has two hinges on front face but unclear. | Fair | Vegetation; erosion; vehicles | |

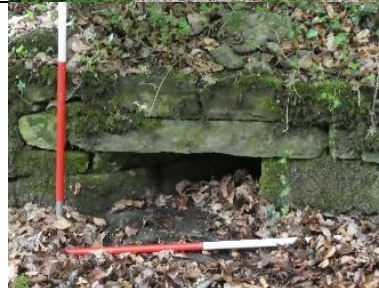
| Feature No. | Feature Type | Description | Condition | Threats | Photograph |
|---|---|---|---|---|---|
| F064 | Culvert | Culvert in the base of a limestone wall, with hedge above it. Culvert created at a diagonal angle and appears to be stone lined. | Good | Sediment; flood | |

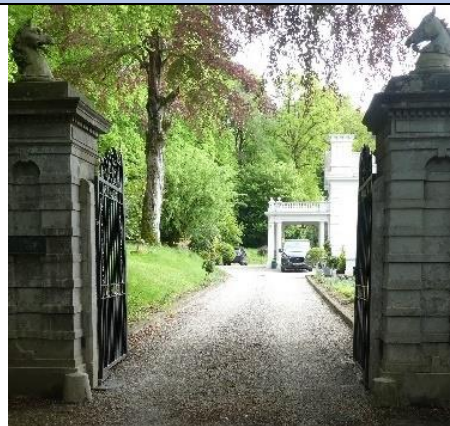
| Feature No. | Feature Type | Description | Condition | Threats | Photograph |
|---|---|---|---|---|---|
| F065 | Cart stops | Two rounded concrete cart stops on the inside edge of both gate piers (topped with the head of a horse and dragon at entrance to Flass house (MYD65773). | Good | Vehicles | |
