# Small-Scale Heritage Features Survey

Technical Report: Nateby  
November 2023

*The small-scale heritage features survey is one of a number of cultural heritage projects undertaken as part of the four-year Westmorland Dales Landscape Partnership Scheme. The scheme is aimed at unlocking and revealing the hidden heritage of the Westmorland Dales.*

*The survey of Nateby took place over one day in August 2020. It was carried out by the Westmorland Dales Countryside Worker Apprentices, led by the Cultural Heritage Officer. This was an opportunity to build on survey skills. It was also important to trial the methodology. However, some restrictions had to be followed in line with the global Coronavirus pandemic.*

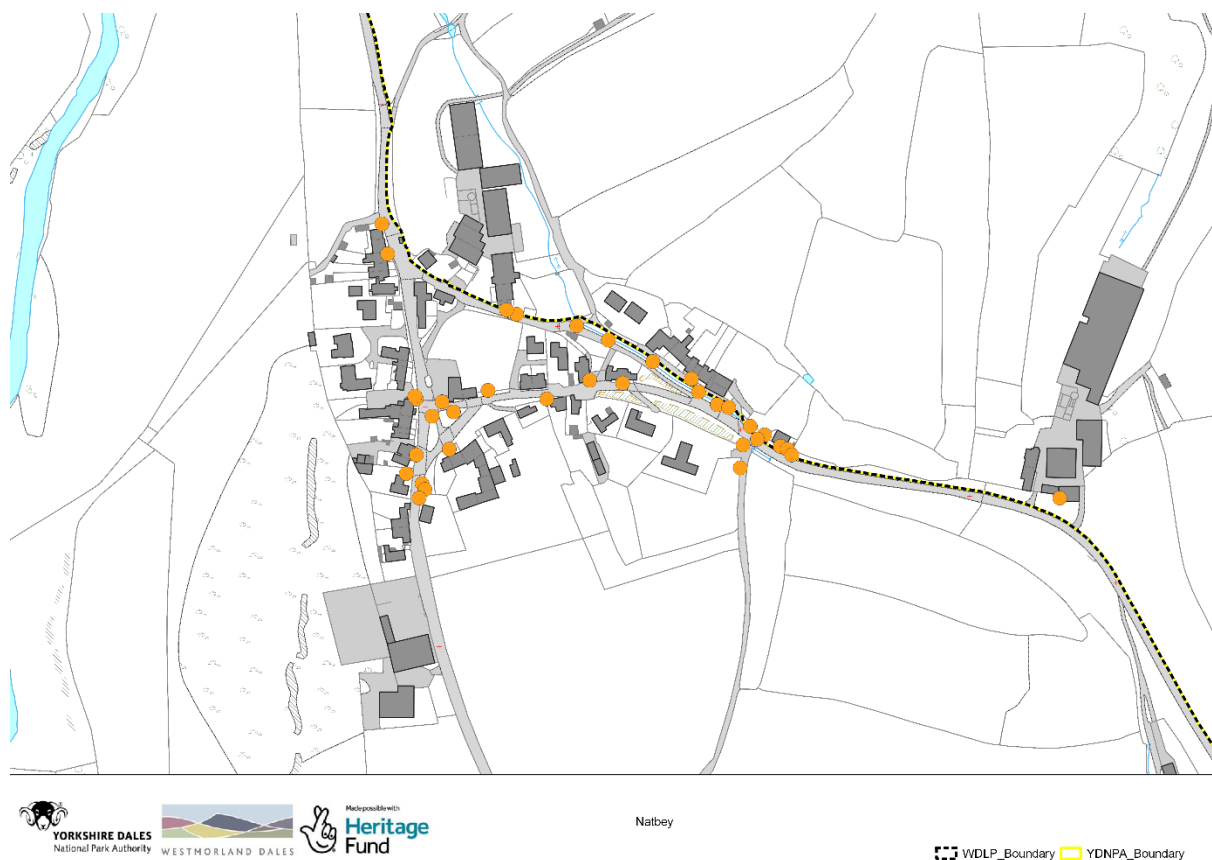
Figure 1 Distribution of the sites found within the village, with each dot indicating a record.

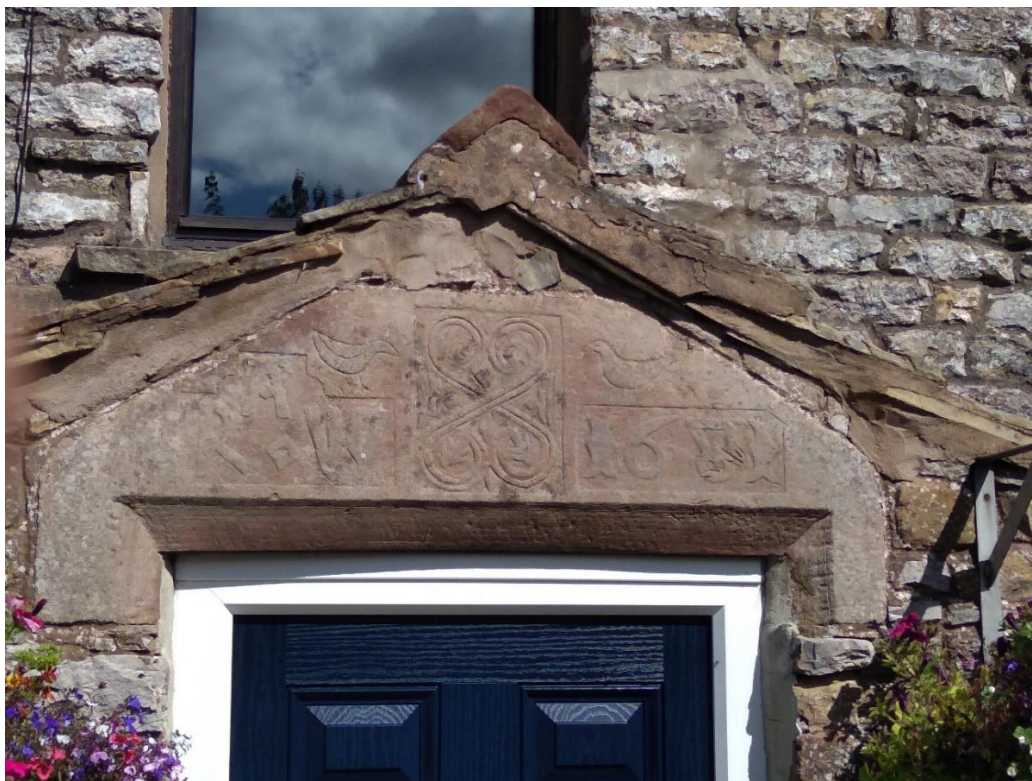
4.5 There are two date stones in the village. One is situated on the porch of a house (**H26**) that is now known as The Old Cottage. The lintel is dated to 1681, with the initials ‘R. & W. A’. No surname beginning with ‘A’ appears on the hearth tax return of 1674. It therefore likely relates to an incoming family or it has been relocated from elsewhere. The lintel has also got decorative detail, including a swirl pattern in the middle and two birds of slightly different designs on either side. The lintel looks like it has been resituated, and appears to have been reshaped to fit. The house on which it is situated is a linear farmstead with many changes, but it does not appear to have any fabric that would correspond with a 1681 date. The other date stone (**H19**) is situated on a farm building at Rakehead Farm, a loose courtyard farmstead that includes the listed Rakehead farmhouse and adjoining cottages (1144856). This stone is dated 1879, with the initials ‘M. R.’, in an oval shape that resembles an eye.

Figure 2 A dated lintel of 1681, which has been repositioned into a porch of a linear farmstead (H26)

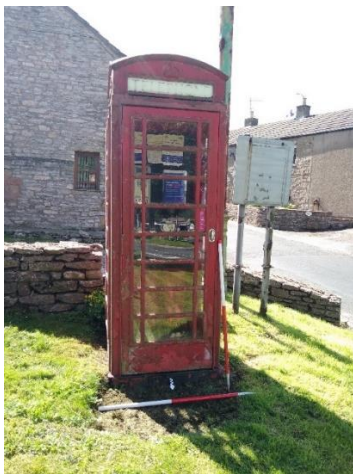
4.8 A red telephone box is situated on a green verge area to the east of B6259. These red boxes, originally designed by Sir Giles Gilbert Scott are a familiar site around United Kingdom and parts of the Commonwealth. The one found in Nateby is of a K6 design, first made in 1935. This was the first kiosk to be extensively used outside London. The K6 was designed by Scott and they were intended to be a smaller and more streamlined version of the K2. One of the differences was that the crown motif, which had previously acted as a ventilator with the ironwork pierced through, was now embossed in bas-relief. The crown may provide some dating evidence. The St Edward's Crown was used from 1953, previously the Tudor Crown, and from the early 1990s British Telecom would have likely painted the crown gold.

4.9 Unusually the telephone box still retains its telephone, as many have now been converted to hold a defibrillator (for instance Orton). This is due to public phones no longer being required with the availability of mobile phones. However, one could argue that there is still a need in more remote locations where mobile signal can be patchy. Despite this, this phone is no longer in operation, and has been scheduled for removal. Although the telephone box is in deteriorating condition with its paint flaking, the glass panes are in good condition, and it still retains its leather hinges, which have been painted red.

*Figure 3 The K6 telephone box (H35)*

5.2 The greatest threats will be neglect or even vandalism (e.g. telephone box, **H35**), erosion (e.g. datestones and benchmarks), vehicle damage (e.g. churn stands and gate stoops), and for some possible removal.

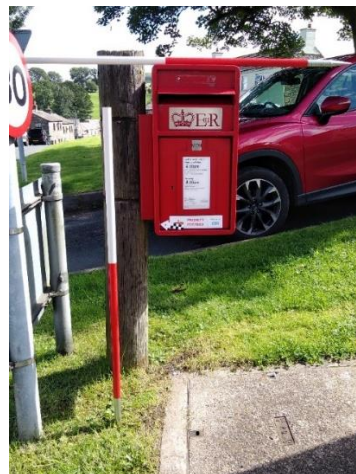
*Figure 4 Letter box (H31)*

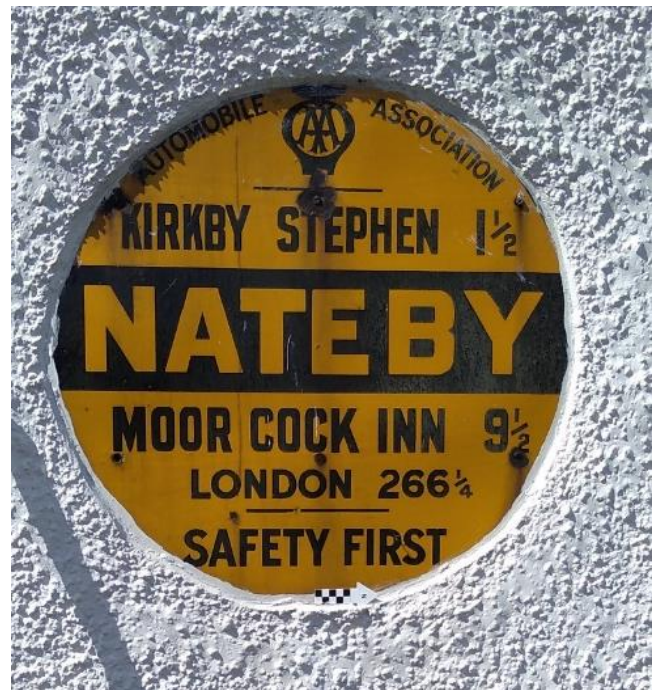
4.12 An Automobile Association yellow circular sign is located on the front elevation of the Black Bull Inn. Signs of this type indicate the distance to the nearest village, town, and London. In this case, the nearest town 'Kirkby Stephen 1 ½', the 'Moor Cock Inn 9 ½', and 'London 266 ¼'. Before World War Two nearly every town and village displayed one of these AA circular plates. However, they were removed, along with all road signs, when the threat of invasion loomed. It is reported that very few were replaced following the end of the war, as many of them had gone towards the scrap drive. This survival in Nateby is therefore unusual. However, it does mean that this might not have been the exact original position.

Figure 5 AA sign (H29) situated on Black Bull Inn

4.13 It is also possible that this sign is not original. These signs can be ordered online, and this one has a digression, as the usual custom of the nearest village has been replaced with a different pub. This being the Moorcock Inn at Garsdale Head, located to the south of Nateby on the B6259. Alternatively, this could just be recording the distance to a nearby prominent landmark, due to its fairly rural location.

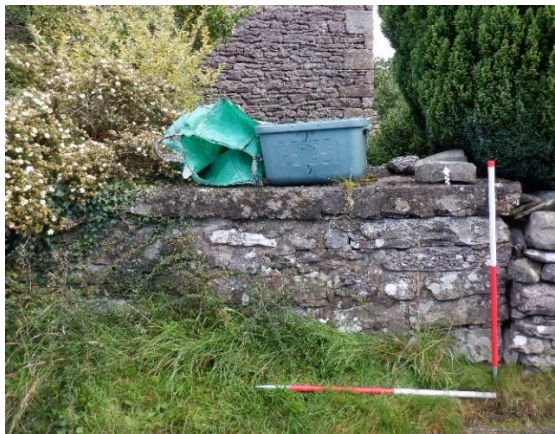
Figure 6 Churn stand (H6) outside Low Farm

4.18 **H6** has been built into the wall of Low Farm, a linear farmstead situated at the north of the village. It is of mixed stone construction, of limestone and sandstone, which is roughly coursed, with the addition of mortar, and has a concrete top. The length was difficult to gauge due to vegetation growth, but it was measured at 2.51m long (a depth of 1.25m and a height of 0.95m). Although it is built into the wall line, it is not continuous with the wall. The eastern (right) side is a wall head, and the western side is obscured with vegetation.

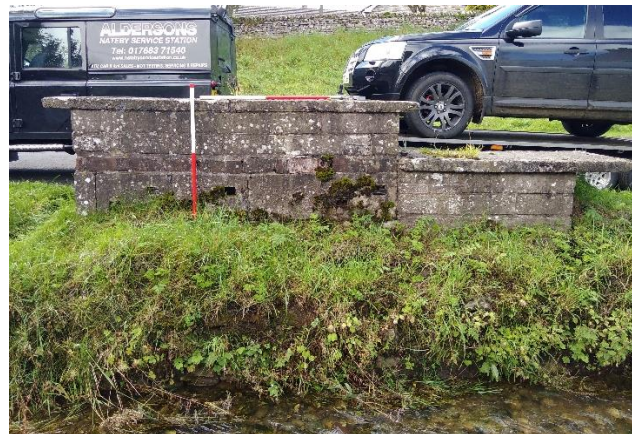
4.17 There are two churn stands in the village of Nateby. They are constructed differently, but would have both been used to place milk churns upon for collection by the milk cart/lorry. They typically date from the coming of the railway, when milk could speedily be transported to towns and cities, until the 1970s when milk was collected by tanker.

Figure 7 Churn stand (H12)

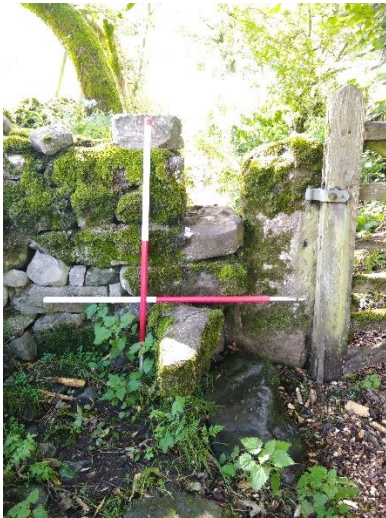
Figure 8 Step stile (H28a)

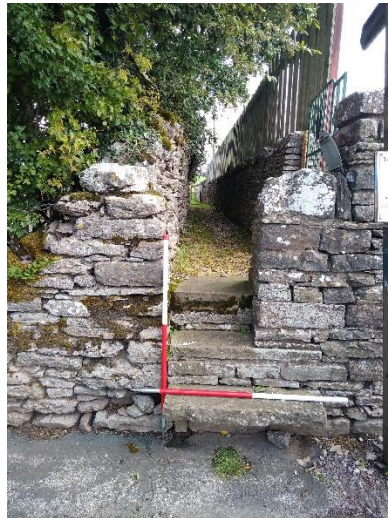
Figure 9 Step stile (H40)

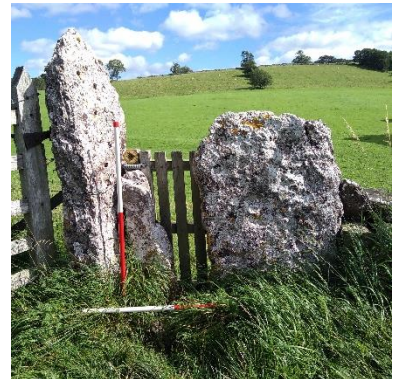
4.23 Three stiles were surveyed in Nateby – two step stiles and one squeeze stile. The squeeze stile (**H41b**) consist of two limestone upright slabs of varying sizes and orientations. The two step stiles differ from one another. **H28a** is more crudely built, with one step on the south side and two steps to the north side. The stile is adjacent to a gate stoop (**H28b**), and in fact the stoop acts as the right side of the stile, with a dry stone wall to the left and below. **H40** only has steps on one side, with three steps leading to a right of way signposted to Wharton Hall. The stile is built into a dry stone wall, but does not act in quite the same way as other step stiles.

Figure 10 Squeeze stile (H41b)

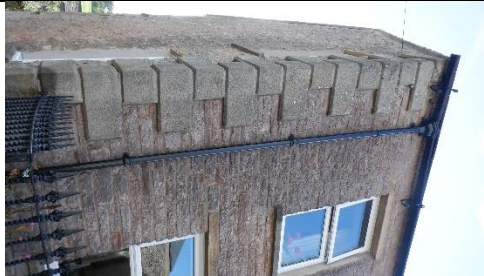
| Feature No. | Feature Type | Description | Condition | Threats | Photos |
|---|---|---|---|---|---|
| H1 | Hopper and down pipe | Metal hopper and downpipe, painted black. Decorative brackets are holding the gutter. | Good | Vegetation & build-up of material | |

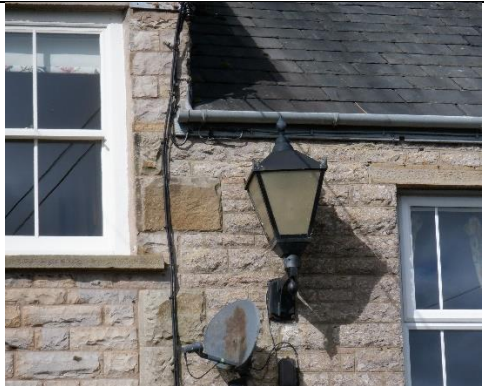
| Feature No. | Feature Type | Description | Condition | Threats | Photos |
|---|---|---|---|---|---|
| H3 | Lamp | Electric lamp attached to house – sheet metal and clouded plastic?, with finial on top. | Good | N/A | |

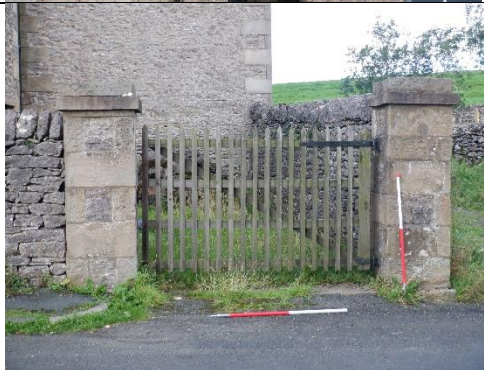
| Feature No. | Feature Type | Description | Condition | Threats | Photos |
|---|---|---|---|---|---|
| H4 | Gate piers | 2 gate piers on gate leading to small enclosure by barn. Coursed sandstone and limestone<br>Whole gateway is 3.6m wide.<br>Pier to S is 0.66m wide and 1.4m high. | Good | Vehicles | |

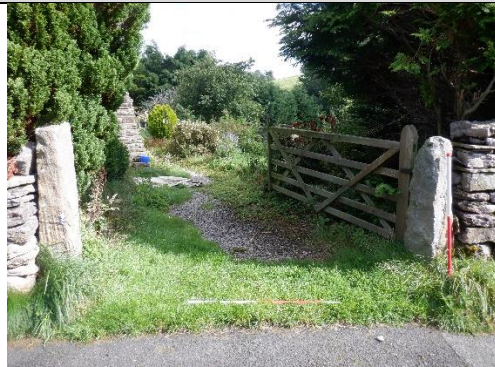
| Feature No. | Feature Type | Description | Condition | Threats | Photos |
|---|---|---|---|---|---|
| H5 | Gate stoops | 2 gate stoops, limestone.<br>Whole gateway is 3.8m wide – leads to driveway.<br>Stoop to NE is 0.22m wide and 2.3m high.<br>Stoops have different tops – one on left is flat, one on right is sub-rounded | Good | Vehicles & erosion | |

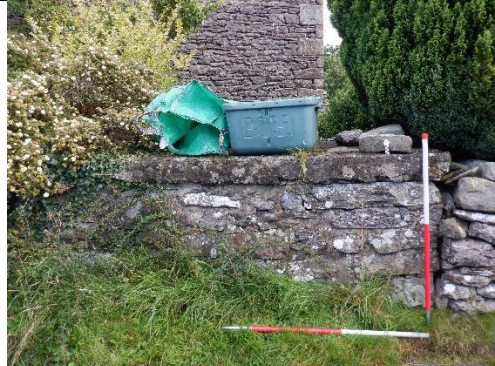
| Feature No. | Feature Type | Description | Condition | Threats | Photos |
|---|---|---|---|---|---|
| H6 | Churn stand | Churn stand along wall line, coursed limestone with concrete top.<br>2.51m x 1.25m x 0.95m | Good | Vegetation | |

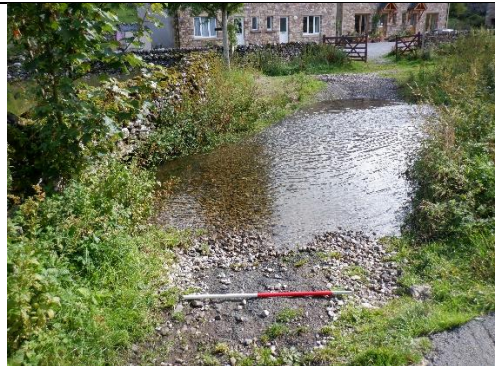
| Feature No. | Feature Type | Description | Condition | Threats | Photos |
|---|---|---|---|---|---|
| H7 | Ford | Ford – leading from road to track | Good | N/A | |

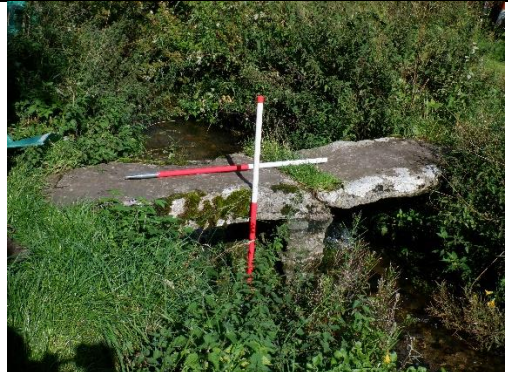
| Feature No. | Feature Type | Description | Condition | Threats | Photos |
|---|---|---|---|---|---|
| H8 | Clapper bridge | Clapper bridge consisting of 2 slabs of limestone going across beck with central roughly coursed pillar.<br>2.6m long and 0.7m wide<br>Visible on 6 and 25-inch OS maps. | Good, some vegetation growing on it | Vegetation & flood event | |

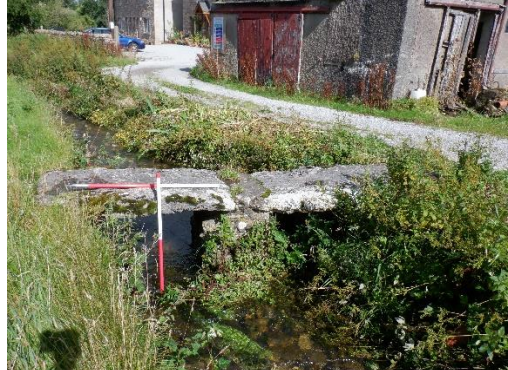
| Feature No. | Feature Type | Description | Condition | Threats | Photos |
|---|---|---|---|---|---|
| H9 | Clapper bridge | Clapper bridge consisting of 2 slaps of limestone crossing over beck with roughly coursed central pillar.<br>3.83m long and 1.05m wide<br>Visible on 6 and 25-inch OS maps. | Good | Vegetation & flood event | |

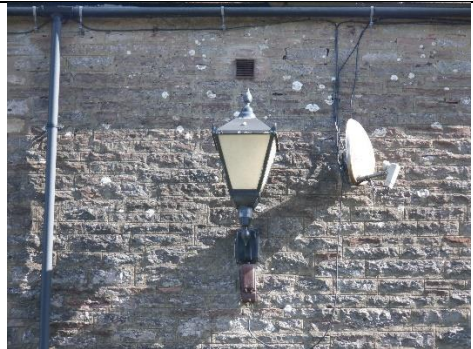
| Feature No. | Feature Type | Description | Condition | Threats | Photos |
|---|---|---|---|---|---|
| H10 | A. Lamp<br>B. Railings | Electric lamp attached to front of house (converted barn) - sheet metal and clouded plastic?, with finial on top.<br>Metal railings in front of adjacent house. | Good | Erosion - weather | |

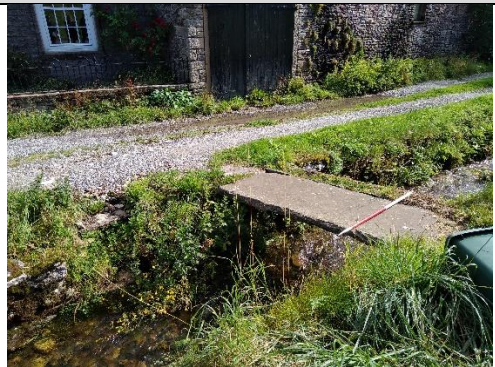
| Feature No. | Feature Type | Description | Condition | Threats | Photos |
|---|---|---|---|---|---|
| H11 | Bridge | Single slab of limestone crossing beck. Wooden gutter? alongside to E.<br>3.6m long, slab 0.76m wide, gutter 0.26m wide.<br>3 steps leading down beck to west. 0.72m wide.<br>Postdates clapper bridges (H8, H9, H13a) | Good | Flood event | |

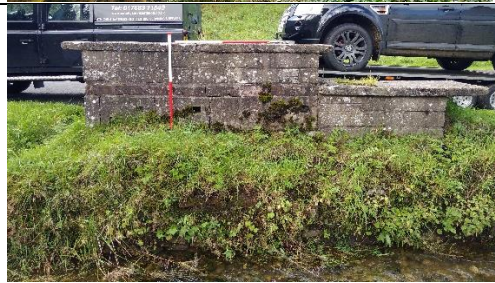
| Feature No. | Feature Type | Description | Condition | Threats | Photos |
|---|---|---|---|---|---|
| H12 | Churn stand | Large churn stand of 2 heights, lower to W. Concrete top – there is a hole in the top. Coursed stone with single brick course, and reused stone (or concrete blocks?) at base.<br>Total length of top – 4.49m<br>Total length of base – 3.9m<br>W height – 0.44m<br>E height – 0.89m | Good | Vegetation & vehicles | |

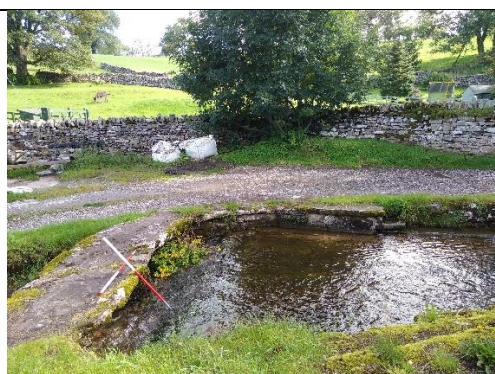
| Feature No. | Feature Type | Description | Condition | Threats | Photos |
|---|---|---|---|---|---|
| H13 | A. Clapper bridge<br>B. Unknown feature | 2 slabs of limestone across beck, with 2 slabs acting as pillar in centre. Very low to the water, compared to the other clapper bridges in Nateby.<br>Visible on 6 and 25-inch OS maps.<br>Possible unknown feature upstream, could be linked to revetment of beck bank in relation to the track, but protrudes into beck more than necessary. Constructed with a number of stones, with one large stone above it, giving the appearance of a surface, along with a small low stone to its right. | Good | Vegetation & flood event | |

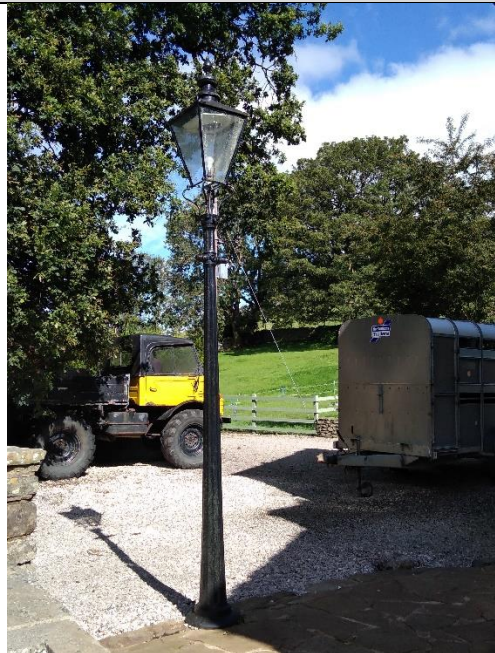
| Feature No. | Feature Type | Description | Condition | Threats | Photos |
|---|---|---|---|---|---|
| H14 | Lamp post | Electric lamp post in garden – added as decorative feature for garden, possibly repositioned. Metal lamp with glass, finial on top. Has either been made to look like a former gas lamp, or it has been converted. | Good – but some damage to glass | Erosion | |

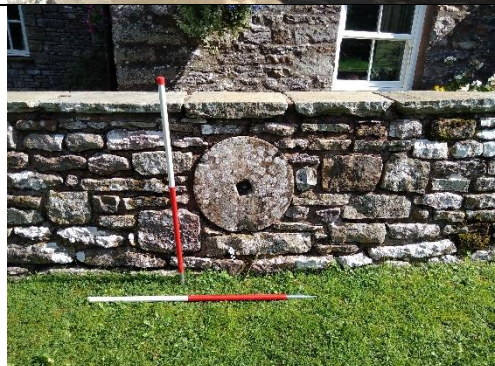
| Feature No. | Feature Type | Description | Condition | Threats | Photos |
|---|---|---|---|---|---|
| H15 | Grinding stone | Possible sharpener, repositioned into wall. Centre square recess for circular motion<br>0.53m wide | Good | Wall collapse | |

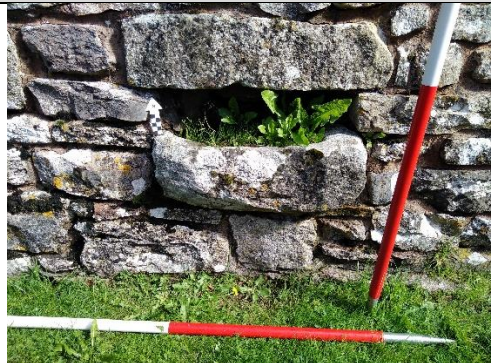
| Feature No. | Feature Type | Description | Condition | Threats | Photos |
|---|---|---|---|---|---|
| H16 | Trough ? | Small trough-like feature, which has purposefully been placed into a recess in the wall, with a lintel above it. Now used as a planter (or vegetation has grown into it). | Good | Wall collapse | |

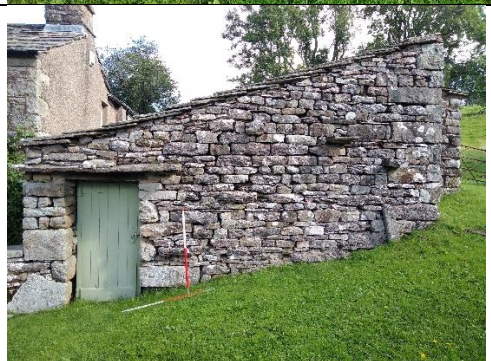
| Feature No. | Feature Type | Description | Condition | Threats | Photos |
|---|---|---|---|---|---|
| H17 | Hennerypiggery, and associated features | Monopitched TFB. Door on S facing elevation, also several protruding stones (acting like steps) to blocked small opening, probably for hens. Stone ramp (built into wall) leads to trough on W facing wall. There is a small outshot on the E facing wall. This building is not present on the six-inch OS map, but is visible on the 25-inch OS map, therefore it was built between when these maps were surveyed. | Good | N/A | |

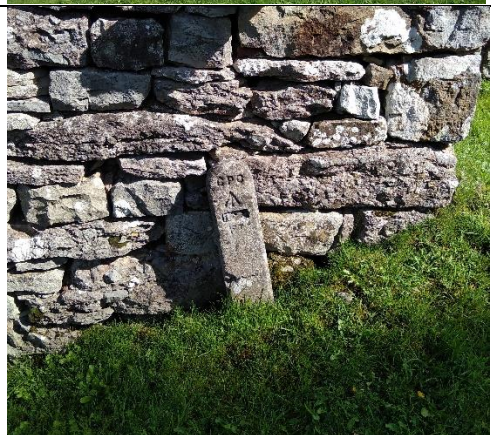
| Feature No. | Feature Type | Description | Condition | Threats | Photos |
|---|---|---|---|---|---|
| H18 | GPO marker post | Concrete General Post Office (GPO) marker post, with Pheon (marking it as UK gov. property), and no. of feet marking distance to telephone cable. Only one of these numbers (1) survives, with the other two interchangeable numbers no longer present. 0.17m wide, 0.57 high, 0.08 depth. Located in front of H17. | Fair – loose with some cracking at base | Further damage, removal, erosion | |

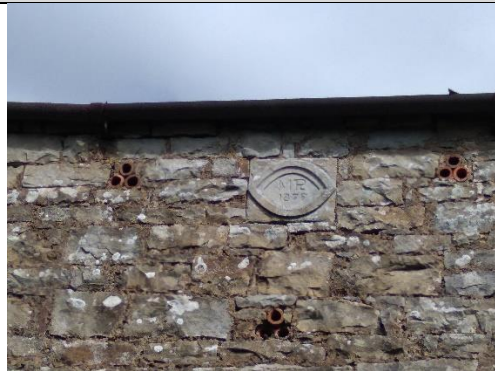
| Feature No. | Feature Type | Description | Condition | Threats | Photos |
|---|---|---|---|---|---|
| H19 | Date stone | Date stone – MR 1879, on S facing gable of TFB | Good | Erosion | |

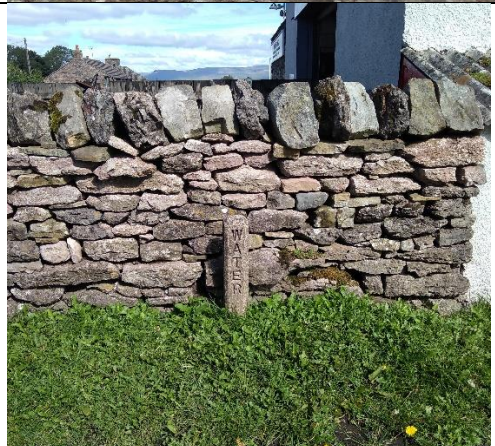
| Feature No. | Feature Type | Description | Condition | Threats | Photos |
|---|---|---|---|---|---|
| H20 | Water post | Concrete 'WATER' marker post | Good | N/A | |

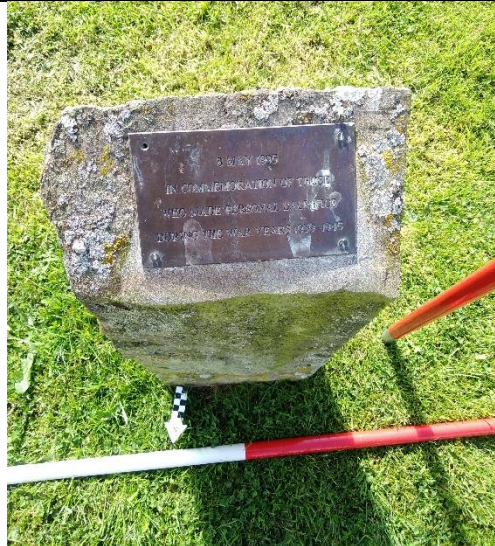
| Feature No. | Feature Type | Description | Condition | Threats | Photos |
|---|---|---|---|---|---|
| H21 | War memorial (WW2) | War memorial situated on green, put in place in 1995. Single upright sandstone, with plaque on – ‘8 May 1995 / IN COMMEMORATION OF THOSE / WHO MADE PERSONAL SACRIFICE / DURING THE WAR YEARS 1939-1945’<br>0.68m high, 0.27m wide, 0.15m depth | Good | Erosion | |

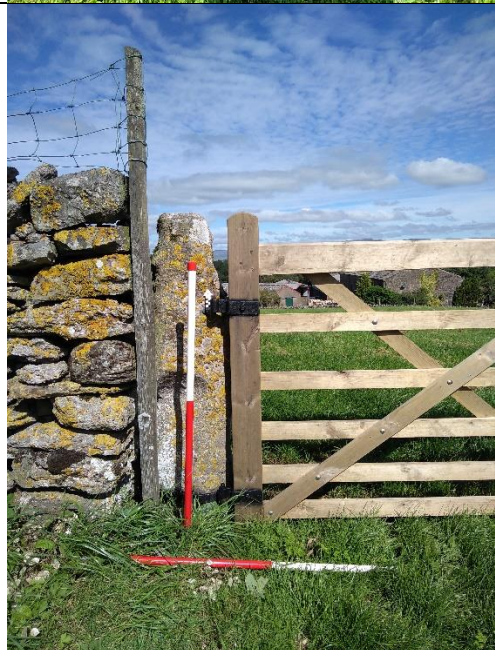
| Feature No. | Feature Type | Description | Condition | Threats | Photos |
|---|---|---|---|---|---|
| H22 | Gate stoop | Single limestone stoop, with flat top, to west of gate opening. Gate attached to stoop with iron work<br>0.32m wide, 1.41m height | Good | Erosion & vehicles | |

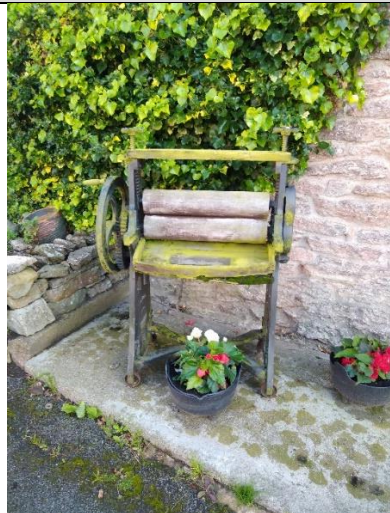
| Feature No. | Feature Type | Description | Condition | Threats | Photos |
|---|---|---|---|---|---|
| H23 | Mangle | Mangle positioned outside Ridding House | Good | Easily movable;<br>weathering | |

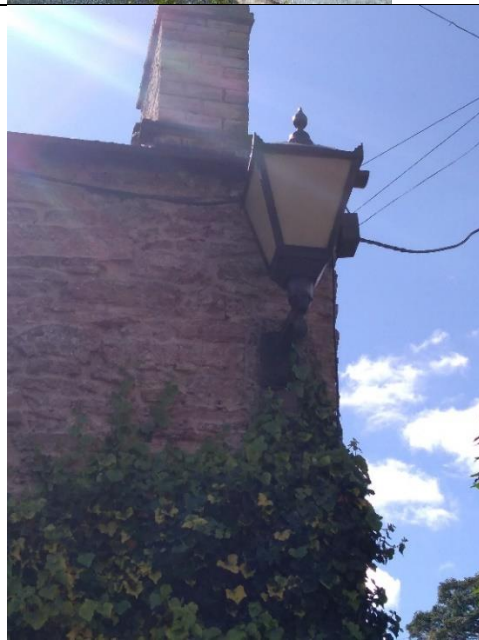
| Feature No. | Feature Type | Description | Condition | Threats | Photos |
|---|---|---|---|---|---|
| H24 | Lamp | Electrical lamp on side of house - sheet metal and clouded plastic?, with finial on top. | Good | Erosion &<br>vegetation? | |

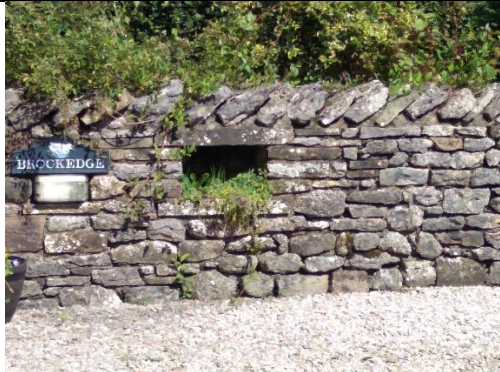
| Feature No. | Feature Type | Description | Condition | Threats | Photos |
|---|---|---|---|---|---|
| H25 | Recess in wall | Recess in wall with sill and lintel. Possible bee bole?<br>Vegetation currently growing out of it. | Good | Vegetation? &<br>wall collapse | |

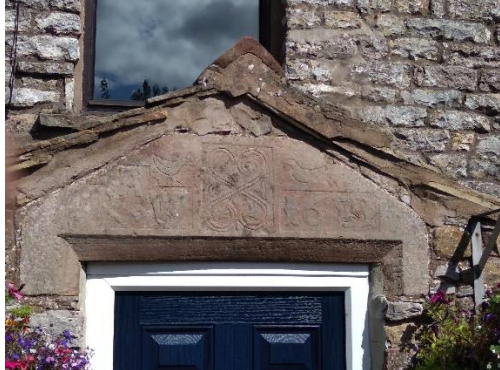
| Feature No. | Feature Type | Description | Condition | Threats | Photos |
|---|---|---|---|---|---|
| H26 | Date stone | Repositioned date stone<br>A<br>R W 1681<br>Also decorated, with swirling detail in middle, and two different birds on either side (one above initials and one above date)<br>Situated on porch of house. Part of lintel – has it been reshaped or was it always a sort of trapezoidal shape?, with a deep chamfer around opening. | Good | Weathering | |

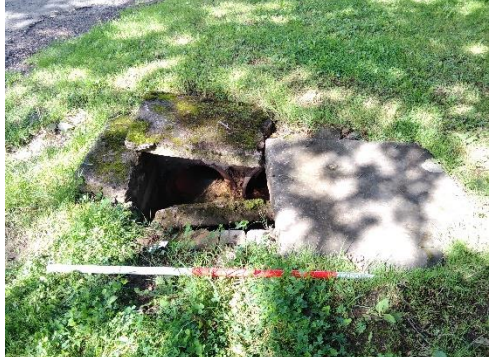
| Feature No. | Feature Type | Description | Condition | Threats | Photos |
|---|---|---|---|---|---|
| H27 (A + B) | Culverts<br>A & B | 2 culverts<br>A – brick built leading to 2 pipes<br>B – stone built with 2 pipes<br>Pipes lead to beck | A – Good<br>B – roof slap displaced | Further damage | |

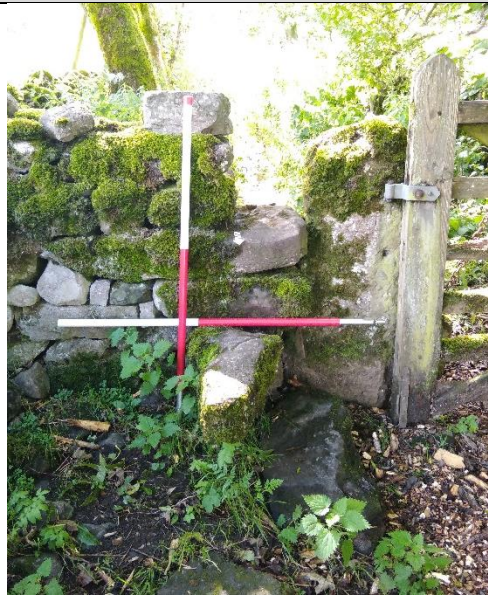
| Feature No. | Feature Type | Description | Condition | Threats | Photos |
|---|---|---|---|---|---|
| H28 | A – step stile<br>B – gate stoops | <p>A – 1 step to S, 2 steps to N. 1 step not tied into wall.<br/> A lot of moss – mix of limestone and sandstone<br/> 0.5m width (top of stile), 1.58m width (step to step)<br/> B – 2 stone stoops, limestone<br/> Total gate width – 2.52m<br/> E stoop – 1.17m height and 0.37m wide<br/> W stoop – 1.07m height</p> | Good | Vegetation & erosion | |

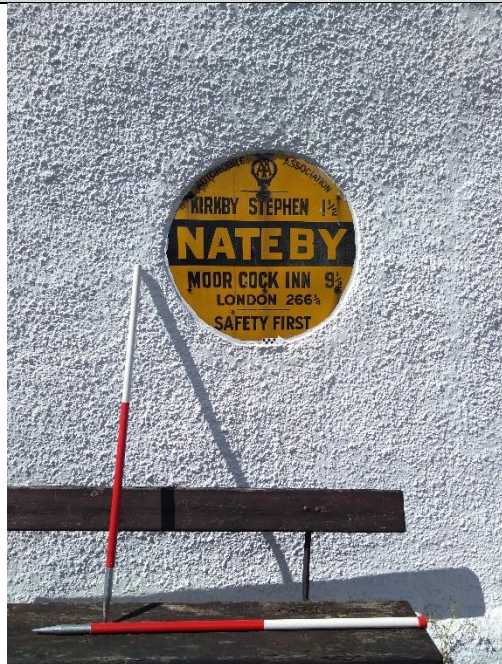
| Feature No. | Feature Type | Description | Condition | Threats | Photos |
|---|---|---|---|---|---|
| H29 | AA sign | Round yellow sign in wall of Black Bull pub with distances to Kirkby Stephen (1 ½), Moor Cock Inn (9 ½) and London (266 ¼). For the 'Automobile Association', and the words 'SAFETY FIRST'<br>Painted yellow and black<br>0.77m wide | Good | Erosion | |

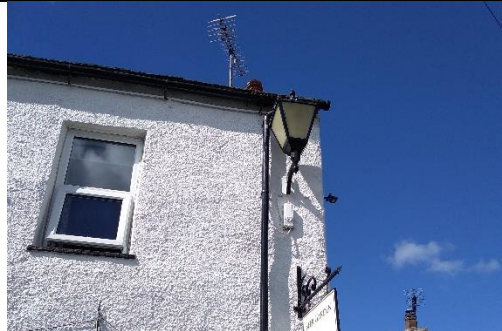
| Feature No. | Feature Type | Description | Condition | Threats | Photos |
|---|---|---|---|---|---|
| H30 | Lamp | Electric lamp attached to Black Bull pub - sheet metal and clouded plastic?, with finial on top. | Good | Erosion | |

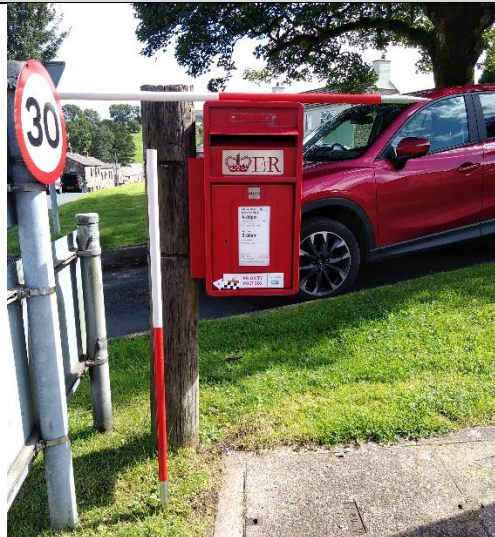
| Feature No. | Feature Type | Description | Condition | Threats | Photos |
|---|---|---|---|---|---|
| H31 | Letter box | <p>Elizabeth II letter box, attached to wooden post. Plaque with 'ROYAL MAIL' screwed on. A fairly recent installation.</p> <p>0.6m height, 0.3m wide, 0.34m depth</p> <p>An earlier letter box was situated just to the north of this location (shown on 6 and 25" maps)</p> | Good | N/A | |

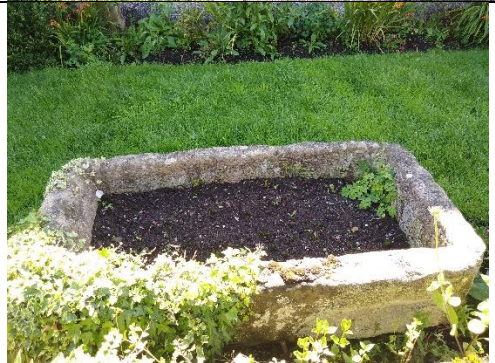
| Feature No. | Feature Type | Description | Condition | Threats | Photos |
|---|---|---|---|---|---|
| H32 | Trough | Trough located in front garden, now used as planter | Good | Erosion | |

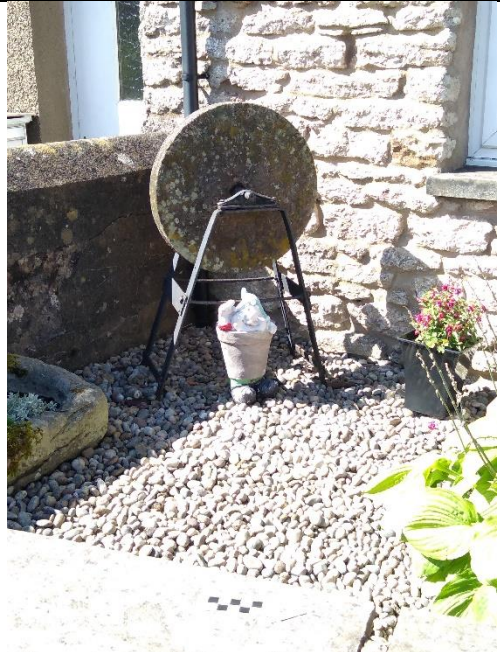
| Feature No. | Feature Type | Description | Condition | Threats | Photos |
|---|---|---|---|---|---|
| H33 | Grinding stone | Grinding stone (sandstone) on metal frame, now located in front garden | Good | Moveable | |

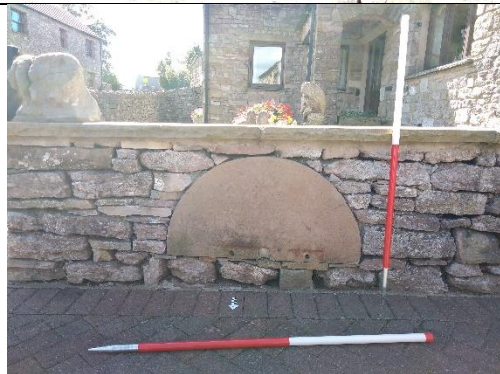
| Feature No. | Feature Type | Description | Condition | Threats | Photos |
|---|---|---|---|---|---|
| H34 | Former mill stone? | Pink sandstone, was likely circular, and now cut in half – with central square opening, as well as two smaller holes to either side with evidence that there an attachment linked to them. Now in garden wall. 0.85m wide, 0.45m high | Poor (but good in current condition) | Erosion & wall collapse | |

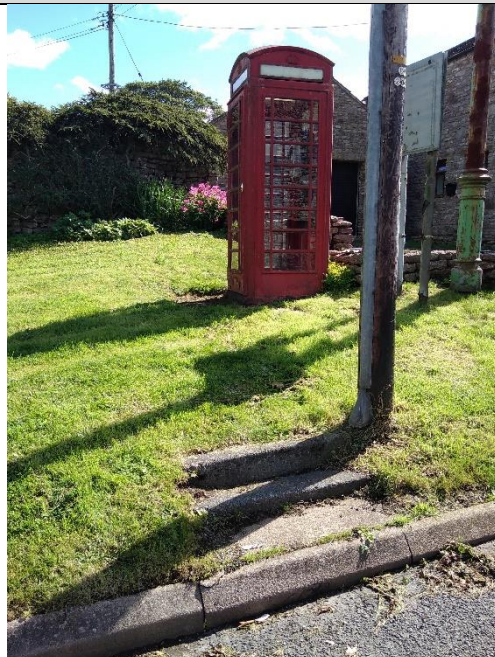
| Feature No. | Feature Type | Description | Condition | Threats | Photos |
|---|---|---|---|---|---|
| H35 | Phone box | <p>Telephone kiosk with 3 concrete steps leading up to it (from the road). Small concrete slab in front.</p> <p>K6. Painted red with glass panels. Still has a telephone inside. This was once coin operated but is no longer in operation.</p> <p>Crown on top (painted red), and 'TELEPHONE' sign on all 4 faces.</p> <p>Leather hinges internally for door, painted red.</p> <p>0.88m wide and 2.4m height</p> | Fair – paint flaking | <p>Erosion, removal of phone, continuing maintenance?, and vandalism.</p> <p>There are public notices which state that the payphone kiosk will be removed.</p> | |

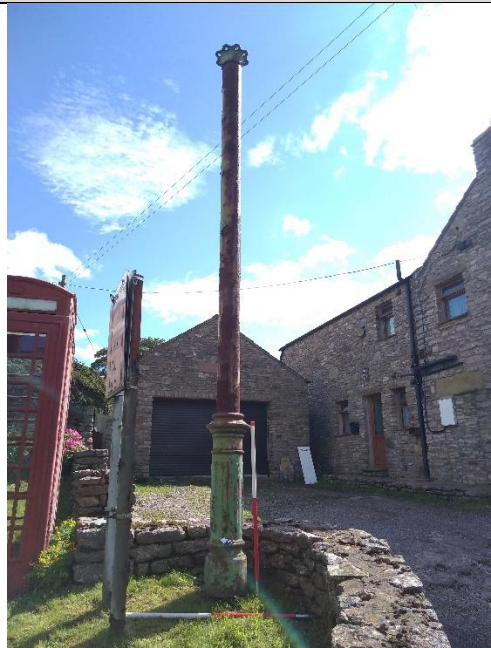
4.30 **H36** is situated next to the telephone box (**H35**). This post appears to have been for a former gas lamp post, however the lamp does not survive. This is likely the only original light to survive, albeit in a poor condition. The other lamp post (**H14**) is situated in a property's garden, and may therefore have been installed as a garden feature. However, it has either been made to look like a gas lamp, or it once was one that has been resituated and converted to electric. The five lamps that are attached to buildings are all electric and quite modern in date, but they are all in the same style. Therefore, it can be concluded that they were added at the same time.

| Feature No. | Feature Type | Description | Condition | Threats | Photos |
|---|---|---|---|---|---|
| H36 | Post – lamp? | Green post, possibly gas lamp post, lost its “lamp”<br>Makers mark – ADAMS LTD YORK. | Poor – rusting<br>and lost<br>function | Erosion &<br>removal | |

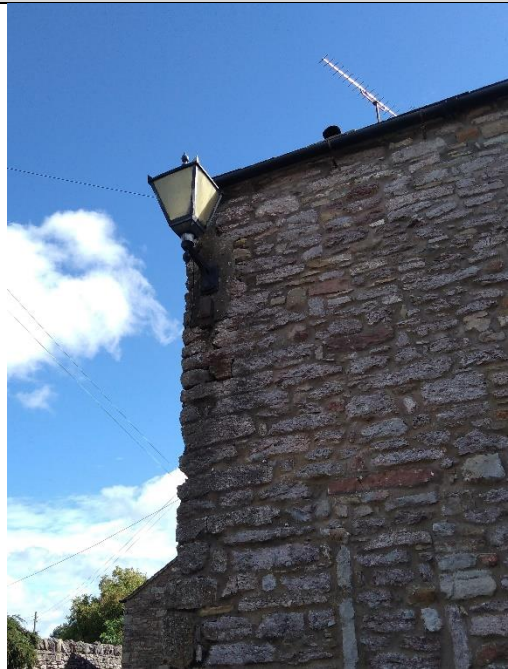
| Feature No. | Feature Type | Description | Condition | Threats | Photos |
|---|---|---|---|---|---|
| H37 | Lamp | Electric lamp attached to home (converted barn) - sheet metal and clouded plastic?, with finial on top. | Good | Erosion | |

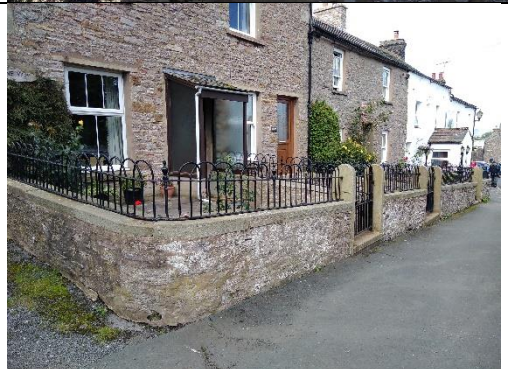
| Feature No. | Feature Type | Description | Condition | Threats | Photos |
|---|---|---|---|---|---|
| H38 | Railings | Railings outside several houses | Good | Erosion | |

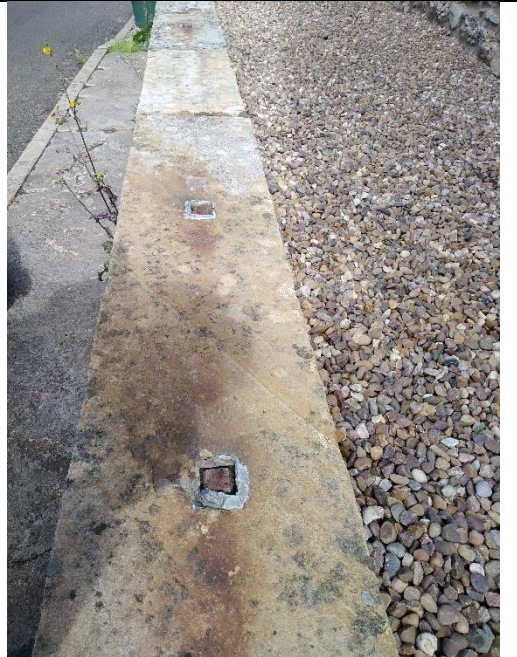
| Feature No. | Feature Type | Description | Condition | Threats | Photos |
|---|---|---|---|---|---|
| H39 | Railings | Railings removed, evidence of them in wall | Railings removed | N/A | |

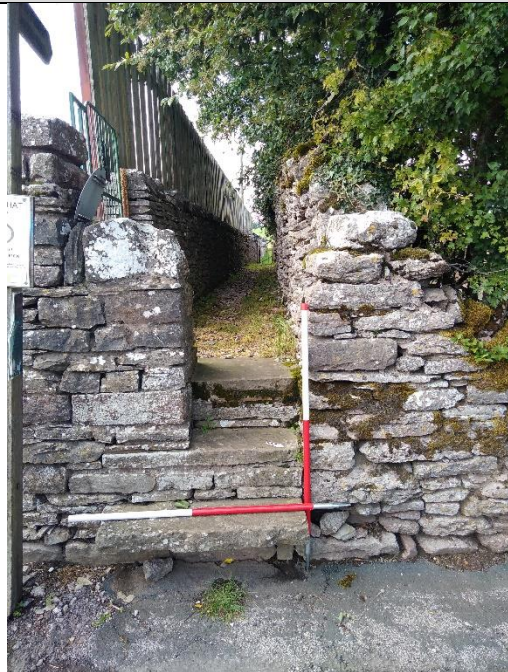
| Feature No. | Feature Type | Description | Condition | Threats | Photos |
|---|---|---|---|---|---|
| H40 | Step stile | <p>Step stile leading to footpath towards Wharton Hall. Stile of atypical construction. Limestone and sandstone. 3 steps from footpath adjacent to road, to ROW.</p> <p>Height ground to top – 0.83m</p> | Good | Erosion & wall collapse | |

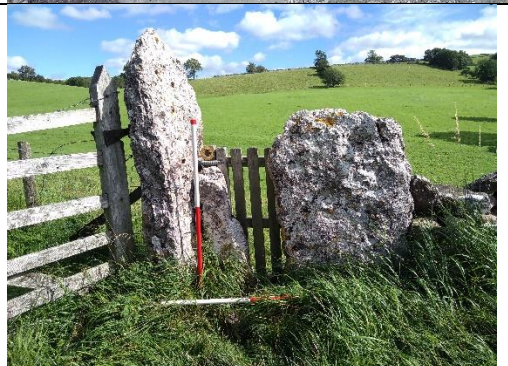
| Feature No. | Feature Type | Description | Condition | Threats | Photos |
|---|---|---|---|---|---|
| H41 | <p>A – Gate stoops</p> <p>B – Squeeze stile</p> | <p>Limestone slabs making up squeeze stile and gate stoop.</p> <p>Stones of squeeze stile of very different shapes, and now with added wooden gate.</p> <p>Stoop to E of gate opening, with pointed top.</p> <p>A – 1.68m high, 0.74m wide</p> <p>B – entire width 1.37m</p> <p>Slab to N – 0.8m high, 0.28m wide; slab to S – 1.25m high, 0.9m wide</p> | Good | Erosion | |

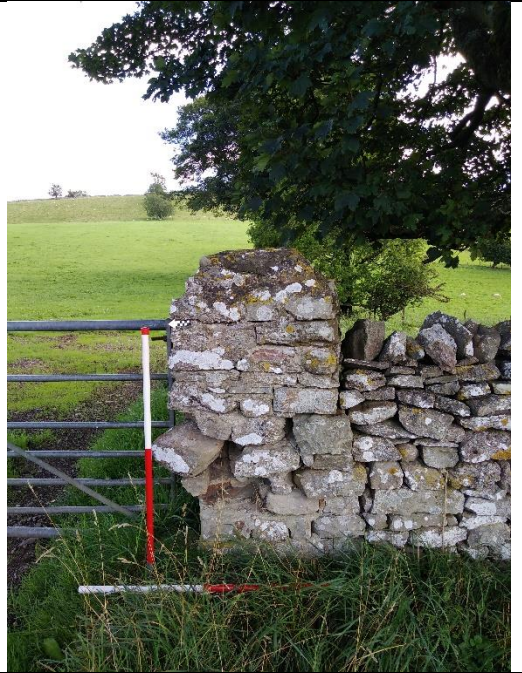
| Feature No. | Feature Type | Description | Condition | Threats | Photos |
|---|---|---|---|---|---|
| H42 | Gate pier | Pier to S of gate entrance, coursed limestone, mortared<br>1.5m high, 0.67m wide, 0.69m depth | Fair – unstable walling | Collapse & erosion & vehicles | |

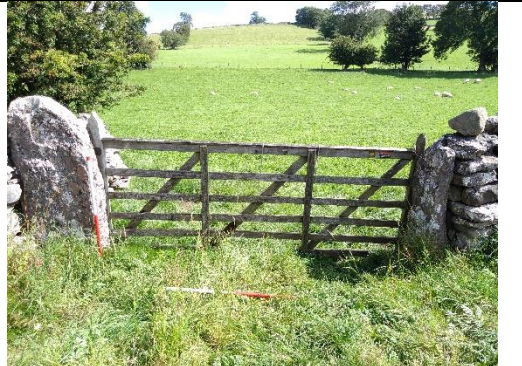
| Feature No. | Feature Type | Description | Condition | Threats | Photos |
|---|---|---|---|---|---|
| H43 | Gate stoops | 2 gate stoops, limestone, one parallel with wall towards S, whereas N one angled – of different sizes<br>Gate width – 3.7m<br>N stoop – 1.47m high, 0.66m wide<br>S stoop – 1.2m high, 0.17m wide | Good | Erosion & vehicles | |

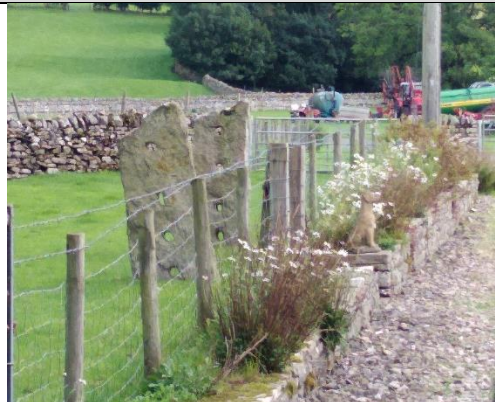
4.25 In Nateby the gate stoops were of quite a crude form, predominantly of limestone, but none of them showed any evidence of being dressed. The slip gate posts (**H44a** and **b**) are an unusual survival, especially as neither pair is currently situated in a boundary. They are not a typical type of stoop in the Westmorland Dales area, although they are found in other areas of Cumbria. In these examples, one pair has four circular holes in each stoop, and the other pair has three circular holes in each stoop. **H44b** currently has a manger feeder positioned between the stoops, with the manger attached using bailer twine through the holes.

| Feature No. | Feature Type | Description | Condition | Threats | Photos |
|---|---|---|---|---|---|
| H44 | Slip gate posts A & B | A – 4 holes on each stoop, no longer on wall boundary<br>B – 3 holes? on each stoop, also no longer on boundary, appears to be used as a feeder | Good | Not in use - removal | |

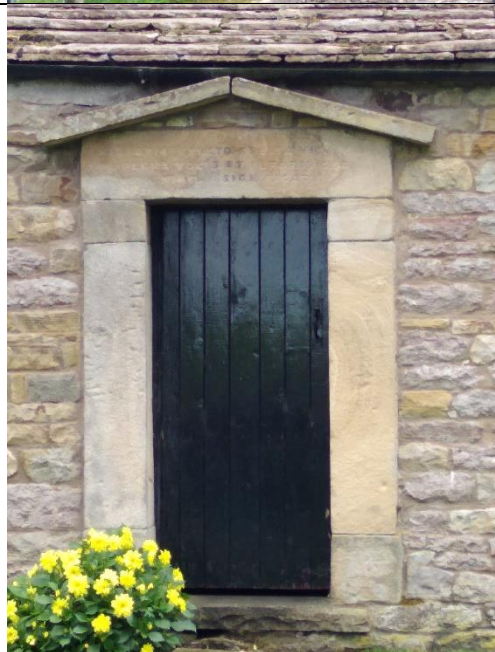
| Feature No. | Feature Type | Description | Condition | Threats | Photos |
|---|---|---|---|---|---|
| H45 | Latin inscribed lintel | Latin inscription on lintel, possibly repositioned, but whole door surround is contemporary. Attempt at a classical style? Includes inscribed lintel, jambs (of 3 pieces on each side), and 2 protruding stones at angle to make slight “porch”.<br>Not possible to read the whole inscription. | Fair – hard to read | Erosion | |

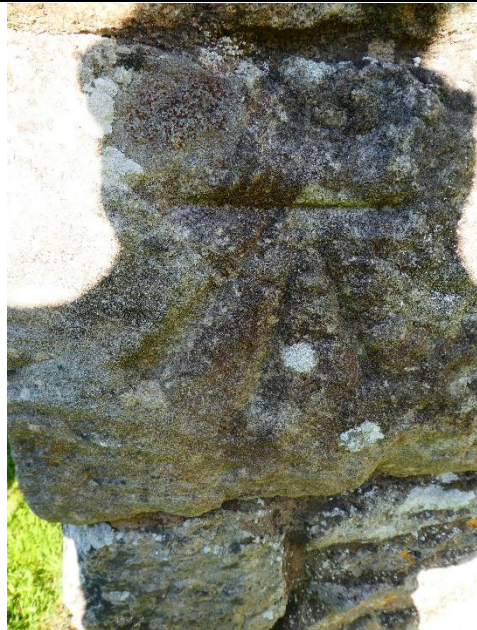
| Feature No. | Feature Type | Description | Condition | Threats | Photos |
|---|---|---|---|---|---|
| H46 | OS benchmark | Benchmark on E facing wall of H17. Located on sandstone quoin.<br>It is situated about 1m above ground level.<br>On the 6" map, a benchmark is indicated on the corner of Wellhead Cottages. However, on the 25" map it is shown on the outbuilding, which is its present position. | Good | Erosion | |
