# Small-Scale Heritage Features Survey

Technical Report: Newbiggin-On-Lune  
November 2023

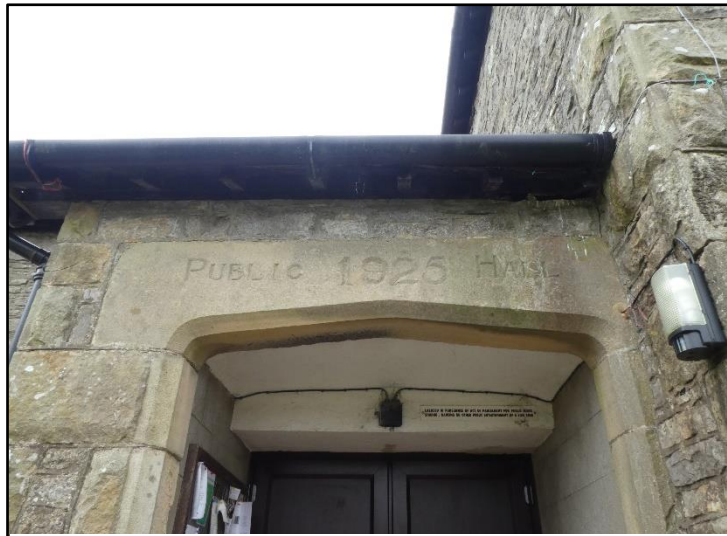
*Figure 4: Image showing the inscribed lintel on the Public Hall in Newbiggin-On-Lune.*

4.8 Feature B20 (Figure 4) is a lintel inscribed with “PUBLIC 1925 HALL” situated over the porch opening of Newbiggin-On-Lune’s Public Hall. There is no building in this area shown on the third edition six or twenty-five-inch map, but a building in this location is shown on 1:25,000 Outline Series map<sup>6</sup> corroborating that it was built in 1925.

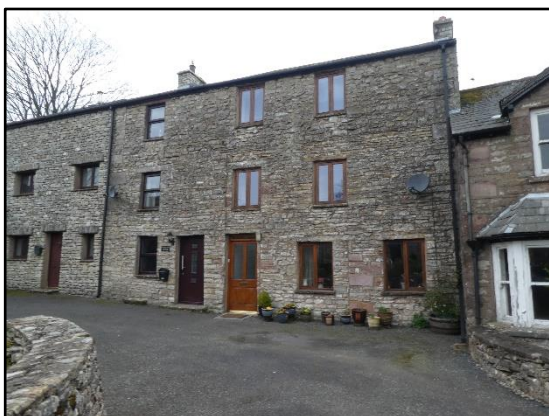
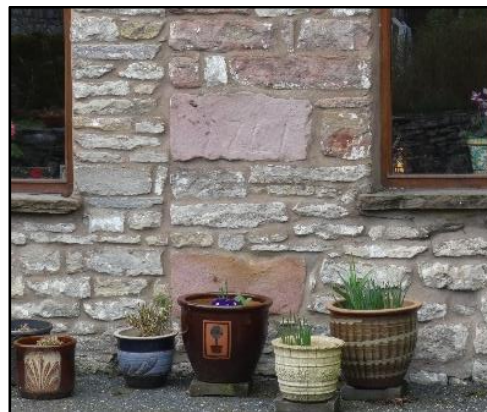
*Figure 5: Image showing Oddfellows' cottage (above) and a close up of the inscribed quoin (right).*

4.9 Feature B26 (Figure 5) is a red sandstone quoin dated 1741, located on the edge of Oddfellows Cottage, formerly the Oddfellows’ Arms Inn (discussed 3.29). The quoin is situated on the right side of a former door way which has since been blocked and converted into a window; however it may have been resituated from elsewhere.

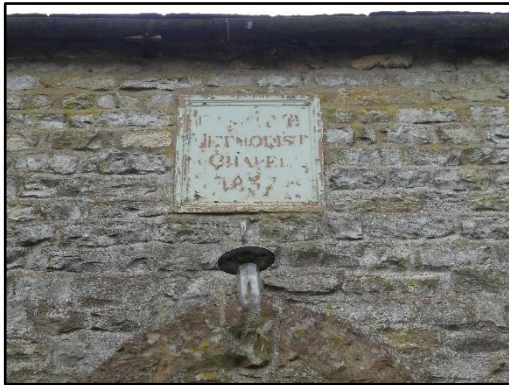
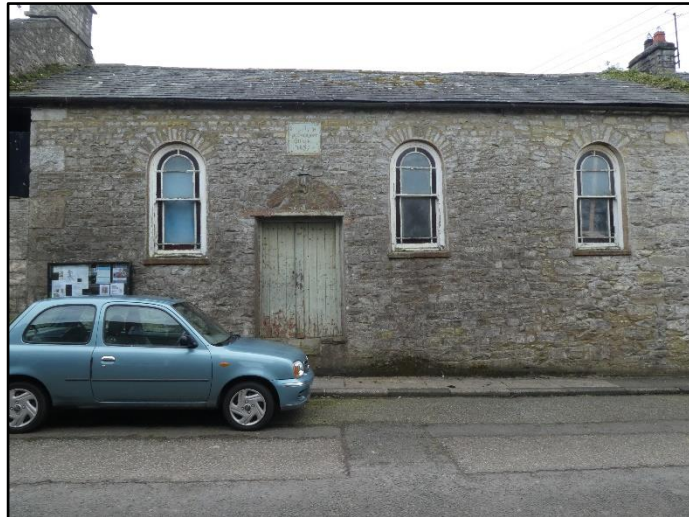
*Figure 6: Image showing the Date Stone on the Methodist Chapel (above) and the location of the stone in relation to the doorway (right).*

4.10 The third date stone (B28, Figure 6) is situated above the doorway of the methodist chapel. The date stone appears to be a sandstone block that has previously been painted (the paint is now peeling making it difficult to read), and incised with “[PRIMITIVE] METHODIST CHAPEL 1837”. A “Methodist Chapel (Primitive)” is marked in this location on both the first edition six-inch and twenty-five-inch OS maps. While the date stone is likely original, the doorway below it has probably been altered and been made wider. The building is no longer an active chapel and is used for storage.

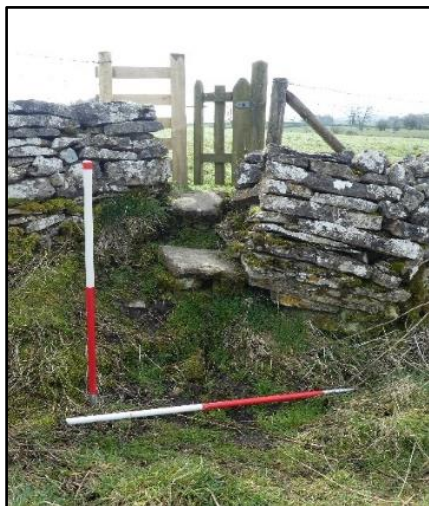
*Figure 8: Image showing feature B05, a step stile with steps cut into the bank situated between the field and sunken lane.*

4.18 Six of the seven step stiles use through stones to create steps in the base of the wall. However one stile (B05) consisted of stone steps placed into the bank/verge of a sunken lane, which was much lower down than the adjoining field (Figure 8).

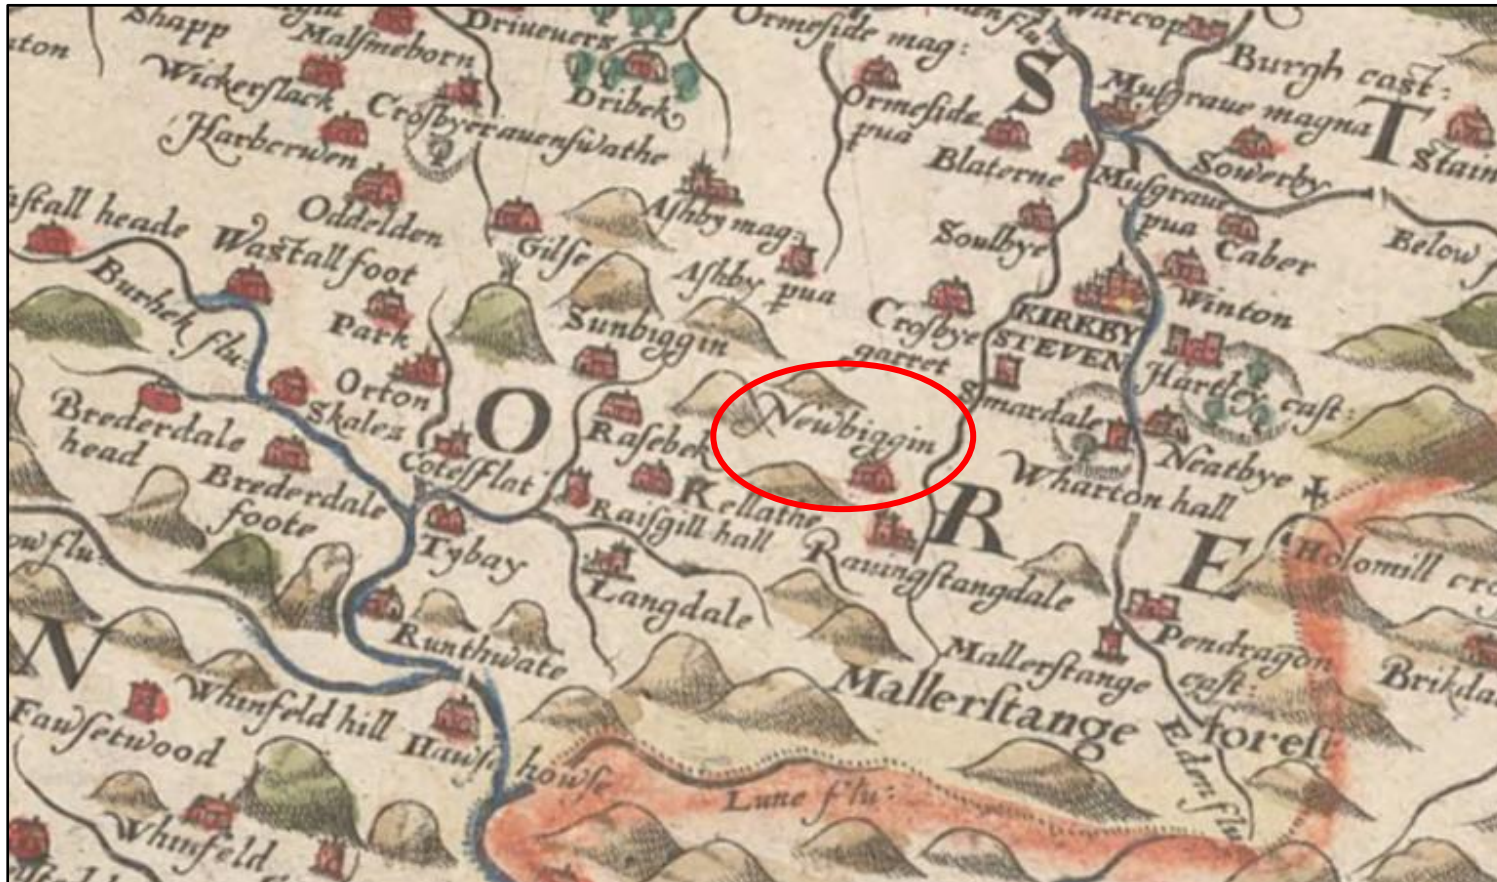
Figure 12: The map of Westmorland and Cumbria from the 1583 edition of the Saxton atlas of England and Wales (Old Maps Online 2022) showing the village of Newbiggin circled in red.

9.1 This 1583 edition of the Saxton Atlas of England and Wales (Figure 12) clearly shows the location of Newbiggin-On-Lune (circled). The village is called 'Newbiggin'. The icon of a house next to the village name suggests there was a small settlement in the area (University of Glasgow 2002).

3.37 Newbiggin-on-Lune is first shown as "Newbiggin" on the Saxton Atlas of England and Wales of 1583 (Figure 12). The icon of a house next to village name suggests there was a small settlement in the area (University of Glasgow 2002).

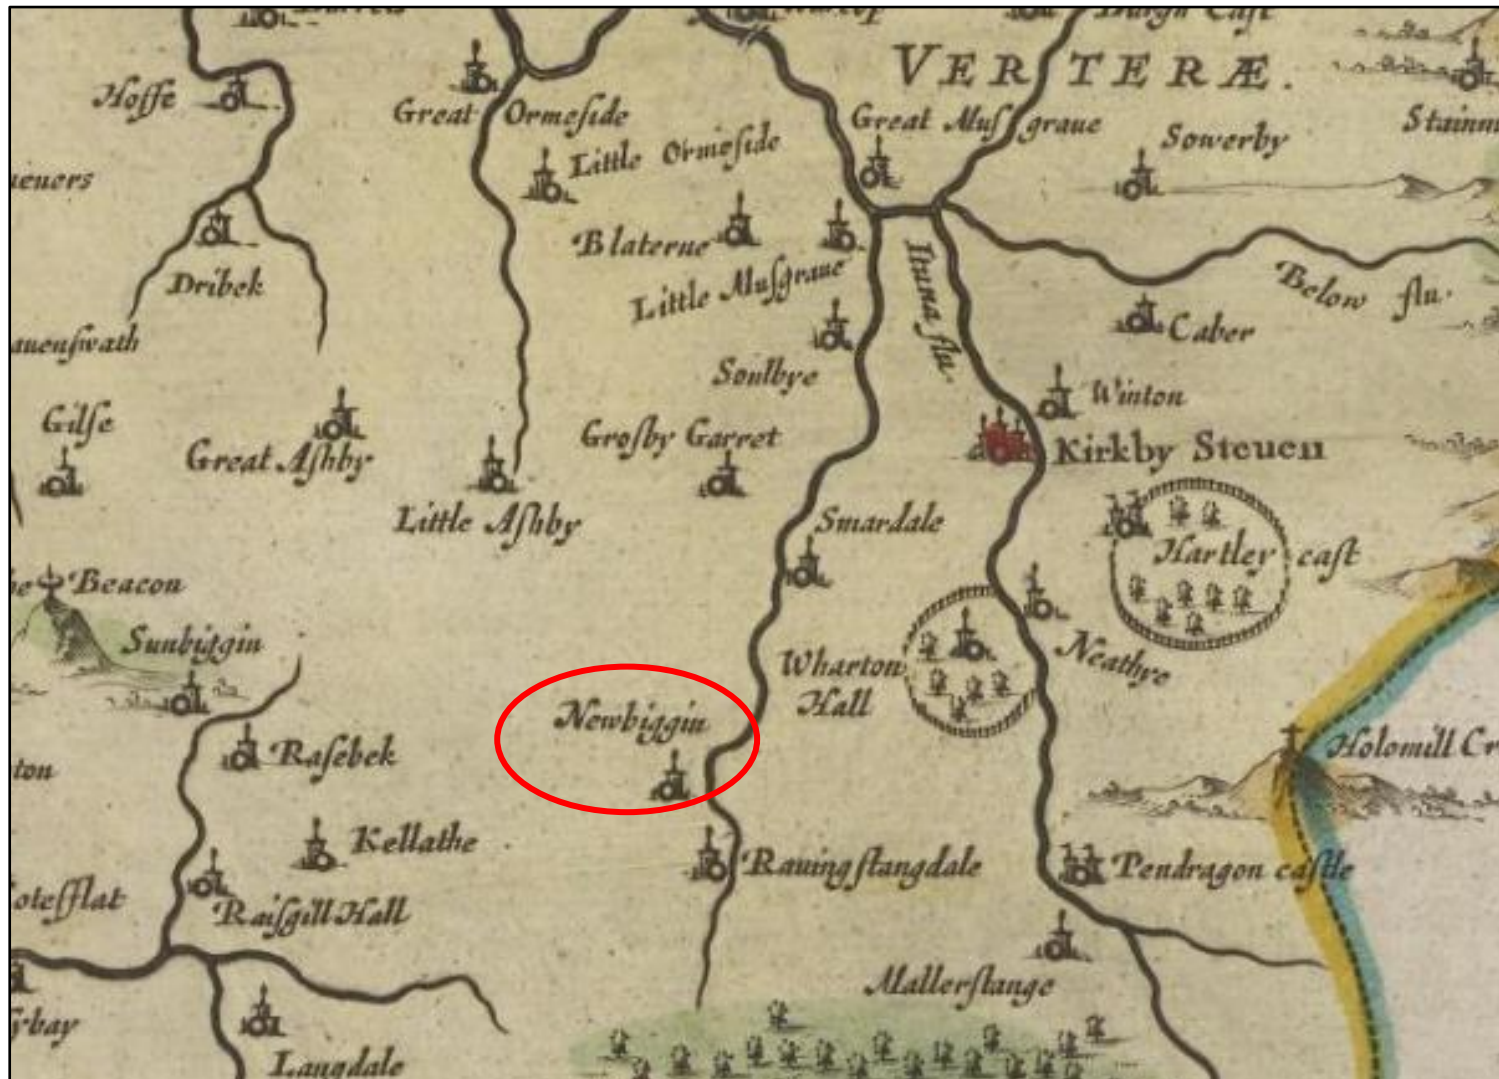
Figure 13: The map of Westmorland by Joan Blaeu, printed in 1662 (National Library of Scotland 2022) showing the village of Newbiggin circled in red.

9.2 This 1662 map by Joan Blaeu (Figure 13) again clearly shows the village of Newbiggin-On-Lune (circled). The symbol next to the village name is possibly a church, which could refer to St Helen's Chapel.

3.24 It is unclear if any deer were kept within the park, as another deer park was also created in the 16<sup>th</sup> century at Wharton Hall near Nateby (Nicolson and Burn 1777; Nicholls 1877, p.24; Curwen 1932; Blackett-Ord 1986). This Wharton Hall deer park can be seen on the 1662 Joan Blaeu map (Figure 13), however no park is shown at or near Newbiggin, suggesting that the park had gone out of use by this time.

3.38 The 1662 map by Joan Blaeu (Figure 13) again clearly shows the village of Newbiggin, with the symbol next to the village possibly being a church. This indicates that there may have been a religious building in the area, which may refer to St Helen's Chapel, however this is uncertain.

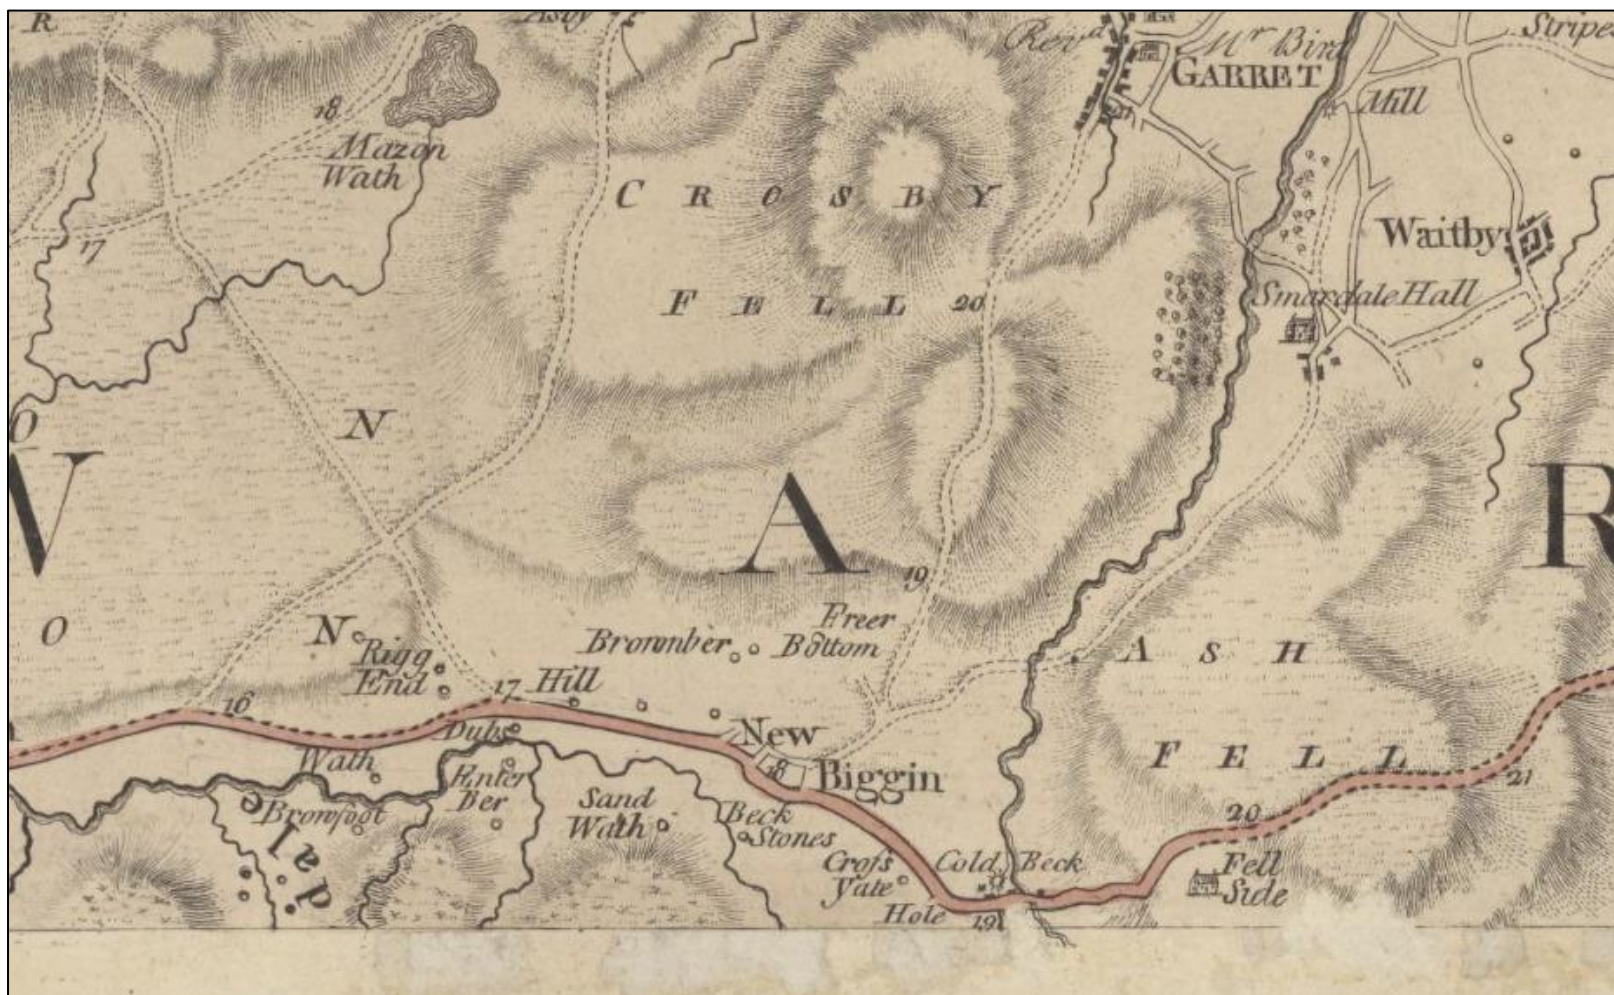
Figure 14: Jeffery's map of The County of Westmoreland surveyed in 1778 (National Library of Scotland 2022) showing New Biggin.

9.3 The Jeffery's 1778 map (Figure 14) shows the village as 'New Biggin' rather than the combined Newbiggin and is the only instance where this occurs; suggesting it was recorded incorrectly. 'Freer Bottom', now Friar Bottom and Brownber are also clearly labelled for the first time.

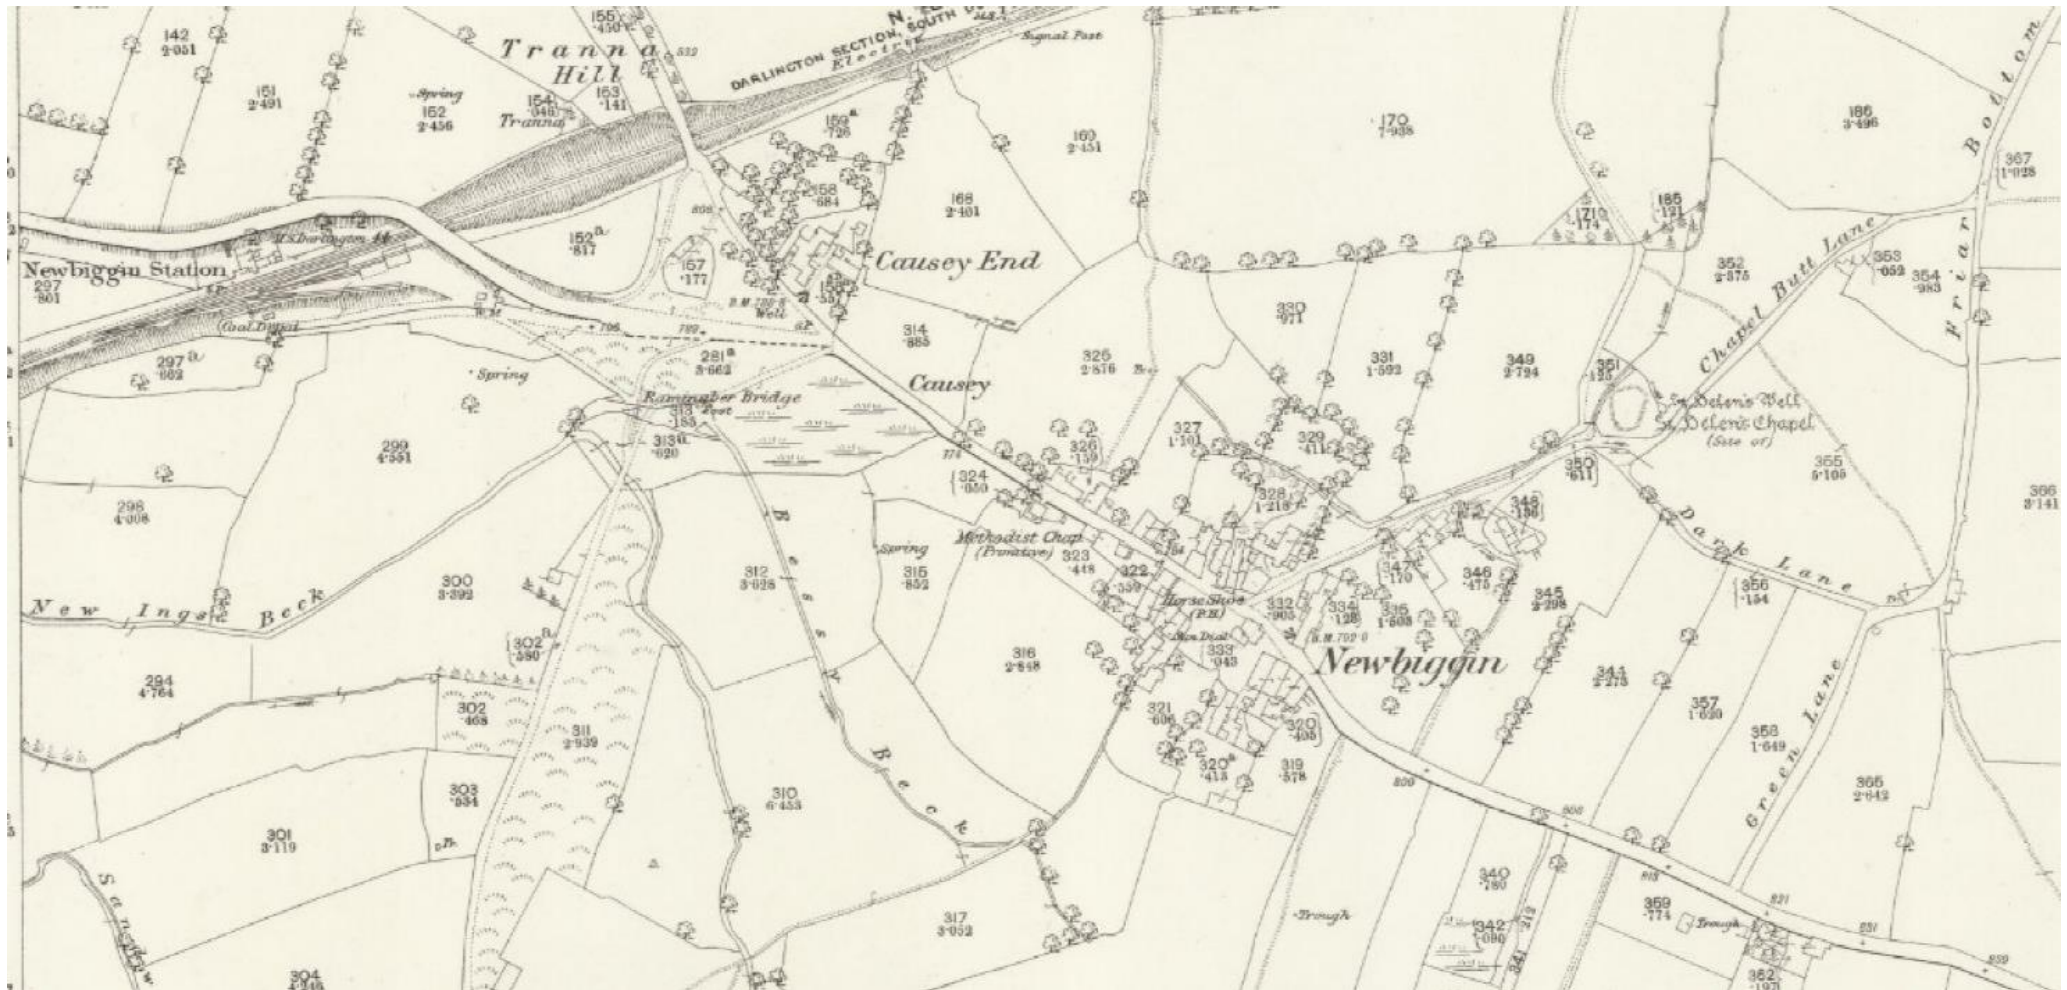
Figure 15: First edition twenty-five-inch OS map (map sheet Westmorland XXIX.8. Surveyed: 1857, Published: 1859. National Library of Scotland).

9.4 The first edition twenty-five-inch Ordnance Survey map (Figure 15) is the first map to give detailed information about the villages layout. The map shows the railway and Newbiggin Station the northwest, the turnpike road through the centre of the village, with a guide post and sun dial near Causey End. The Horse Shoe public house in the centre of the villages, with a sun dial located close by. St Helen's Well and Chapel are labelled the north-east.

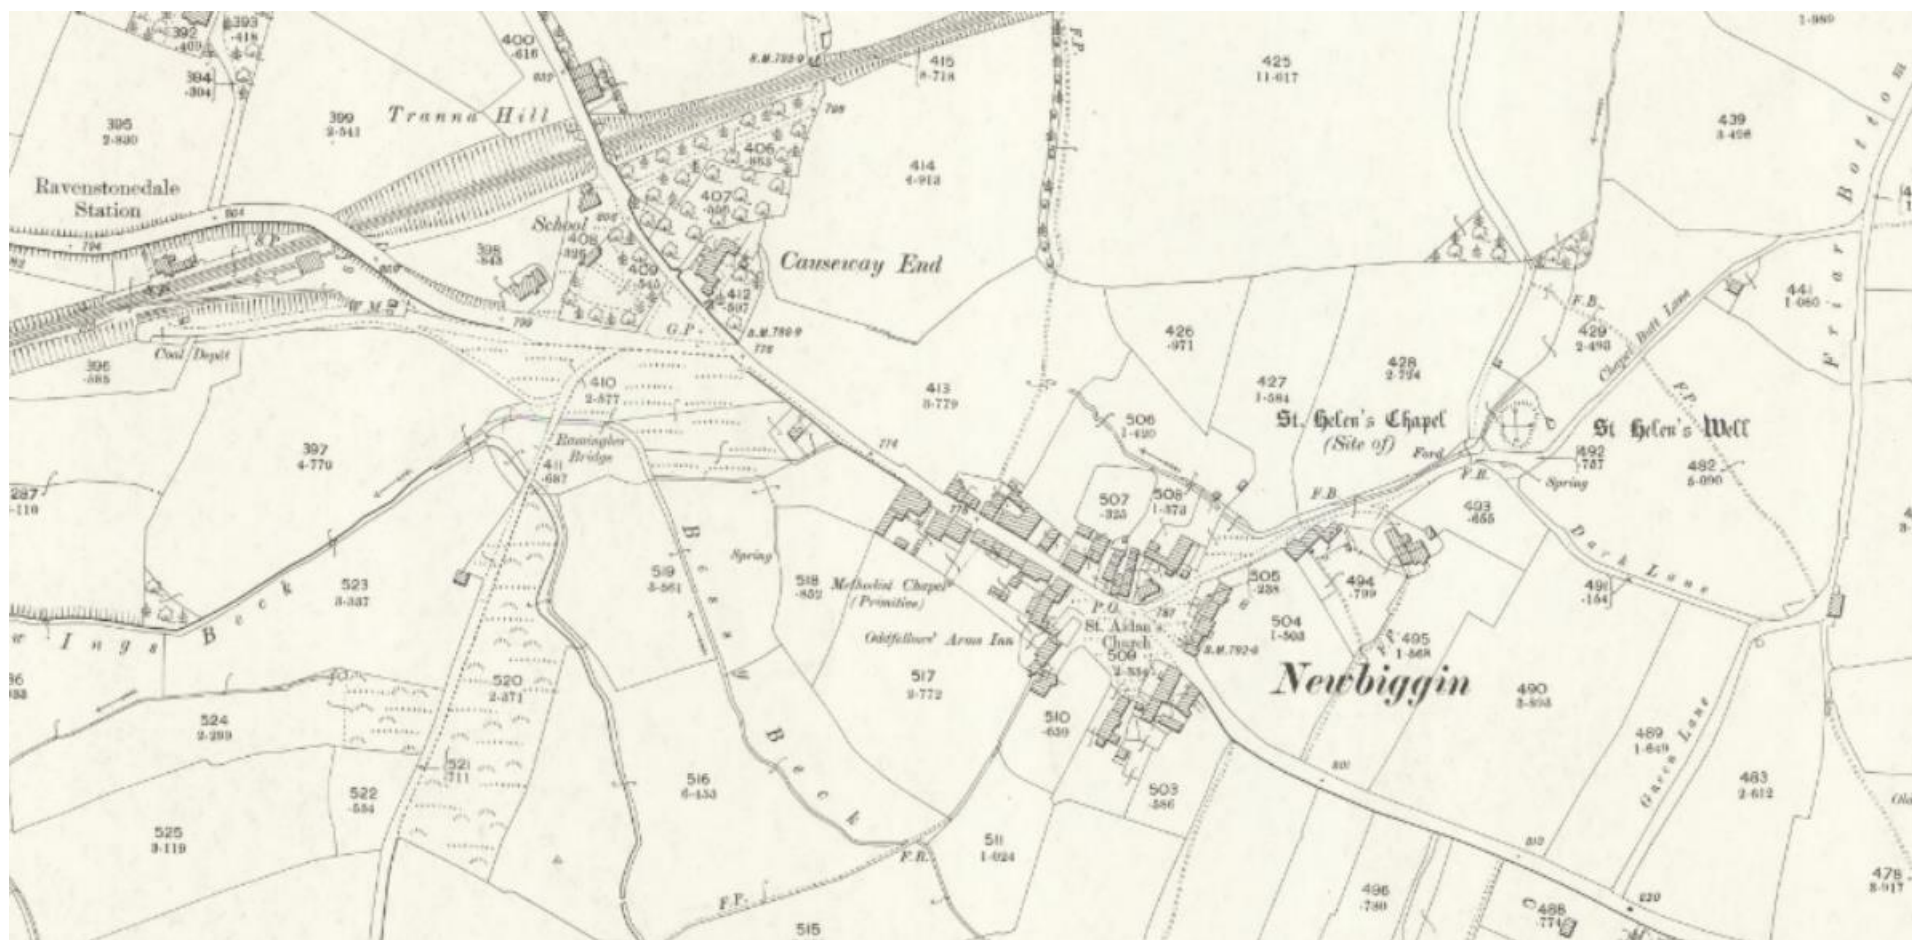
Figure 16: The second edition twenty-five-inch OS map (map sheet Westmorland XXIX.8. Revised: 1897, Published: 1898 Revised: 1897, Published: 1898. National Library of Scotland).

9.5 The second edition twenty-five-inch Ordnance Survey map (Figure 16) shows some changes within the village, with the station to the north-west now named Ravenstonedale Station, the sun dial near Causeway End is no longer shown and the Horse Shoe public house has been renamed as the Oddfellows' Arms Inn. The Post Office and St Aidan's Church are new additions in the centre of the village, however the sun dial is no longer shown. While the field patterns are very similar, some of the possible strip fields to the west have been incorporated into one larger field.

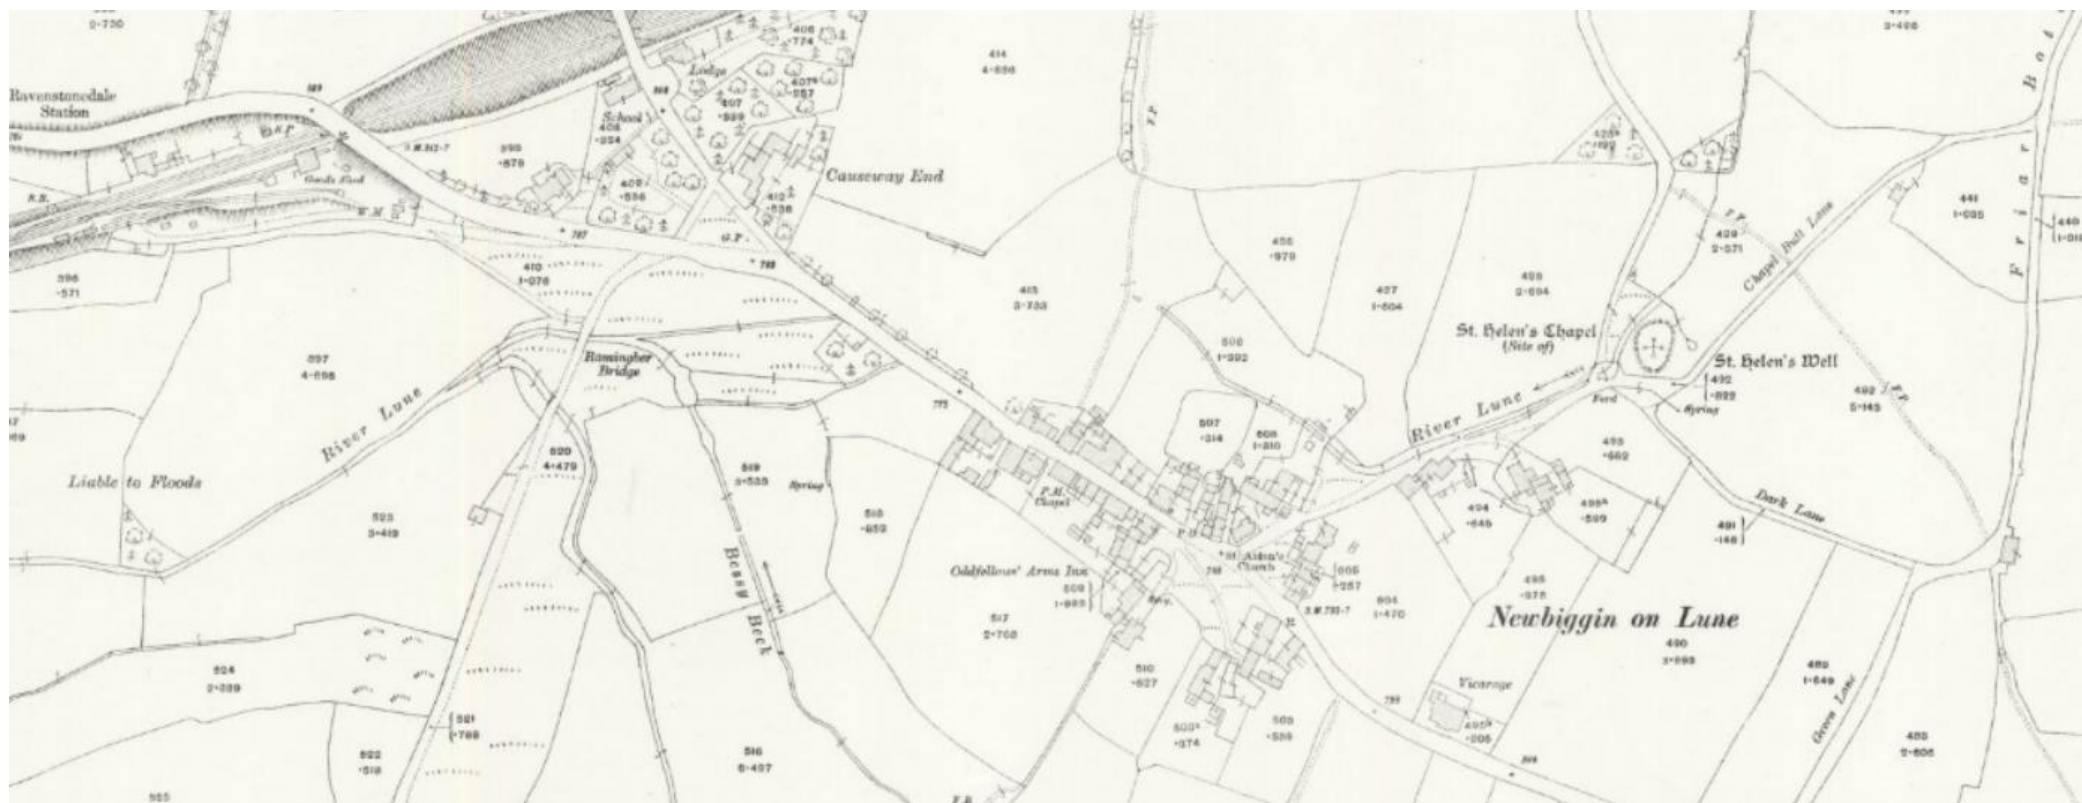
Figure 17: Third edition twenty-five-inch OS map (map sheet Westmorland XXIX.8. Revised: 1912 to 1913, Published: 1915. National Library of Scotland).

9.6 The third edition twenty-five-inch Ordnance Survey map (Figure 17) shows many of the same features as the second edition, with the addition of a smithy in the centre of the village and a vicarage to the east. The field patterns remain the same as on the second edition and the road leading to the station appears more formalised.

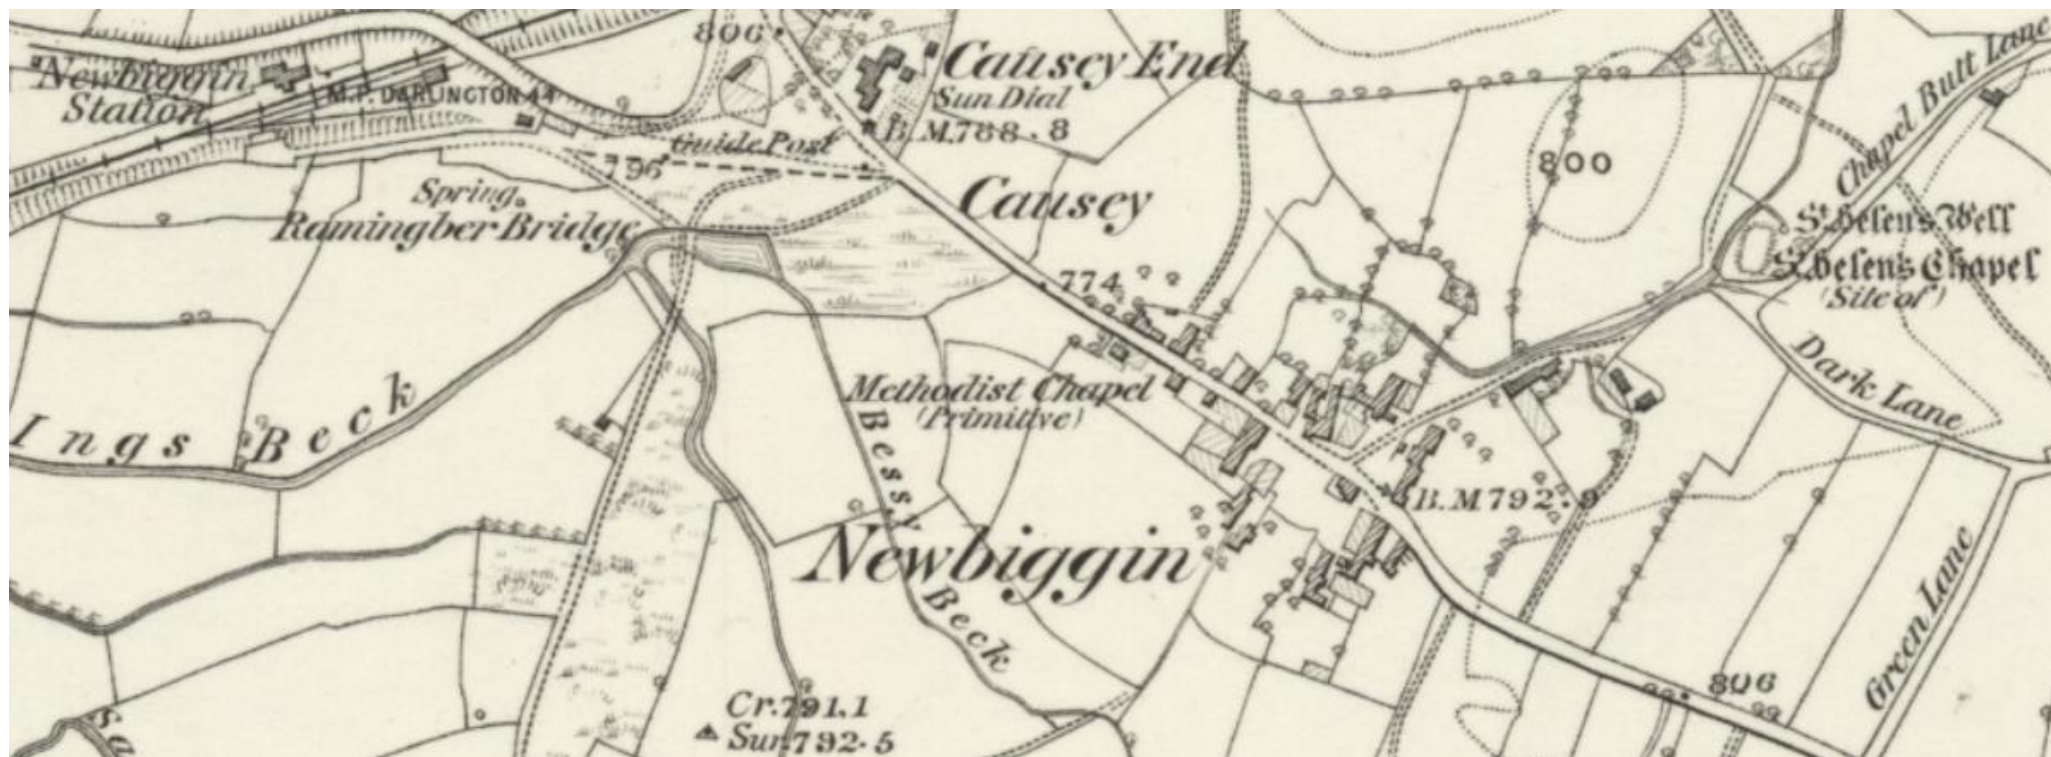
Figure 18: The first edition six-inch OS map (map sheet Westmorland Sheet XXIX. Surveyed: 1858, Published: ca. 1862 to 1863. National Library of Scotland).

9.8 The first edition six-inch Ordnance Survey map (Figure 18) shows many of the same features as the twenty-five-inch OS map, with Newbiggin Station to the northwest, a sun dial and Guide Post near Causey End and a Methodist Chapel (Primitive) on the western edge of the village with St Helens Well and Chapel to the north-east. The Horse Shoe public house and sun dial near the centre of the village are not shown on this map

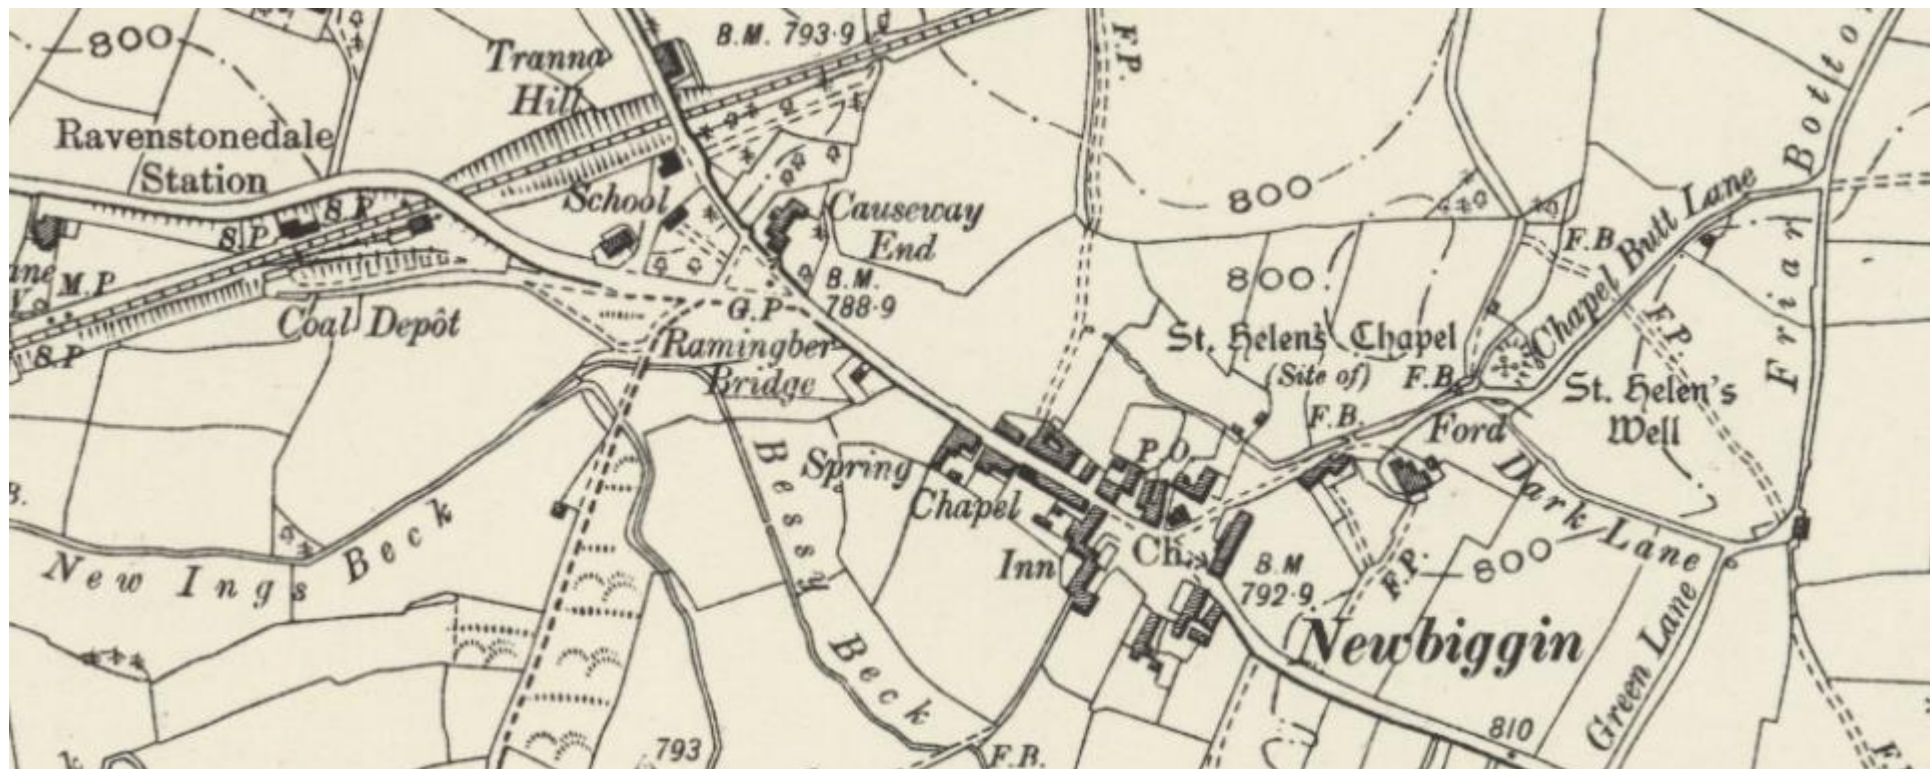
Figure 19: The second edition six-inch OS map (map sheet Westmorland Sheet XXIX.NE. Revised: 1897, Published: 1899. National Library of Scotland).

9.9 The second edition six-inch Ordnance Survey map (Figure 19) shows a Chapel, Inn, Post Office and Church in the centre of the village but provides less detail than the twenty-five-inch map. The map shows Ravenstonedale Station to the west of the village, however the sun dial to the north of the village near Causeway End is no longer shown.

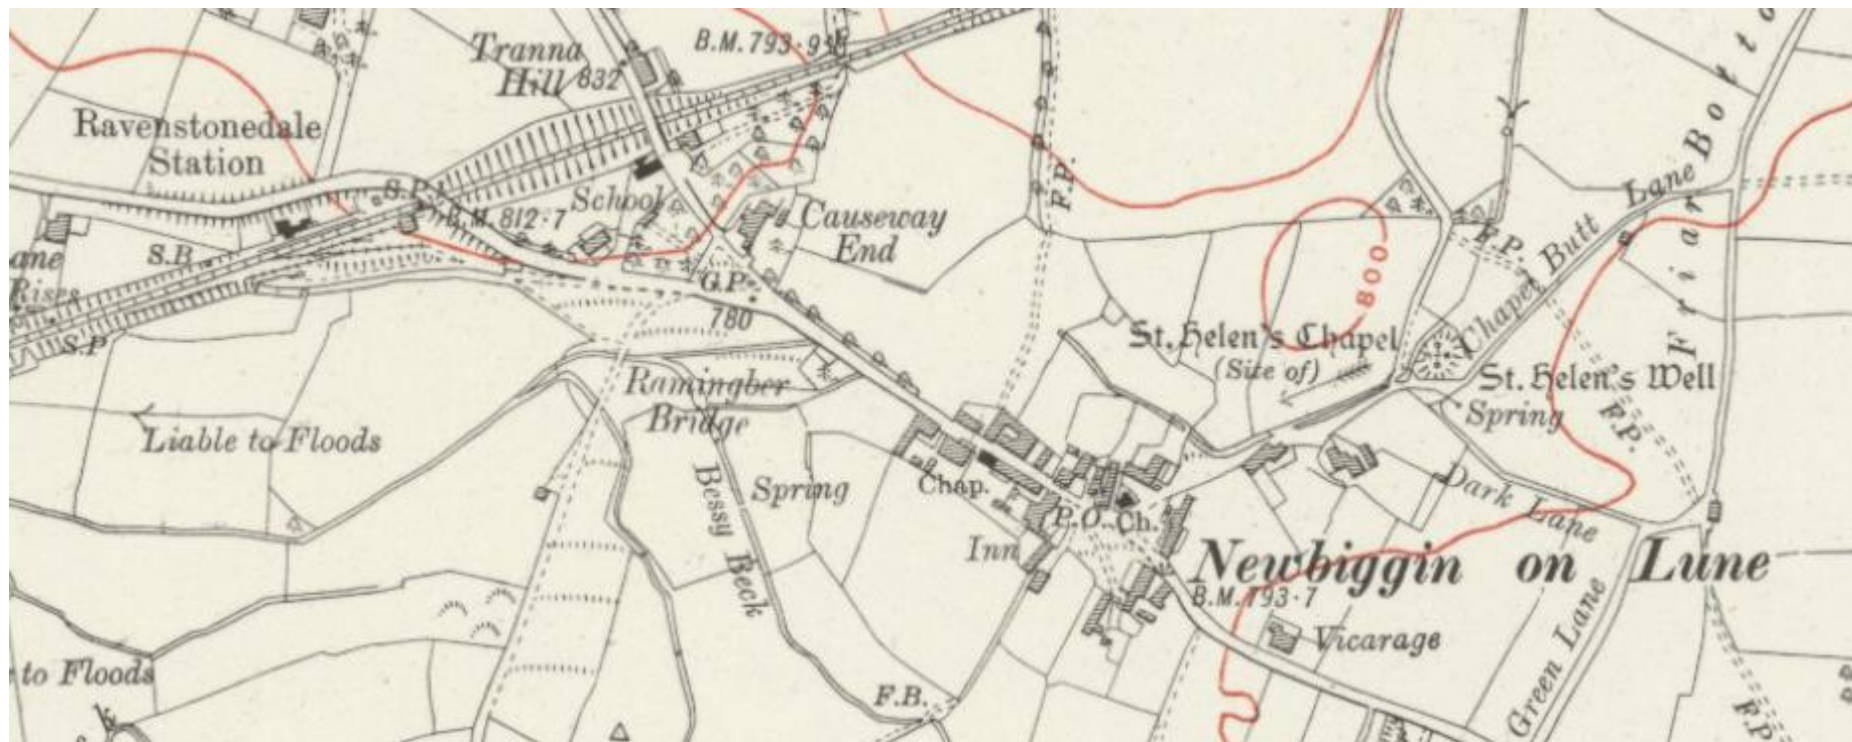
Figure 20: The third edition six-inch-OS map (map sheet Westmorland Sheet XXIX.NE. Revised: 1912 to 1913, Published: 1920. National Library of Scotland).

9.10 The third edition of the six-inch Ordnance Survey map (Figure 20) shows many of the same features as the second edition, with the addition of a vicarage to the east of the village. The smithy shown near the centre of the village on the third edition twenty-five-inch map is now shown on this one.

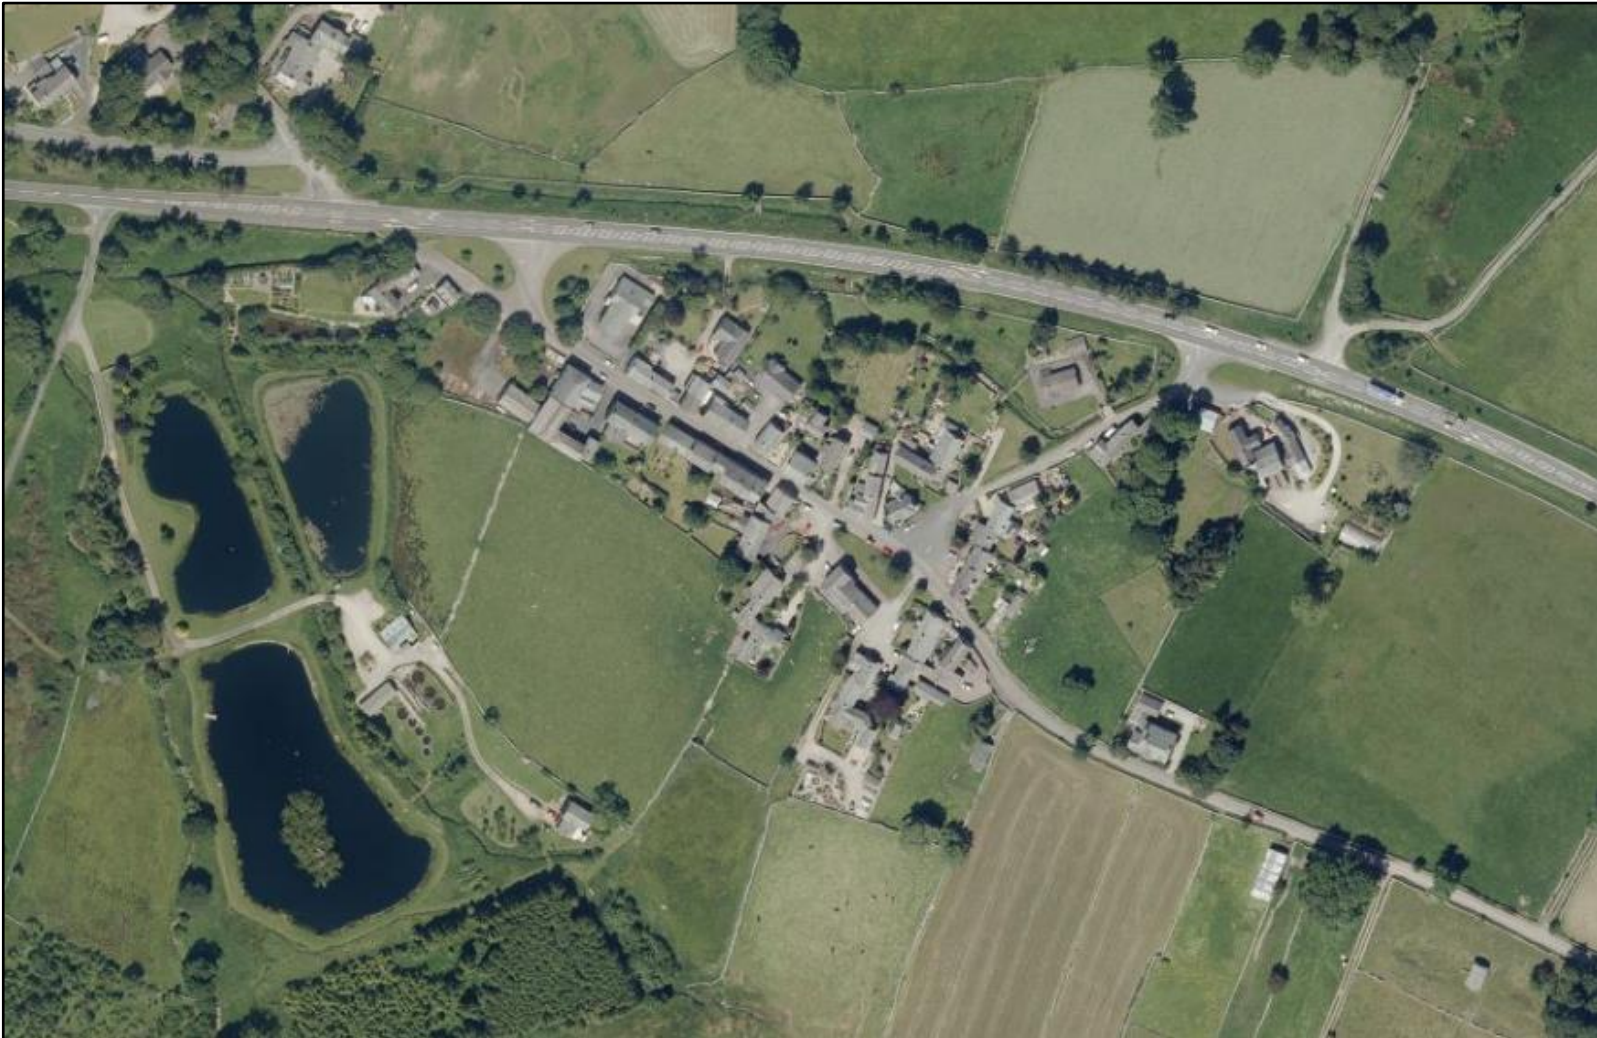
Figure 22: Bing Satellite image of Newiggin-On-Lune (National Library of Scotland 2022, © 2022 Microsoft Corporation. Earthstar Geographics SIO).

9.12 This Bing Satellite image of Newibbin-On-Lune (Figure 22) shows that it has retained much of the same form and character as it did in the early to mid-20<sup>th</sup> century. The visible change is the diversion of the A685 around the north of the village and the creation of fishing lakes along Bessy Beck to the south of the village in the late 20<sup>th</sup> or early 21<sup>st</sup> century.

onwards), and strip fields and ridge and furrow visible on satellite (Figure 22) and LiDAR imagery (Figure 23).

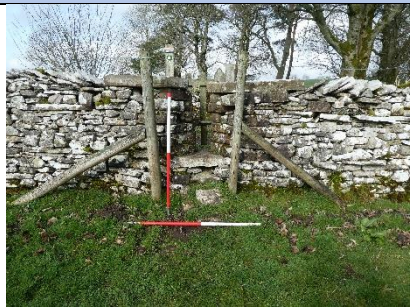
| Feature No | Feature Type | Description | Condition | Threats | Photograph |
|---|---|---|---|---|---|
| B01 | Squeeze Stile | Squeeze stile in limestone wall with sandstone quoins, the stile fans out to the east and has one step on the ground. Located on a public footpath giving access between field and trackway. Stile in fair condition, gaps/some stone misaligned. | Fair | Erosion | |

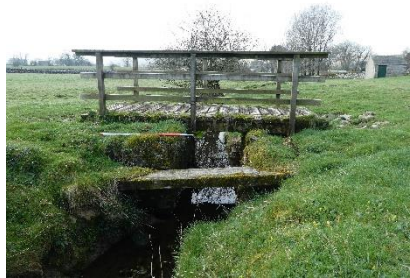
| Feature No | Feature Type | Description | Condition | Threats | Photograph |
|---|---|---|---|---|---|
| B02 | Bridge | Footbridge marked on historic 6" and 25" OS maps as part of a footpath. Mixed limestone and sandstone blocks forming a stone revetment relating to an earlier bridge can be seen in the water course, a newer wooden bridge partly covers the revetment. A wooden plank spanning the water course is located on one side of the revetment and bridge. Associated with St Helen's Well and Chapel area (MYD62347). | Poor | Erosion; Neglect | |

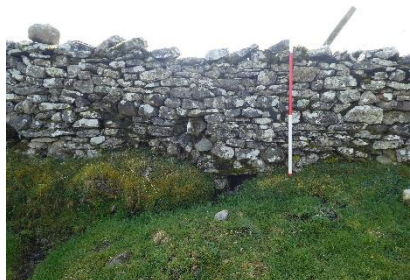
| Feature No | Feature Type | Description | Condition | Threats | Photograph |
|---|---|---|---|---|---|
| B03 | Water Smoot | Smoot in base of limestone dry stone wall with water passing through it and goes down to St Helen's Well. Smoot not visible on road side. Associated with St Helen's Well and Chapel area (MYD62347). | Fair | Vegetation | |

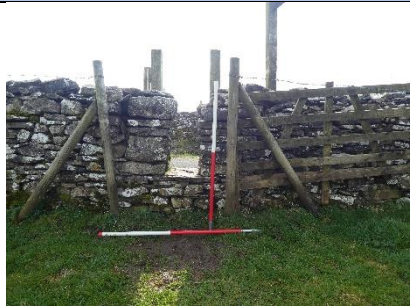
| Feature No | Feature Type | Description | Condition | Threats | Photograph |
|---|---|---|---|---|---|
| B04 | Squeeze Stile | Squeeze stile in limestone wall, stile base is raised and a lambing gate is on one side. Stile located on a public footpath. Associated with St Helen's Well and Chapel area (MYD62347). | Good | Erosion | |

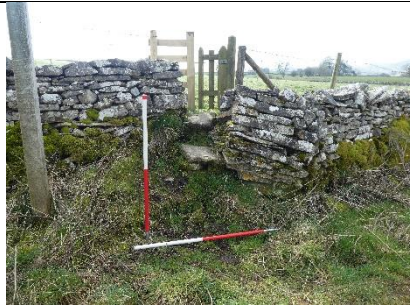
| Feature No | Feature Type | Description | Condition | Threats | Photograph |
|---|---|---|---|---|---|
| B05 | Step Stile | Step stile in a limestone wall with sandstone (?) steps and a wooden gate on one side. The steps are built into a bank/verge, connecting a sunken lane with a field (which is significantly higher). The wall to the right of the steps is out of alignment and uneven with the left side. The steps are starting to slip in the side of the bank and the wall to the right is starting to collapse. | Fair | Erosion; collapse | |

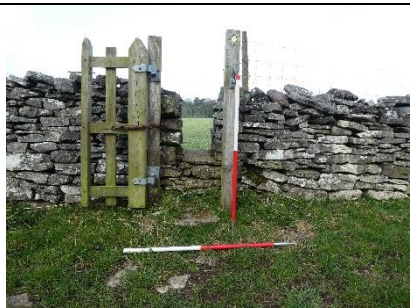
| Feature No | Feature Type | Description | Condition | Threats | Photograph |
|---|---|---|---|---|---|
| B06 | Squeeze Stile | Squeeze stile in limestone dry stone wall with modern wooden gate on one side. Steps on the ground on either side of the stile. | Good | Erosion | |

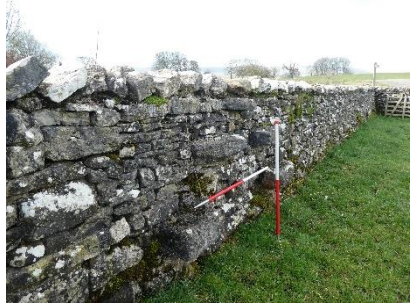
| Feature No | Feature Type | Description | Condition | Threats | Photograph |
|---|---|---|---|---|---|
| B07 | Step Stile | Limestone wall with five protruding through stones in a triangular formation creating steps. Steps are symmetrically coursed. Steps lead from sunken trackway into a raised field with a barn. Steps on public footpath, steps/wall possibly rebuilt following changes to the area when the road was built as seen in historic 6" and 25" OS maps (same style as B08). | Good | | |

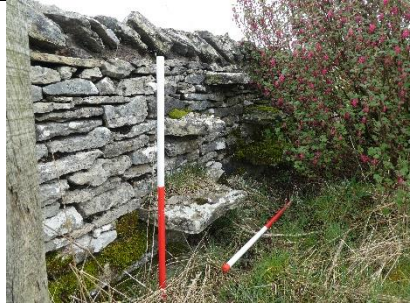
| Feature No | Feature Type | Description | Condition | Threats | Photograph |
|---|---|---|---|---|---|
| B08 | Step Stile | Limestone wall with five protruding through stones in a triangular formation creating steps. Steps are symmetrically coursed. Steps lead from field to roadside as part of public footpath. Steps/wall possibly rebuilt following changes to the area when the road was built as seen in historic 6" and 25" OS maps (same style as B07). | Fair | Vegetation; erosion; neglect | |

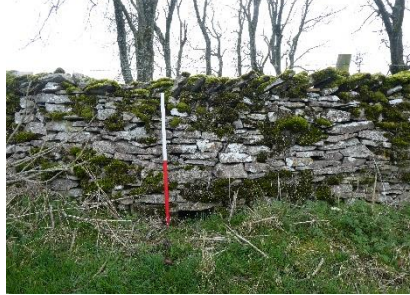
| Feature No | Feature Type | Description | Condition | Threats | Photograph |
|---|---|---|---|---|---|
| B09 | Water Smoot | Hole with lintel (smoot) in the base of a limestone wall, visible on north facing roadside, not visible on south side (field). | Fair | Vegetation | |

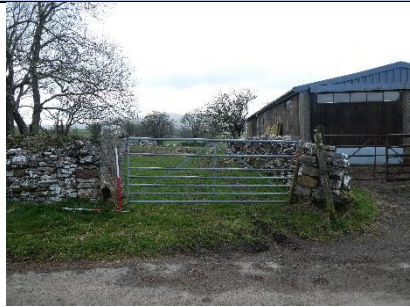
| Feature No | Feature Type | Description | Condition | Threats | Photograph |
|---|---|---|---|---|---|
| B10 | Gate Stoop (Single) | Single limestone gate stoop on the left side of gateway to field with two hinges on the inside face, modern metal gate attached to the hinges. | Good | | |

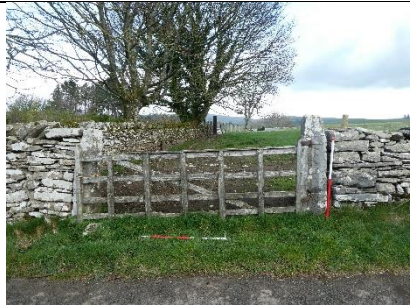
| Feature No | Feature Type | Description | Condition | Threats | Photograph |
|---|---|---|---|---|---|
| B11 | Gate Stoops (Pair) | Pair of limestone gate stoops located at entrance to field. Left stoop has gate catch on the front face, the right stoop has two hinges on the front face with wooden gate attached. | Good | Erosion | |

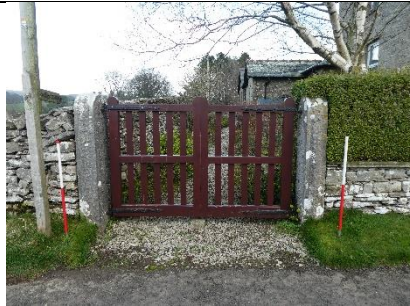
| Feature No | Feature Type | Description | Condition | Threats | Photograph |
|---|---|---|---|---|---|
| B12 | Gate Stoops (Pair) | Pair of dressed (rusticated) limestone gate stoops, with rounded tops. Left stoop has two hinges on the inside face, right stoop has two hinges on the inside face. Located at driveway to private house. Quoins and lintel on house also rusticated – house is the former vicarage shown on the 1937-61 OS dmap. | Good | | |
