# Small-Scale Heritage Features Survey

Technical Report: Newbiggin-On-Lune  
November 2023

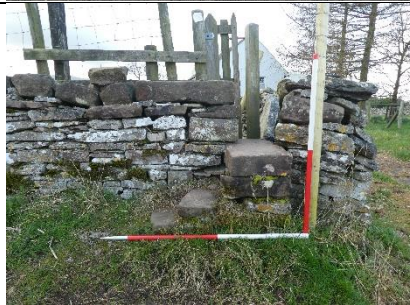
| Feature No | Feature Type | Description | Condition | Threats | Photograph |
|---|---|---|---|---|---|
| B13 | Step Stile | Step stile in limestone wall with sandstone steps and some coping stones. Singular step present on south (field) side. Three steps on the north (road) side, - road is on sunken level. | Fair | Collapse; neglect | |

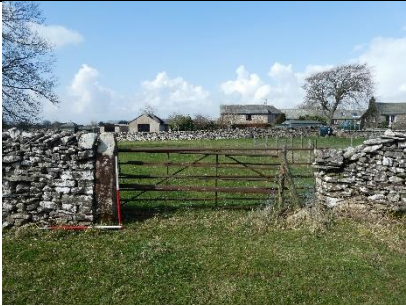
| Feature No | Feature Type | Description | Condition | Threats | Photograph |
|---|---|---|---|---|---|
| B14 | Gate Stoop (Single) | Single sandstone gate stoop with a pointed top on the left side of gateway leading to a field, against a limestone wall. | Good | | |

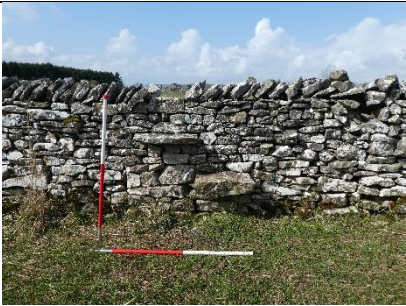
| Feature No | Feature Type | Description | Condition | Threats | Photograph |
|---|---|---|---|---|---|
| B15 | Step Stile | Step stile in limestone wall, two steps are built into the wall with a flat stone on the top of the wall at the crossing point. | Good | | |

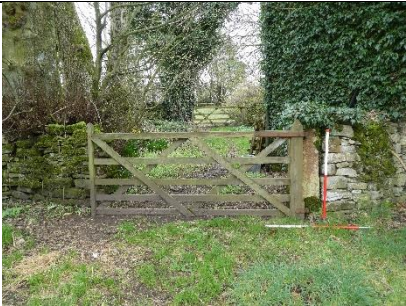
| Feature No | Feature Type | Description | Condition | Threats | Photograph |
|---|---|---|---|---|---|
| B16 | Gate Stoop (Single) | Single sandstone gate stoop, on the left side of gateway adjacent to barn (MYD67766), gateway leading to fields/public footpath. Ivy growing around the top of the stoop, the stoop has two hinges on the front face with gate attached. | Fair | Vegetation | |

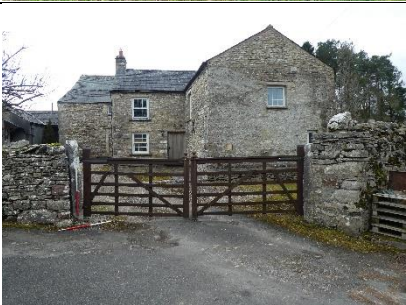
| Feature No | Feature Type | Description | Condition | Threats | Photograph |
|---|---|---|---|---|---|
| B17 | Gate Stoops (Pair) | Pair of limestone gate stoops, both set at angles, with rounded tops leading to former farmstead (MYD67765). Left has two hinges on the inside face with gate attached, the right stoop has two hinges on the inside face with gate attached. Limestone has crinoids in them. Evidence of prior use/attachments. | Good | | |

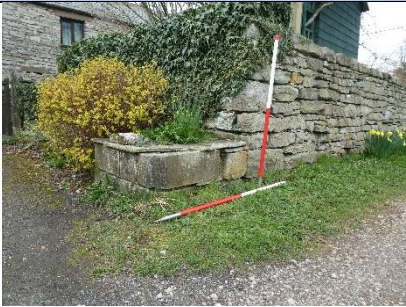
| Feature No | Feature Type | Description | Condition | Threats | Photograph |
|---|---|---|---|---|---|
| B18 | Unknown | Unknown features made from sandstone blocks with dressed corners with damage on one side; possibly a churn stand (?) and associated with former farmstead MYD67767. | Fair | | |

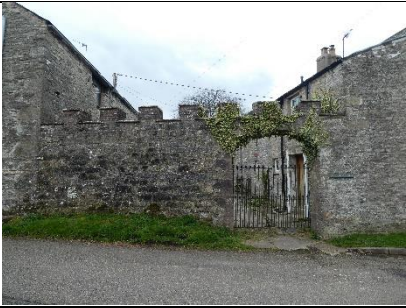
| Feature No | Feature Type | Description | Condition | Threats | Photograph |
|---|---|---|---|---|---|
| B19 | Crenellation | Crenellation on porch of house and the wall along the roadside enclosing the associated courtyard of house and farm building. | Good | Vegetation | |

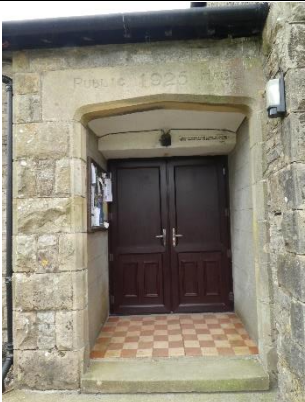
| Feature No | Feature Type | Description | Condition | Threats | Photograph |
|---|---|---|---|---|---|
| B20 | Date stone | Date stone inscribed with "PUBLIC 1925 HALL" on yellow sandstone over the porch opening of Newbiggin-On-Lune's Public Hall. The building is still used as a Public Hall by the local community. | Good | | |

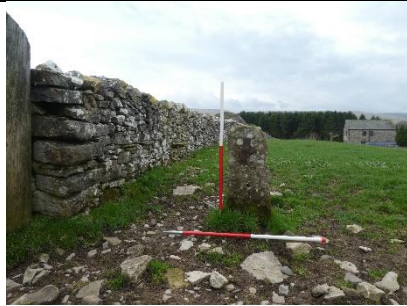
| Feature No | Feature Type | Description | Condition | Threats | Photograph |
|---|---|---|---|---|---|
| B21 | Gate Stoop (Single) | Single sandstone gate stoop with metal “eye” and attachments on one face, held in place by a tie visible on the opposite side. Stone stands on its own, probably marking an old boundary/trackway and public footpath (as seen on the historic 6” and 25” OS maps). | Good | Neglect; removal | |

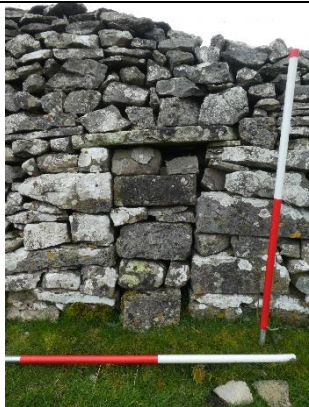
| Feature No | Feature Type | Description | Condition | Threats | Photograph |
|---|---|---|---|---|---|
| B22 | Sheep Smoot | Blocked opening in the lower half of a limestone dry stone wall. A limestone lintel is still visible, the opening was tapered with the top wider than the base and is blocked with limestone blocks. | Good | | |

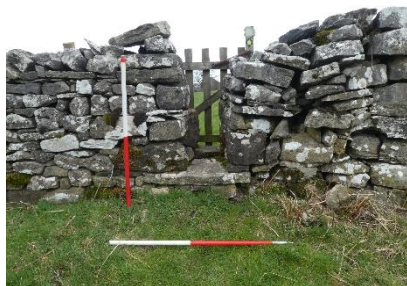
| Feature No | Feature Type | Description | Condition | Threats | Photograph |
|---|---|---|---|---|---|
| B23 | Squeeze Stile | Tapered squeeze stile with higher though stepping stone built into limestone dry stone wall with step on the ground on one side, mixed limestone and sandstone quoins. Stile on public footpath. | Fair | Erosion; collapse | |

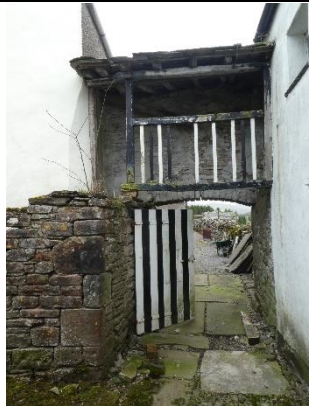
| Feature No | Feature Type | Description | Condition | Threats | Photograph |
|---|---|---|---|---|---|
| B24 | Gallery | Wooden and stone structure forming a 'gallery' above a public right of way. The wooden rail has possibly been reused, possibly a skelbuse from a byre. There are stone steps leading to the gallery on the left, however, no floor of the gallery survives. There is a cobbled surface on the ground to the front of the buildings which then becomes paving. This feature is in the style of former spinning/knitting galleries however there is no evidence for this, and instead likely represents a way of accessing the upper stories of the buildings (former farmsteads – house and farm building). The feature is in a poor state of repair and at threat of collapse. | Poor | Neglect;<br>Deterioration;<br>collapse | |

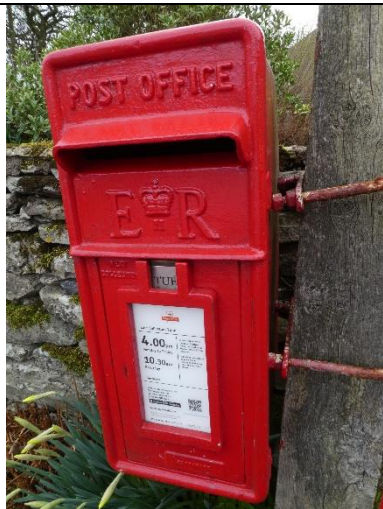
| Feature No | Feature Type | Description | Condition | Threats | Photograph |
|---|---|---|---|---|---|
| B25 | Letter Box | Cast iron (?) ER II letter box painted red, attached to wooden post by metal rings also painted red (light post style). "POST OFFICE" is embossed above the opening, with the insignia "E II R" below the opening. "NEXT COLLECTION" is embossed to the left side of the date token below the opening and makers information at the bottom right side of the box (but not readable). | Good | Removal;<br>replacement | |

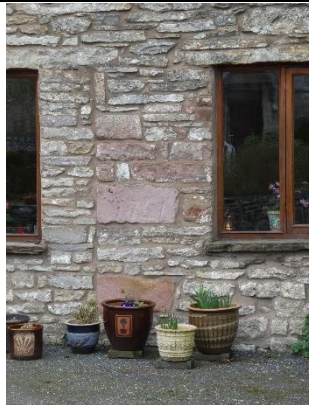
| Feature No | Feature Type | Description | Condition | Threats | Photograph |
|---|---|---|---|---|---|
| B26 | Date Stone | Red sandstone quoin inscribed with date 1741, located on the edge of Oddfellows Cottage. The Oddfellows' Arms Inn is marked on the OS twenty-five inch map, while 'Inn' is simply stated on the six-inch map. The quoin was possibly situated on the right side of a former door way which has since been partially blocked and converted into a window. Date is now very faint. | Fair | Erosion | |

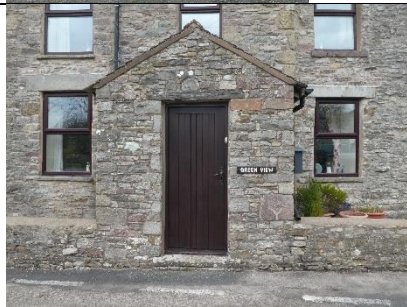
| Feature No | Feature Type | Description | Condition | Threats | Photograph |
|---|---|---|---|---|---|
| B27 | Unknown feature (on quoin) | Sandstone quoin on the porch of Green View with a "Y" on it. The quoin appears to have been reused, as the geology and size is different to the other quoins used on the porch. The "Y" is now infilled with mortar, making it difficult to assess the depth of the marking. It was likely caused by a former use, possibly from a former fixing. | Good | Erosion; vehicles | |

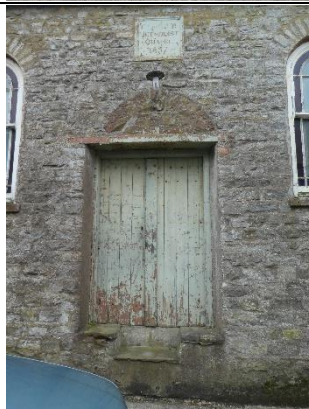
| Feature No | Feature Type | Description | Condition | Threats | Photograph |
|---|---|---|---|---|---|
| B28 | Date Stone | "Chapel" marked on the 6" OS map and "Methodist Chapel (primitive)" marked on the 25" OS map. Sandstone date stone painted pale green with "[PRIMITIVE] METHODIST CHAPEL 1837" on (the paint is now peeling/flaking making it difficult to read). Stone located over the main doorway into the building above a light. Below the light is a stone (relief) arch with a stone seat/step at base of the doorway. The arch suggests that the opening has changed size/shape in the past. | Poor | Erosion; neglect | |

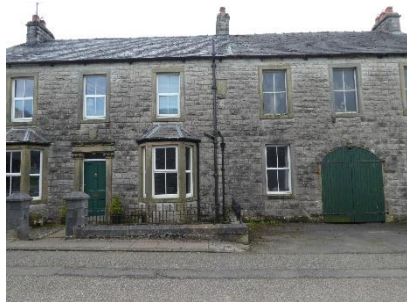
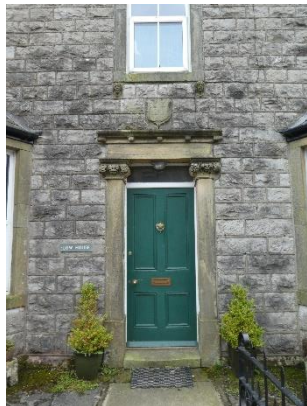
| Feature No | Feature Type | Description | Condition | Threats | Photograph |
|---|---|---|---|---|---|
| B29 | Carvings | <p>A series of stylised stone relief carvings on Low House and adjoining barn/mill/coach house.</p> <p>Doorway – two stone head carvings, a man on the left and woman on the right. A carved shield is below them. Carved grapes on the top of the pillar around the door.</p> <p>Relief carving (mythical animal?) and blank plaque next to drain pipe.</p> <p>Two stone head carvings (left man, right woman) below window base, above cart entrance.</p> <p>Carved rams head bust on keystone of cart entrance archway.</p> | Fair | Erosion to figures | |

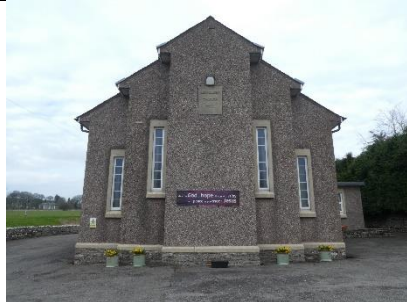
| Feature No | Feature Type | Description | Condition | Threats | Photograph |
|---|---|---|---|---|---|
| B30 | Date Stone | <p>Concrete(?) date stone with raised text showing "METHODIST CHURCH 1939". Stone located on gable end of the building below an outside light, facing the road, the rest of the building is covered in peddle dash/render.</p> | Good | | |

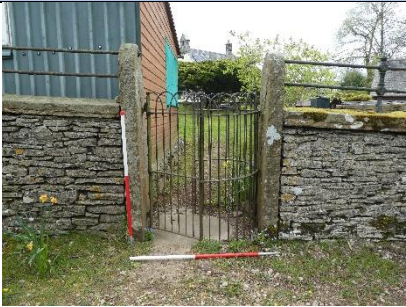
| Feature No | Feature Type | Description | Condition | Threats | Photograph |
|---|---|---|---|---|---|
| B31a | Kissing Gate | Cast iron kissing gate in a half round style with an interlaced bow/hoop top, located on a public footpath possibly associated with the former school (B32). Gates flanked by a pair of sandstone gate stoops (B31b). | Good | Erosion | |

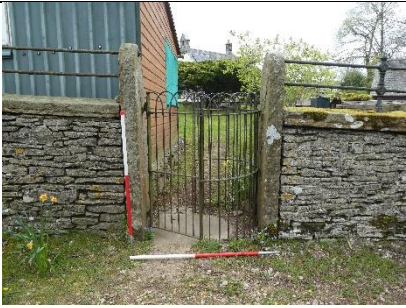
| Feature No | Feature Type | Description | Condition | Threats | Photograph |
|---|---|---|---|---|---|
| B31b | Gate Stoops (Pair) | Pair of gate stoops which taper with rounded top. The left stoop has railings attached to the outside face, two metal hinges are attached to the inside face with the metal gate attached. The right stoop has railings attached to the outside face with the kissing gate railings (B31a) leaded to the inside face hinges. The stoops are associated with PROW to old school (as given on the historic 6" and 25" OS maps, B32). | Good | Erosion | |

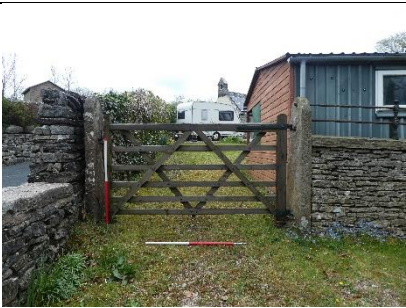
| Feature No | Feature Type | Description | Condition | Threats | Photograph |
|---|---|---|---|---|---|
| B31c | Gate Stoops (Pair) | Pair of sandstone gate stoops on either side of entrance to private residence. Stoops tapered with curved tops. The left stoop has a gate catch on the inside face; the right stoop potentially has some tool markings and two hinges on the inside face. Metal railings also attached on the outside face of the right stoop. | Good | Erosion | |

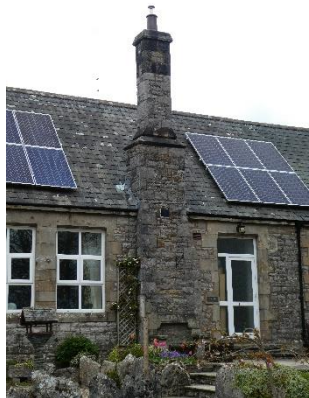
| Feature No | Feature Type | Description | Condition | Threats | Photograph |
|---|---|---|---|---|---|
| B32 | School | Historic 6" and 25" OS maps show this is the location of the former school within Newbiggin-On-Lune, now a private residence called Lindale. The original fireplace mantle (dated 18...?) is now located on the outside of the building, by front door of residence. Building now a domestic residence. | Good | | |

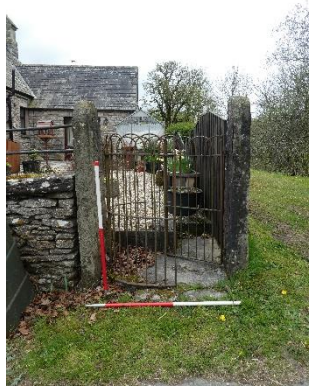
| Feature No | Feature Type | Description | Condition | Threats | Photograph |
|---|---|---|---|---|---|
| B33a | Kissing gate | Cast iron kissing gates in a half round style with an interlaced bow/hoop top, the gate is starting to rust. The gate is flanked by a pair of sandstone gate stoops (B33b). The gate is located at the site of the former village school (feature B32; as given on the historic 6" and 25" OS maps). | Good | Erosion | |

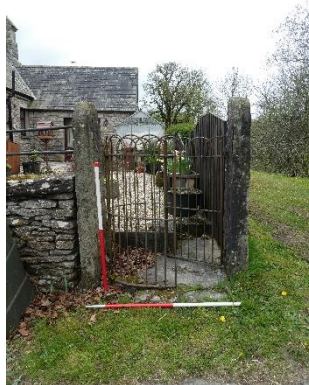
| Feature No | Feature Type | Description | Condition | Threats | Photograph |
|---|---|---|---|---|---|
| B33b | Gate Stoops (Pair) | Pair of gate stoops which taper with rounded top. The left stoop has railings attached to the outside face and two disused holes suggesting older railing were attached, two old unused metal fixing are on the inside face. The right stoop has hinges on the inside face with the gate (of the kissing gate B33a) attached to them, one unused hole visible on the outside face. Some delamination visible on both stoops. The stoops are associated | Good | Erosion | |

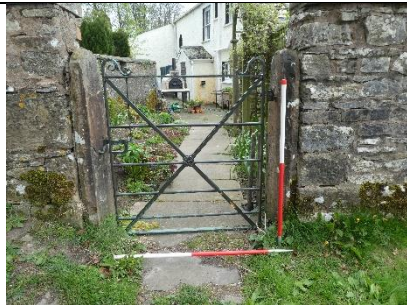
| Feature No | Feature Type | Description | Condition | Threats | Photograph |
|---|---|---|---|---|---|
| B34 | Gate Stoops (Pair) | Pair of sandstone gate stoops, stoops taper with rounded top, evidence of rustication on the sides. Left gate has gate catch on the inside face, the right stoop has two hinges with metal gate attached leading to private garden. Left stoop starting to delaminate. | Good | Erosion | |

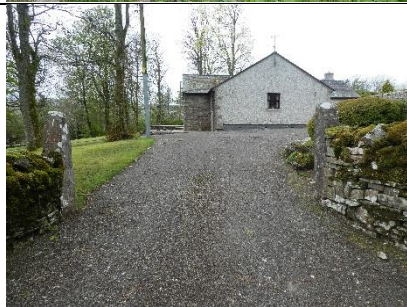
| Feature No | Feature Type | Description | Condition | Threats | Photograph |
|---|---|---|---|---|---|
| B35 | Gate Stoops (Pair) | Pair of roughly hewn sandstone gate stoops at entrance to driveway. Left stoop is pointed at top with two hinges on the rear face, the right stoop has a gate catch on the rear face. | Good | Erosion | |

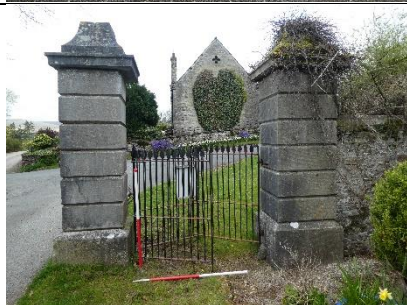
| Feature No | Feature Type | Description | Condition | Threats | Photograph |
|---|---|---|---|---|---|
| B36 | Kissing Gate | Cast iron kissing gate in trapezoid-like shape, spokes going around the gate with leaf shape decorative finials on the top, gate painted black. The gate is located between a wall pier and a gate pier and is associated with the old road/track leading to Brownber (see historic 25" OS map). | Good | Erosion; removal | |

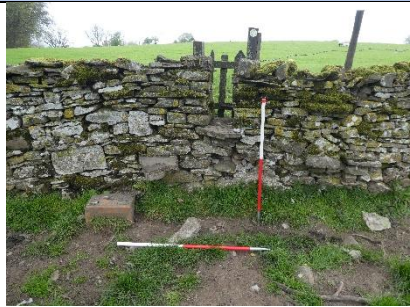
| Feature No | Feature Type | Description | Condition | Threats | Photograph |
|---|---|---|---|---|---|
| B37 | Step Stile | Step stile in limestone dry stone boundary wall between fields. The north side of the stile is level with field, the south side has two steps – one on the ground (modern addition) and one though in the wall – leading to crossing point though the wall. The coping stones are starting to come loose and some of the wall is starting to deteriorate and collapse at the base on the south side. | Fair | Collapse | |

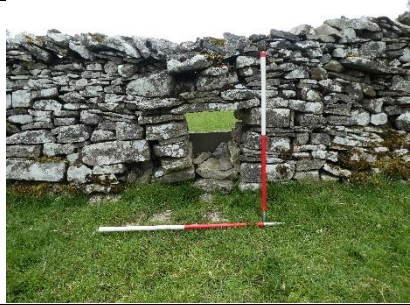
| Feature No | Feature Type | Description | Condition | Threats | Photograph |
|---|---|---|---|---|---|
| B38 | Sheep Smoot | Sheep smoot in base of limestone dry stone wall with lintel at the top. The smoot is now blocked with stones at the base and a concrete(?) slab on one side. Wall looks like it's starting to collapse on one side with stones missing. | Fair | Collapse | |

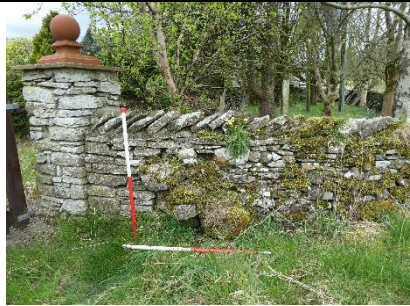
| Feature No | Feature Type | Description | Condition | Threats | Photograph |
|---|---|---|---|---|---|
| B39 | Step Stile | Step stile in limestone dry stone wall with corresponding steps on other side. Though step stones placed close together. Stile associated with public footpath from before the road was built (see the historic 6" and 25" OS maps), but does not appear to be accessible anymore. | Fair | Erosion; removal; neglect | |

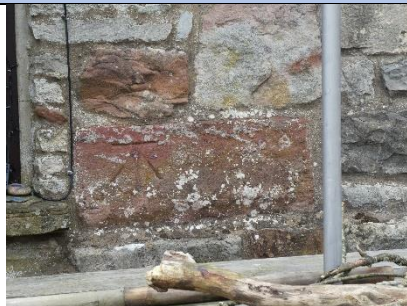
| Feature No | Feature Type | Description | Condition | Threats | Photograph |
|---|---|---|---|---|---|
| B40 | OS Bench Mark | OS bench mark shown on historic 6" and 25" OS maps. Bench Mark engraved on sandstone quoin to the right of west facing wall (to the right of the porch) on Church View Cottage.<br>On quoin of former doorway, now partially blocked and a window. | Good | Erosion | |
