# Small-Scale Heritage Features Survey

Technical Report: Orton  
November 2023

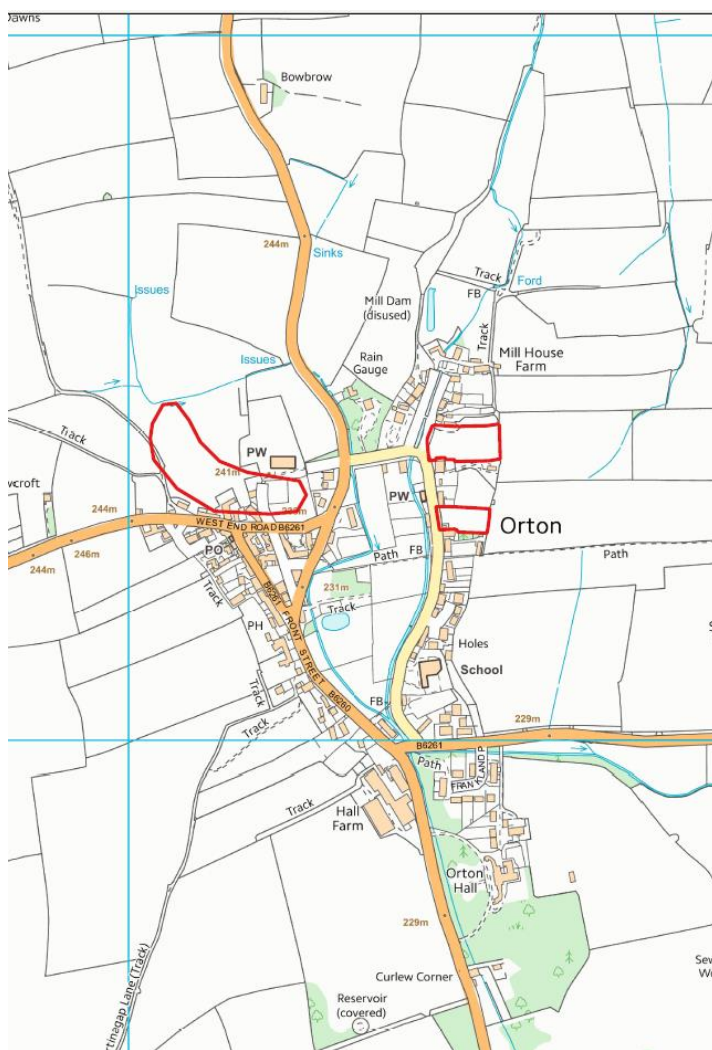
Figure 1 The red polygons define the 'medieval core' of Orton. © Crown copyright and database rights 2022 Ordnance Survey 100023740 Additional information: © Yorkshire Dales National Park Authority.

2.8 However, in the case of Orton, the polygons defining the medieval core for Orton were much smaller (see Figure 1). As a result, the survey area for Orton was extended to include the main settlement area of the village, as this reflected the extent for the other villages in this project. The former back lanes were used to provide the survey's extent.

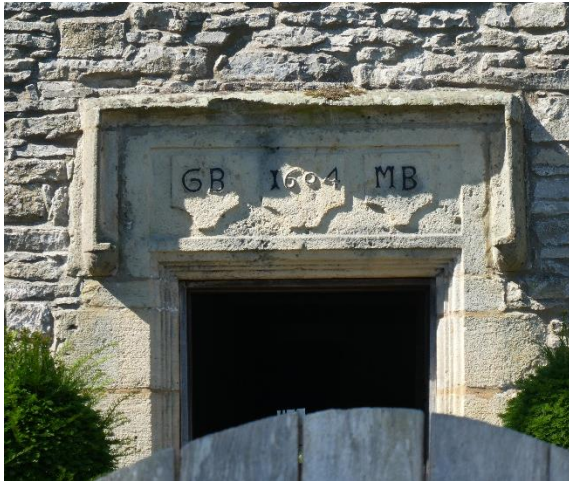
Figure 3 Date stone of 1604 (G088) on Petty Hall.

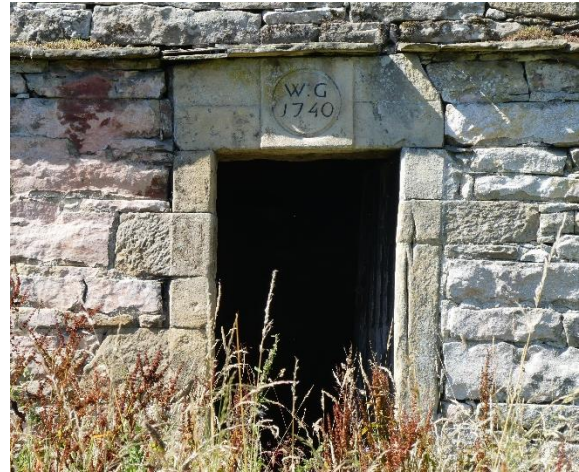
Figure 4 Date stone of 1740 (G089a) on the attached barn.

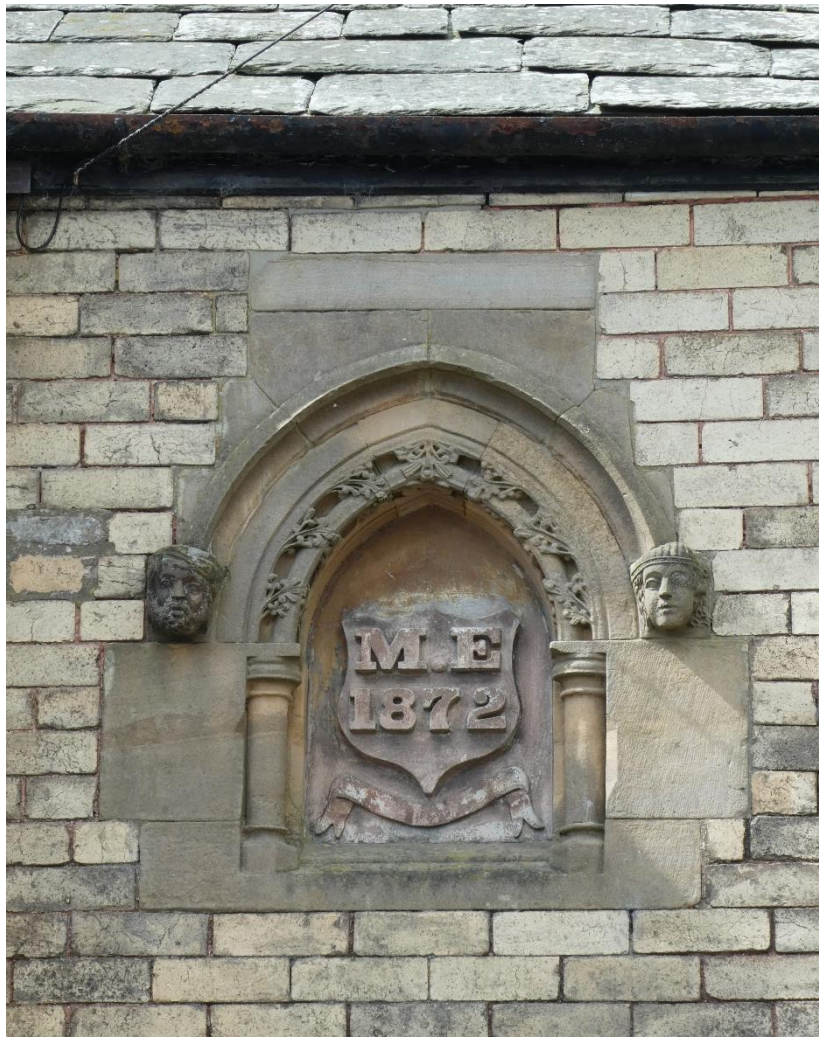
4.7 One of the more unusual buildings in Orton is Swan Villa, with a date stone of 1872 and the initials 'M.E' (G009a). By 1872, William Wilson (having worked on several commissions in the local area; see 3.26) turned his attention to the improvement of his own residence, Swan Villa. Above the front door is a niche with a shield, the date stone. The initials are of Mary Ellwood, his wife's maiden name. On either side of the shield are Tuscan columns, with the arch decorated with a botanic motif. The "hoodmould" has carved faces for its stops. There are other pieces of decorative carving on the house, all in his 'ecclesiastical' (or gothic revival) style. This is especially evident around the front door – the "jambs" are highly chamfered with a scroll stop with bar, it has been suggested that these are pilasters bearing capitals decorated with fleurons and dog-tooth carving; above the door there are three carved quatrefoils, two with fleurons and one with a shield, and above this is a hoodmould, the left side of which has a carved human head as a stop (Smith). The detail on either side of the entrance has been truncated by later alterations.

*Figure 5 Date stone on Swan Villa, erected by William Wilson with the initials of his wife.*

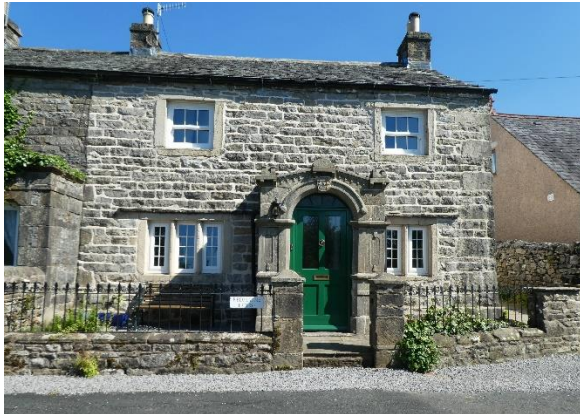
4.9 There are two date stones that have the initials 'J.S.S' – G075 has the date 1872 and G002 has the date 1874. The 1874 date stone is rectangular with the carving of a shield-like shape, which is located at sill level of the first floor windows. The 1872 date is on a false keystone as part of an arch over the door; this is located on a later porch that has been added onto the house. The house itself is vernacular and dates to the late 17<sup>th</sup> or 18<sup>th</sup> century. The porch appears to be 19<sup>th</sup> century in date, in a gothic revival style. According to the current resident, the porch was moved from a house that had burnt down near Ravenstonedale. However, this

*Figure 6 A late 17th/18th century house with dated 19th century porch. See date stone (G075) in more detail below.*

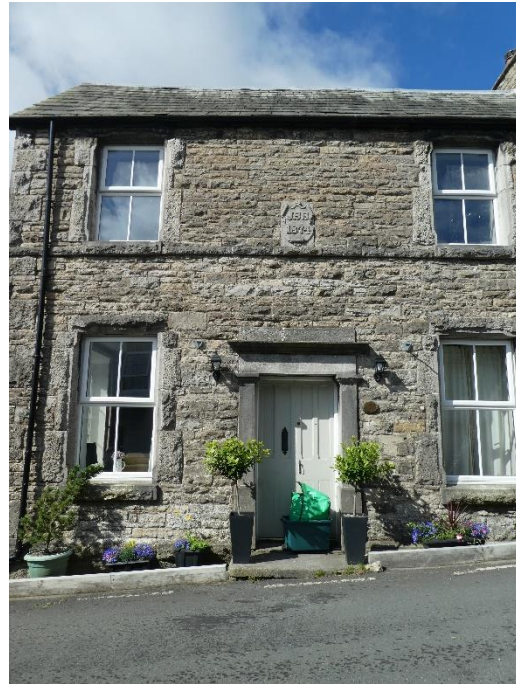
*Figure 7 House built in the second half of the 19th century. See date stone (G002) in more detail below.*

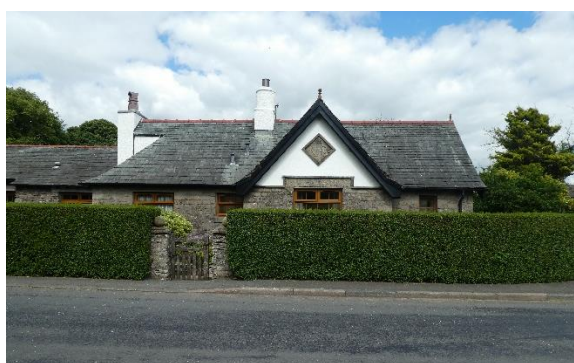
4.10 One of the houses is dated to 1908 with the initials 'HG' for Harvey Goodwin (G021). Harvey Goodwin was the owner of Orton Hall, greatly enlarging and

*Figure 8 House (within survey area) with date stone of 1908 and the initials 'HG'.*

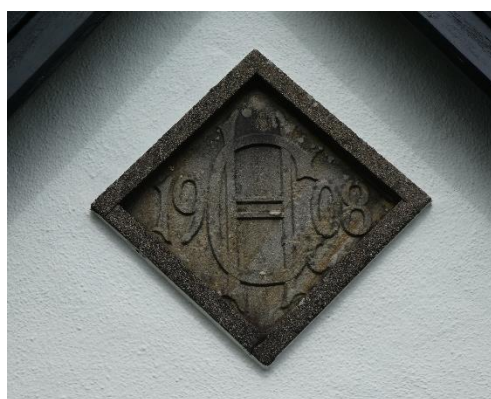
*Figure 9 Date stone (G021) in a diamond shape with a frame that projects from the wall.*

| Feature No. | Feature Type | Description | Condition | Threats | Photographs |
|---|---|---|---|---|---|
| G021 | Date Stone | Diamond sandstone(?) with "19" "HG" "08" in a relief carving (HG = Harvey Goodwin). Date stone located on the SW elevation of private residence. | Good | Erosion | |

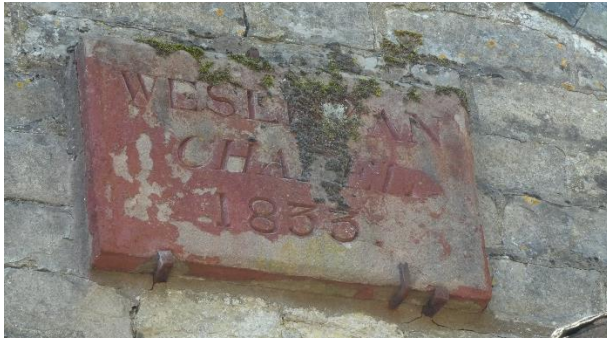
Figure 10 Date stone on the Wesleyan Chapel (G071a) - the inscription is becoming obscured by lichen and weathering.

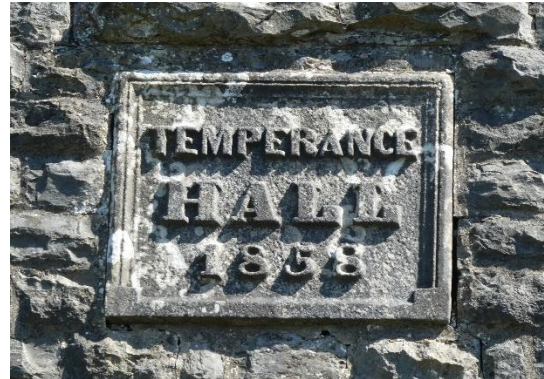
4.11 Three of the date stones relate to public buildings - one to a non-conformist chapel (G071a), another to a Temperance Hall (G069a), and finally one to a club building (G087). They all date to the 19<sup>th</sup> century, a period when non-conformist religions and social clubs flourished. The 'Wesleyan Chapel' was built in 1833. The date is inscribed on sandstone, and is located on the front gable above the porch. The 'Temperance Hall' was built in 1858. The date is probably on limestone with a framed border edge, and is also located on the front gable above the door.

Figure 11 Date stone on the Temperance Hall (G069a). It is not included on the second edition 25" map that was surveyed in 1858-59.

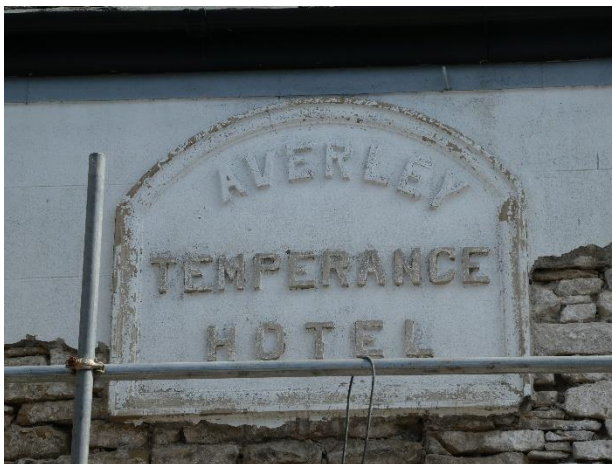
Figure 12 The sign on the former Waverley Temperance Hotel (G004) - the 'W' is missing.

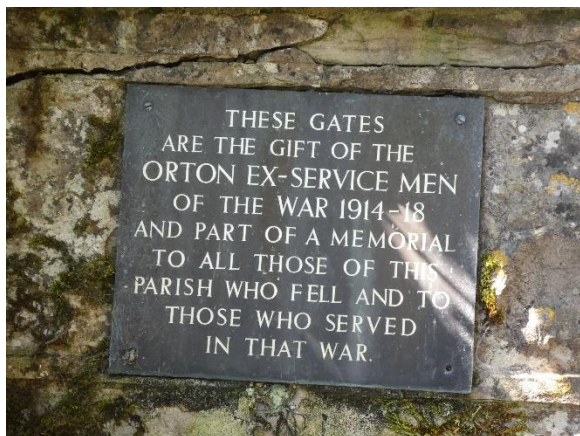
4.14 The gate piers (G062) on the entrances into the churchyard have plaques to those 'who fell and to those who served' in the First World War. The gates were 'the gift of the Orton ex-service men of the war 1914-18' and comprise 'part of a memorial'. There is a free-standing war memorial located in the south transept of All Saints Church that is 'to the men of this parish who died during the Great War', and comprises of 18 names (Imperial War Museum 2023).

Figure 14 Plaque (G062) to those who fell and served in the First World War.

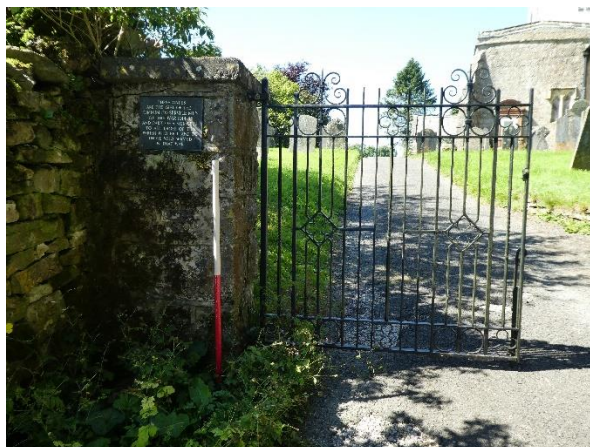
Figure 15 The plaques are attached to gate piers at the entrance to the churchyard.

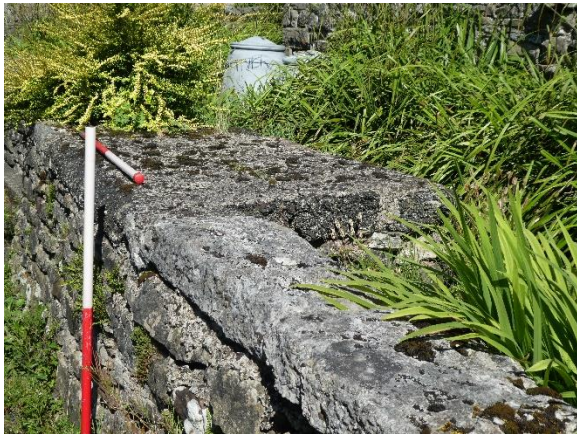
*Figure 16 Churn stand (G077) built into the boundary wall of a farmstead.*

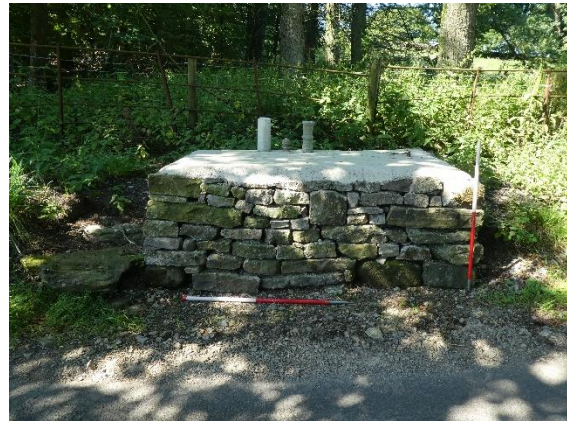
*Figure 17 Churn stand (G061) is freestanding, located on the B6260 towards Orton Scar.*

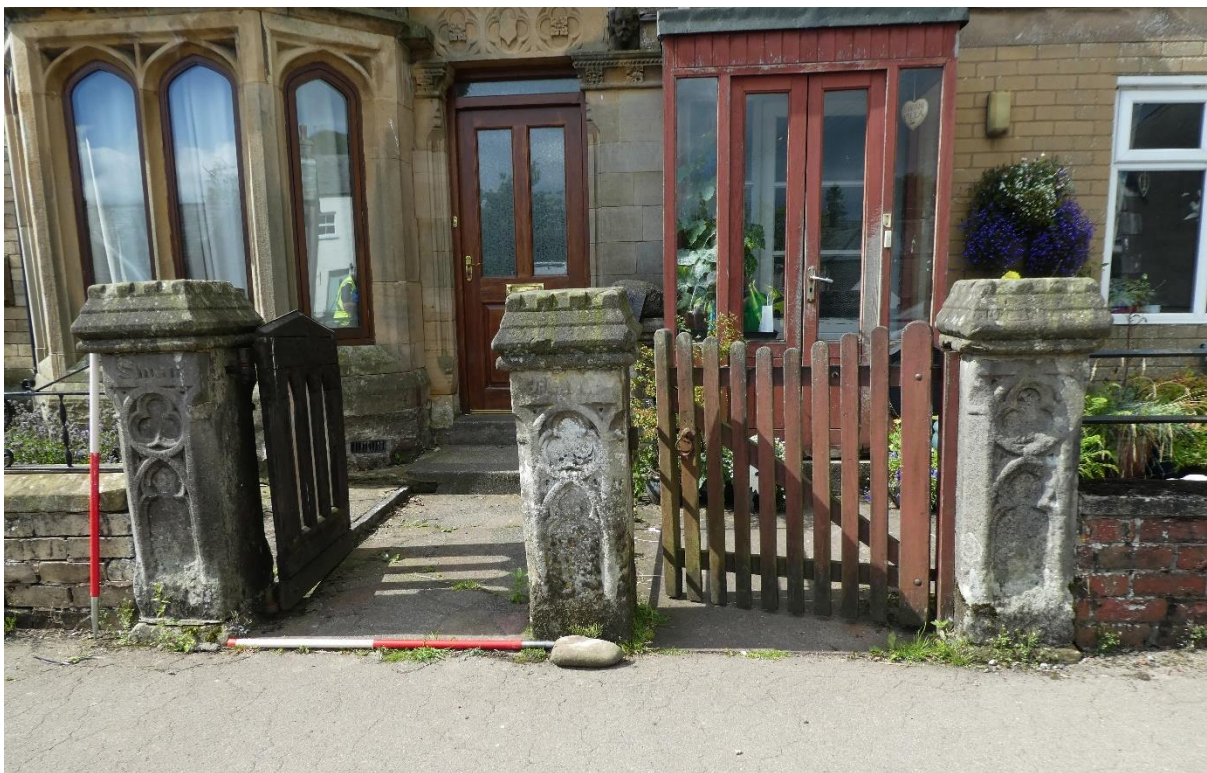
*Figure 18 Gate piers (G009b) outside Swan Villa - the left and central pier lead to the original doorway, the one on the right appears to be a repurposed and relocated wall pier.*

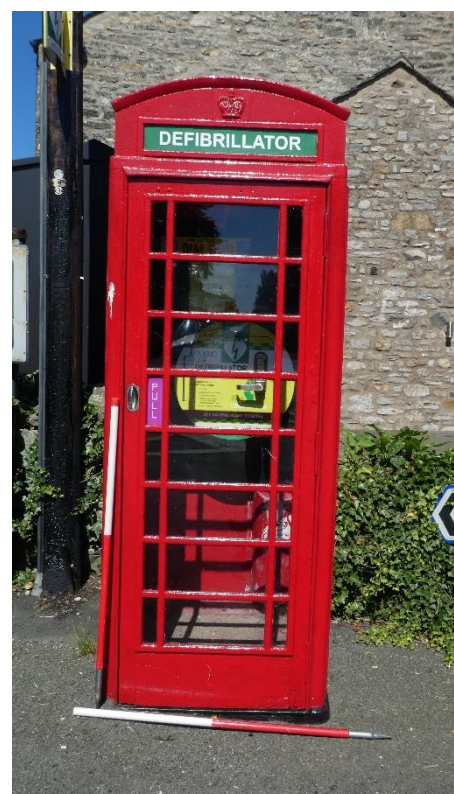
*Figure 19 Telephone kiosk (K091) situated on the corner at the junction of Front Street and the B6260.*

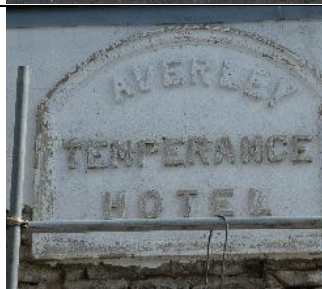
| Feature No. | Feature Type | Description | Condition | Threats | Photographs |
|---|---|---|---|---|---|
| G004 | Former Hotel | Former Temperance Hotel, the name of the hotel is made from plaster/lime mortar(?) and painted white, "[W]AVERLEY TEMPERANCE HOTEL" (the "W" is missing) and is positioned in a curved top rectangle with raised edges. House undergoing renovation work at the time of survey. "Inn" marked on some of the historic maps. | Fair | Removal; erosion | |

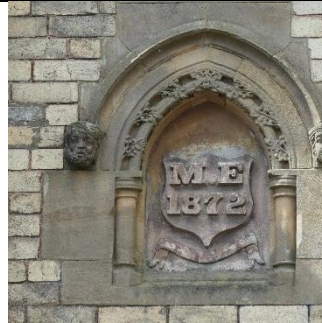
| Feature No. | Feature Type | Description | Condition | Threats | Photographs |
|---|---|---|---|---|---|
| G009a | Date Stone | Carved sandstone date stone in a shield shape with "M.E" "1872" over two lines in the centre. The shield is situated in a highly decorated arch with two Tuscan columns on either side of the recess. Two relief carved heads are located on either side of the arch. Date stone located above the former main entrance (house was originally Swan Villa, but has now been split into two dwellings). Carved by former resident William Wilson. | Good | Erosion | |

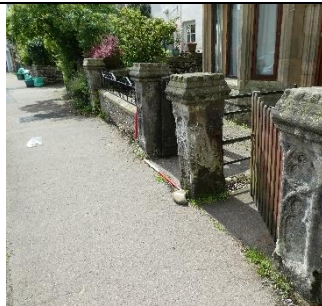
| Feature No. | Feature Type | Description | Condition | Threats | Photographs |
|---|---|---|---|---|---|
| G009b | Gate Piers | Four sandstone gate/wall piers, two located at the front of Swan Villa and two in front of Stone Leigh (formally all one building called Swan Villa). The piers are all highly decorated in an ecclesiastical style, with chamfered sides and decorative pier caps. The central left pier is engraved with "SWAN" on the top front face, with two hinges on the inside face (gate attached). The right central pier has traces of a former engraving which is now unclear on the front face, with a gate catch on both side faces for separate gates belonging to each property. Probably carved by former resident William Wilson. | Fair | Erosion; neglect' removal | |

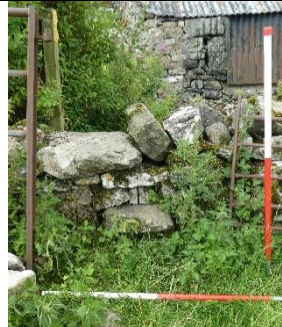
| Feature No. | Feature Type | Description | Condition | Threats | Photographs |
|---|---|---|---|---|---|
| G011 | Step Stile | Step style in predominantly limestone dry stone wall on the PROW (possibly marking the old back lane). There is one step on either side, with the one on the south west side slightly broken. | Fair | Collapse; removal | |

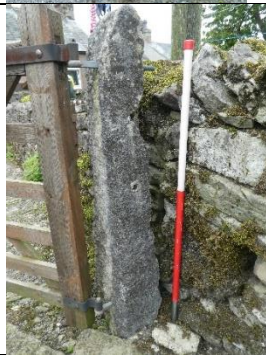
| Feature No. | Feature Type | Description | Condition | Threats | Photographs |
|---|---|---|---|---|---|
| G014 | Gate Stoop (Single) | Single limestone gate stoop located on the right side of gateway leading to an alleyway. The stoop has two broken leaded hinges on the front face, with one leaded hinge on the inside face at the base with gate attached, and newer hinge going through the stoop at the top of the inside face with gate attached. | Good | Removal; erosion; vehicles | |

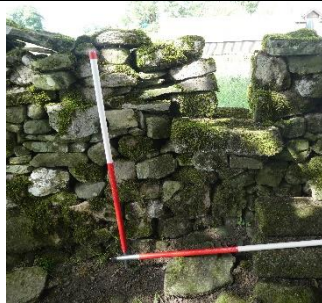
| Feature No. | Feature Type | Description | Condition | Threats | Photographs |
|---|---|---|---|---|---|
| G019 | Step Stile | Step stile in mixed dry stone wall, on the former back lane (now PROW). Stile has two concrete steps on the ground on the SE side, with one step on the other side. | Fair | Collapse/removal | |

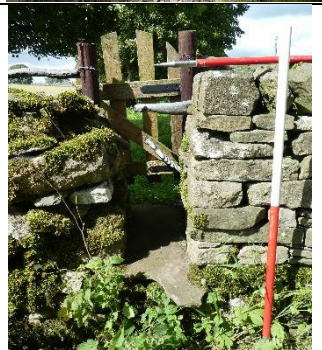
| Feature No. | Feature Type | Description | Condition | Threats | Photographs |
|---|---|---|---|---|---|
| G020 | Squeeze Stile | Squeeze stile in dry stone wall with lambing gate, on the former back lane (now PROW). Base though stone slightly broken on one side. | Fair | Removal | |

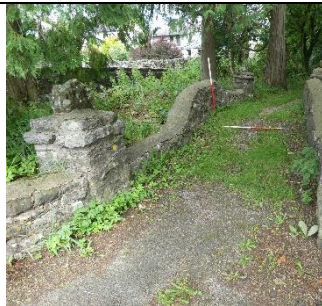
| Feature No. | Feature Type | Description | Condition | Threats | Photographs |
|---|---|---|---|---|---|
| G022 | Footbridge | Footbridge marked on 25" OS map. Stone footbridge with concrete capping on path/track leading to Orton Hall, going over Chapel Beck. Bridge has wall pier on either end and a raised arch in the centre. Bridge located to the SE of Raisbeck Road bridge. | Good | Flood;<br>removal | |

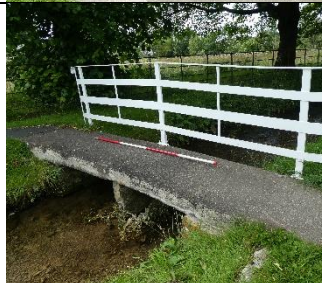
| Feature No. | Feature Type | Description | Condition | Threats | Photographs |
|---|---|---|---|---|---|
| G025a | Clapper bridge | Footbridge marked on historic 6" and 25" OS maps. Clapper bridge is built from sandstone with one central support, located on a PROW. The top of the bridge is covered in concrete, with a metal rail on one side. Stone revetment visible on either side of the bank supporting the bridge. | Good | Flooding;<br>removal | |

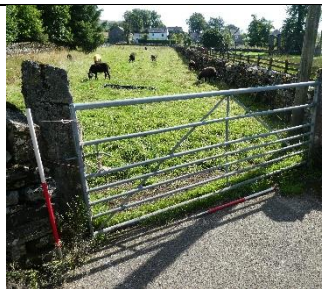
| Feature No. | Feature Type | Description | Condition | Threats | Photographs |
|---|---|---|---|---|---|
| G026 | Gate Stoops (Pair) | Pair of roughly hewn limestone gate stoops at entrance to field. Left stoop is shorter (possibly broken) and has a chain attached to inside face, right stoop has chain around its centre, with a gate attached to the chain. | Good | Erosion; removal | |

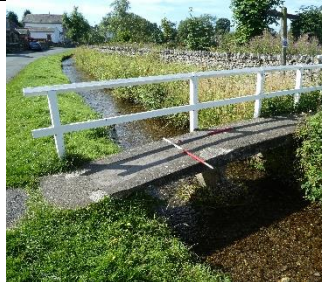
| Feature No. | Feature Type | Description | Condition | Threats | Photographs |
|---|---|---|---|---|---|
| G027 | Clapper Bridge | Footbridge marked on historic 6" and 25" OS maps. Clapper bridge is built with one central (limestone) support, located on a PROW. The top of the bridge is covered in concrete, with a wooden handrail on one side. Stone revetment visible on either side of the bank supporting the bridge. | Good | Erosion; flooding | |

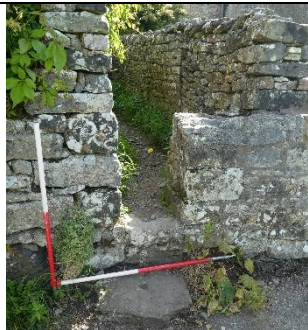
| Feature No. | Feature Type | Description | Condition | Threats | Photographs |
|---|---|---|---|---|---|
| G028 | Stile | Stile in limestone dry stone wall leading to alleyway between two sets of houses, possibly leading to former back lane (now PROW) and runs east to west (G029 at west end). Alleyway is higher so there is a step down to the road on the east side. Stile and wall have been (in part) re-mortared. | Good | Erosion; removal | |

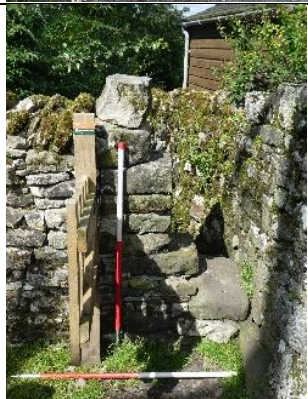
| Feature No. | Feature Type | Description | Condition | Threats | Photographs |
|---|---|---|---|---|---|
| G029 | Step Stile | Step stile in mixed dry stone wall at the west end of an alleyway between houses that leads to the former back lane (G028 at east end of alleyway), with lambing gate on one side. West-side has three steps, east side one step. | Good | Erosion | |

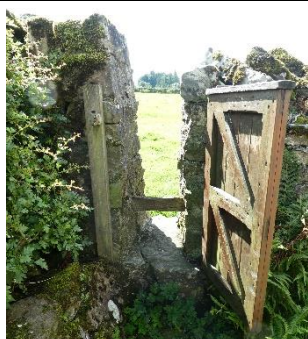
| Feature No. | Feature Type | Description | Condition | Threats | Photographs |
|---|---|---|---|---|---|
| G030 | Squeeze Stile | Squeeze stile in limestone wall (some evidence of mortar) with wooden bar through the lower quarter of the wall and gate on one side. Stile leading to probable former back lane behind private residence. | Good | Removal; erosion | |

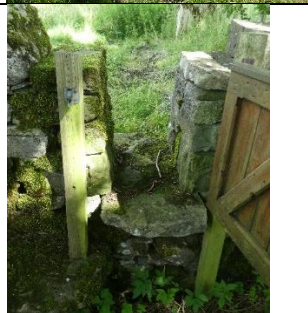
| Feature No. | Feature Type | Description | Condition | Threats | Photographs |
|---|---|---|---|---|---|
| G032 | Step Stile | Step stile in mixed limestone sandstone dry stone wall between two fields, with lambing gate on the south side and through stone step built into both sides of the wall. Stile located on footpath, probably the former back lane. | Good | Vegetation; erosion | |

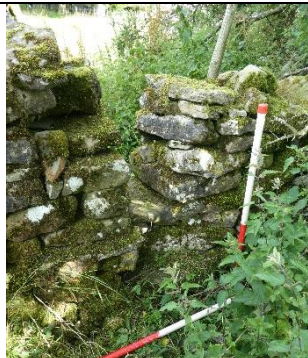
| Feature No. | Feature Type | Description | Condition | Threats | Photographs |
|---|---|---|---|---|---|
| G033 | Squeeze Stile | Squeeze stile in mixed limestone and sandstone wall between fields, with one step on either side of the wall. East section of wall starting to collapse. Located on public footpath, possible former back lane. | Poor | Neglect;<br>collapse;<br>vegetation | |

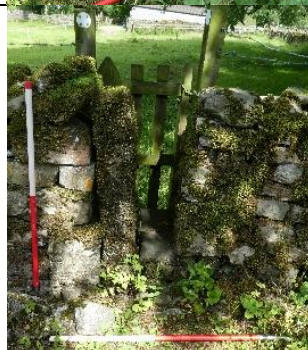
| Feature No. | Feature Type | Description | Condition | Threats | Photographs |
|---|---|---|---|---|---|
| G034a | Squeeze Stile | Squeeze stile in mixed limestone and sandstone dry stone wall with a step at the base. A gate stoop has been used on the west side of the stile (a second gate stoop located further to the west marking a blocked gateway (G034b)). Stile and former gateway next to converted field barn, located on public footpath, probable former back lane. | Good | Erosion;<br>vegetation | |

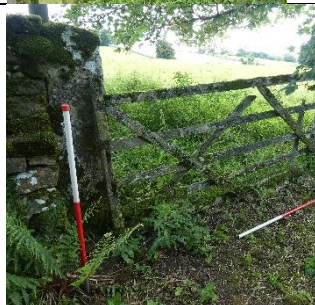
| Feature No. | Feature Type | Description | Condition | Threats | Photographs |
|---|---|---|---|---|---|
| G037 | Gate Stoops (Pair) | Pair of limestone gate stoops leading to a field off the public footpath (probable former back lane). Left stoop has gate catch and chain on the front face; right stoop has two hinges on the front face with gate attached. | Good | Removal; erosion; vehicles | |

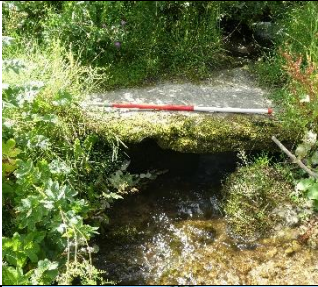
| Feature No. | Feature Type | Description | Condition | Threats | Photographs |
|---|---|---|---|---|---|
| G040b | Footbridge | Footbridge marked on the 6" and 25" OS maps over the mill race/Chapel Beck. The clapper bridge is made from a sandstone slab supported by a bank on either side. | Good | Flooding; erosion; vegetation; removal | |

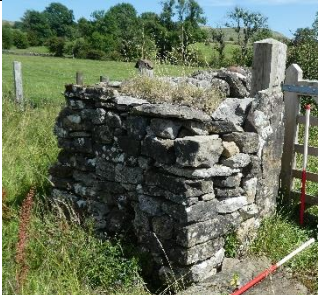
| Feature No. | Feature Type | Description | Condition | Threats | Photographs |
|---|---|---|---|---|---|
| G041a | Gate Stoop (Single) | Single limestone gate stoop on the north side of gateway which leads to a track/former back lane. Stoop has two metal hinges on the east face. | Good | Erosion | |

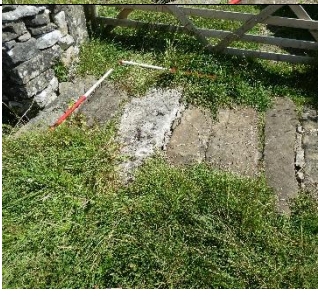
| Feature No. | Feature Type | Description | Condition | Threats | Photographs |
|---|---|---|---|---|---|
| G041b | Culvert | Eight stone slabs laid to create a bridge/culvert, probably associated with the leat leading to the Mill Dam outlined on the historic 6" and 25" OS map. The stone slabs are possibly former repurposed gate stoops based on their size. Seven are sandstone, one is limestone. Some cracking and weathering on the slabs. | Fair | Erosion; flooding | |

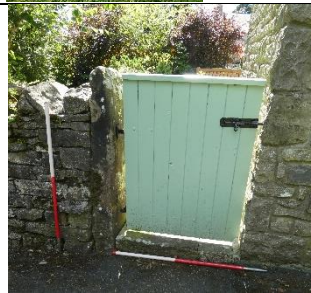
| Feature No. | Feature Type | Description | Condition | Threats | Photographs |
|---|---|---|---|---|---|
| G043 | Gate Stoop (Single) | Single sandstone gate stoop on the left side of gateway leading to private garden. One bracketed hinge and one hinge on the inside face with wooden gate attached. | Good | Erosion | |

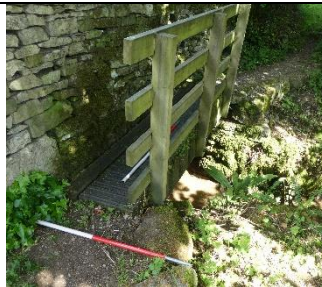
| Feature No. | Feature Type | Description | Condition | Threats | Photographs |
|---|---|---|---|---|---|
| G045 | Footbridge | Footbridge shown over former Mill Leat on the 25" OS map. Current footbridge is built on older stone revetment. | Fair | Erosion; flooding; removal | |

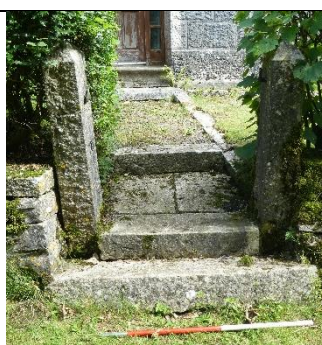
| Feature No. | Feature Type | Description | Condition | Threats | Photographs |
|---|---|---|---|---|---|
| G046b | Gate Stoops (Pair) | Pair of limestone gate stoops. Stoops worked in a square profile with pointed pyramidal top; stoops located at the entrance pathway of private residence. Stoops set at an angle, possible moved/damaged in the past. Left stoop has a gate catch and eye with single chain on the inside face; right stoop has two hinges on the inside face. | Fair | Erosion; removal; neglect | |

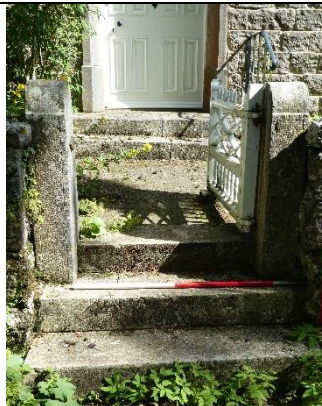
| Feature No. | Feature Type | Description | Condition | Threats | Photographs |
|---|---|---|---|---|---|
| G047 | Gate Stoops (Pair) | Pair of limestone gate stoops with rounded tops and shoulders. Located on the second step of the entrance pathway to private house. Left stoop has a gate catch on the inside face; right stoop has two hinges on the inside face with gate attached. | Good | Erosion; vegetation | |

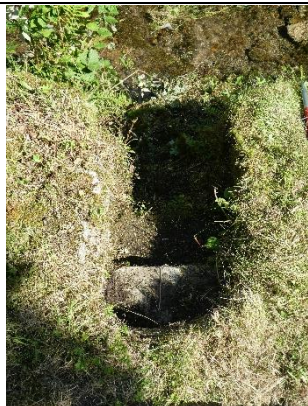
| Feature No. | Feature Type | Description | Condition | Threats | Photographs |
|---|---|---|---|---|---|
| G049a | Steps | Four mixed sandstone and limestone stone steps cut into the bank leading to the stream/mill leat. Steps not shown on Historic OS maps and are of unknown purpose. | Fair | Vegetation; erosion; flooding | |

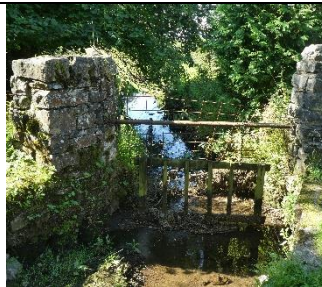
| Feature No. | Feature Type | Description | Condition | Threats | Photographs |
|---|---|---|---|---|---|
| G054 | Water Gate | Water gate shown on historic 25" OS map, made up of a metal pole spanning the stream, supported and built into two walls on either side. The pole has two chains hanging off it, onto an attached wooden "gate". | Fair | Flooding; removal; collapse | |

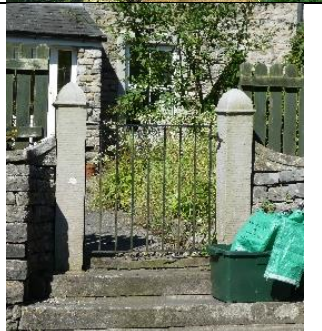
| Feature No. | Feature Type | Description | Condition | Threats | Photographs |
|---|---|---|---|---|---|
| G055 | Gate Stoops (Pair) | Two dressed gate stoops now painted white, located on the top step leading to private residence. Stoops have arched pyramidal tops set on raised shoulders, with a square profile. Left stoop has gate catch on the inside face, right stoop has two hinges on the inside face and gate attached. | Good | Removal; vehicles | |

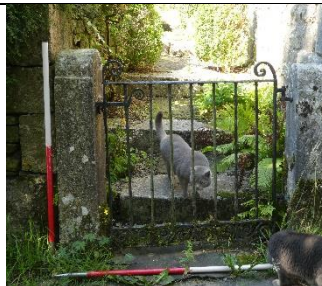
| Feature No. | Feature Type | Description | Condition | Threats | Photographs |
|---|---|---|---|---|---|
| G060 | Gate Stoops (Pair) | Pair of limestone gate stoops with rounded tops and shoulders, Stoops dressed with incised profile visible on the inside face. Stoops located at the entrance to garden of private residence. Left stoop has two metal hinges with gate attached on inside face, right stoop has gate catch on inside face. | Fair | Vegetation; removal; erosion | |

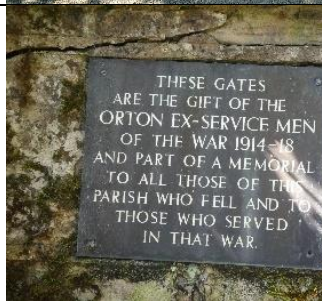
| Feature No. | Feature Type | Description | Condition | Threats | Photographs |
|---|---|---|---|---|---|
| G062 | Memorial | Memorial wall piers and gates located at the east and south-west entrance to the churchyard of All Saints Church, Orton. The memorial dedication is metal with white writing and is screwed into the left gate pier at both entrances and reads "THESE GATES ARE THE GIFT OF THE ORTON EX-SERVICEMEN OF THE WAR 1914-18 AND PART OF A MEMORIAL TO ALL THOSE OF THIS PARISH WHO FELL AND TO THOSE | Good | Removal; erosion | |

| Feature No. | Feature Type | Description | Condition | Threats | Photographs |
|---|---|---|---|---|---|
| | | WHO SERVED IN THAT WAR". Each gate pier has two hinges on the inside face with a gate attached. | | | |

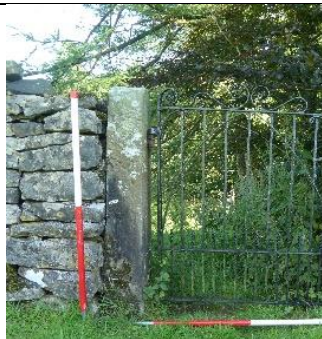
| Feature No. | Feature Type | Description | Condition | Threats | Photographs |
|---|---|---|---|---|---|
| G063 | Gate Stoops (Pair) | Pair of sandstone gate stoops with rounded tops and tool marks in the limestone dry stone boundary wall around All Saints Church Orton leading to adjacent field. Left stoop has two hinges on the inside face, right stoop has a gate catch on the inside face. No public footpath associated with gateway. | Good | Erosion; removal | |

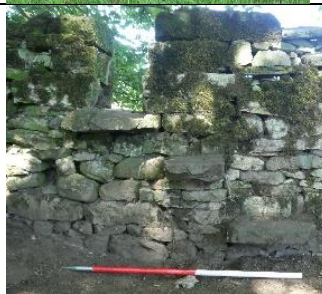
| Feature No. | Feature Type | Description | Condition | Threats | Photographs |
|---|---|---|---|---|---|
| G065 | Step Stile | Step stile in boundary wall of All Saints Church, Orton. Stile is made from limestone, with sandstone steps. Stile has two steps on the south facing side and three steps on the north facing side. Stile associated with public footpath that goes to Orton Scar and Crosby Ravensworth Fell. | Good | Vegetation; erosion; collapse | |

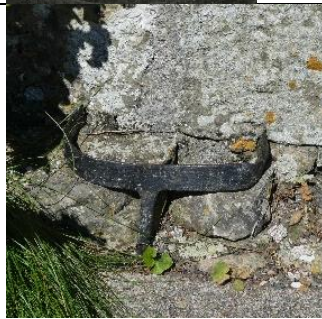
| Feature No. | Feature Type | Description | Condition | Threats | Photographs |
|---|---|---|---|---|---|
| G067 | Boot Scrapers (Pair) | Two iron boot scrapers located on the right and left side of the main porch entrance to All Saints Church, Orton. Boot scrapers are a curved shape, with each end leaded into the wall and a central metal spike that goes into the ground to help support the scraper. The left scraper is bent and less uniform in shape compared to the right, with the leaded ends also starting to come away from the wall. | Fair | Neglect; removal | |

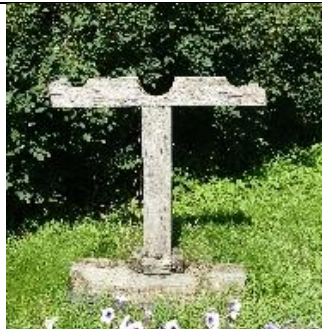
| Feature No. | Feature Type | Description | Condition | Threats | Photographs |
|---|---|---|---|---|---|
| G068 | Pillory | Wooden pillory situated on a wooden plinth, without top board but with an eye for a padlock on the left side. The pillory is located on the left side of the south-west entrance to All Saints Church, Orton and was erected by the parish council to reflect the "Stocks" labelled on first edition 25" OS map in this location. | Poor | Neglect; erosion; removal | |

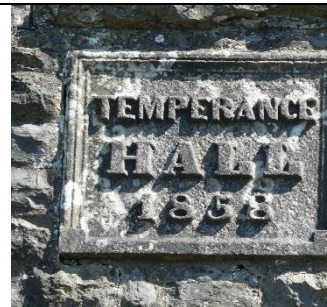
| Feature No. | Feature Type | Description | Condition | Threats | Photographs |
|---|---|---|---|---|---|
| G069a | Date Stone | Temperance Hall marked on historic 6" and 25" OS map. Hall has a sandstone(?) square date stone with some border decoration showing "TEMPERANCE HALL 1858" in raised text, located on the gable end of building. The lintel above the door is dressed with a bad crack on the right side, now causing movement and cracking in the stonework above. There are four holes in the centre of the lintel possibly depicting a cross shape or where a former light was fixed. | Fair | Erosion; collapse | |

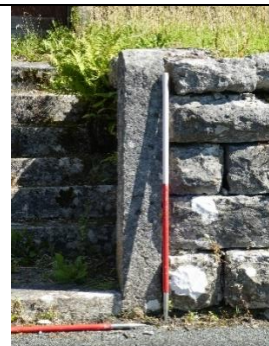
| Feature No. | Feature Type | Description | Condition | Threats | Photographs |
|---|---|---|---|---|---|
| G069b | Gate Stoop (Single) | Single limestone(?) gate stoop with rounded top on the right side of gateway leading to steps to the Temperance Hall with two hinges on the rear face. | Good | Erosion; vehicles | |

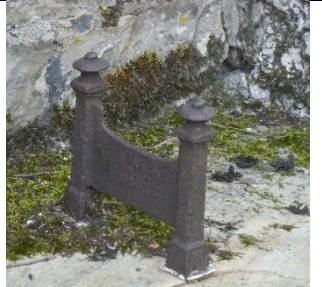
| Feature No. | Feature Type | Description | Condition | Threats | Photographs |
|---|---|---|---|---|---|
| G071b | Boot Scraper | Metal boot scraper in an "H" shape with two finials at either end, leaded into the flag stones adjacent to the chapel's main elevation. The scraper is of unknown date but is probably pre 1800s and has been moved more recently to its current location based on the limited lead oxidisation. | Good | Erosion; removal | |

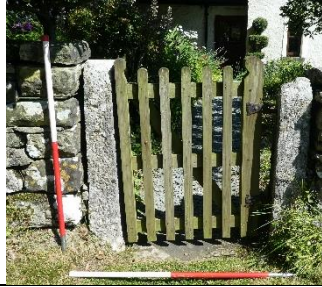
| Feature No. | Feature Type | Description | Condition | Threats | Photographs |
|---|---|---|---|---|---|
| G072 | Gate Stoops (Pair) | Pair of limestone gate stoops with rounded tops outside private garden. Left stoop has gate catch on the inside face, right stoop has two hinges on the inside face and some damage to the top of the stoop. | Fair | Erosion; removal | |

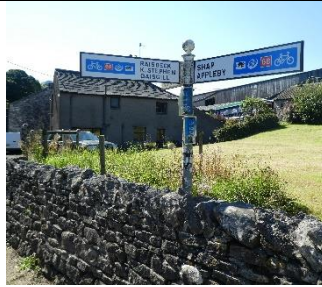
| Feature No. | Feature Type | Description | Condition | Threats | Photographs |
|---|---|---|---|---|---|
| G085 | Finger Post | Finger post consisting of an aluminium(?) black and white painted (now peeling) post, with a round finial on the top and with two "finger" sign posts. The sign pointing toward Tebay appears to be the oldest, with the signs pointing towards Appleby and Raisbeck newer. possibly replacing older signs as the fixings appear older. | Fair | Erosion; removal | |

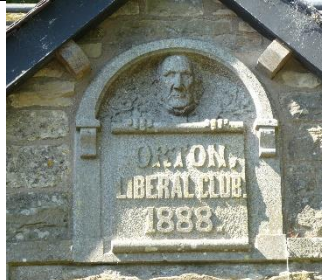
| Feature No. | Feature Type | Description | Condition | Threats | Photographs |
|---|---|---|---|---|---|
| G087 | Date Stone | Sandstone arched date stone with relief carving of a man (William Gladstone) with flowers on either side, holding a scroll with "ORTON." "LIBERAL CLUB." "1888." over three lines. The stone is situated above doorway in the porch on a now private house. | Good | Erosion | |

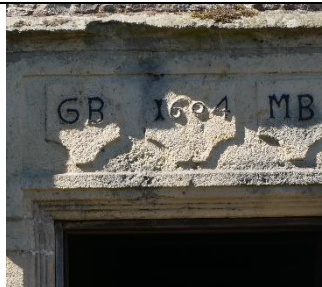
| Feature No. | Feature Type | Description | Condition | Threats | Photographs |
|---|---|---|---|---|---|
| G088 | Date Stone | Carved sandstone lintel with initials and date. The lintel is surrounded by a hood-mould, beneath which are three raised shapes with initials and date "GB" "1604" "MB" painted black and refer to George and Mary Birkbeck, with the house being completed in 1604. The lintel is situated over the main doorway to Petty Hall. | Good | Erosion | |

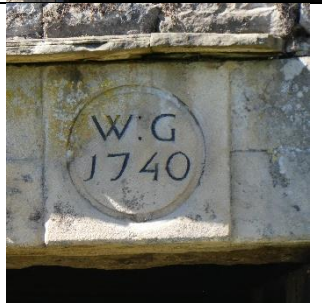
| Feature No. | Feature Type | Description | Condition | Threats | Photographs |
|---|---|---|---|---|---|
| G089a | Date Stone | Square sandstone block with a carved circle within which are carved initials "W: G" and date "1740" over two lines and painted black, W: G. possibly refers to William Garnett. The stone is part of the lintel over the main doorway (left most) of the barn attached to Petty Hall. A course of through stones run above all the openings on the elevation acting as a drip course. | Good | Erosion; collapse; removal | |

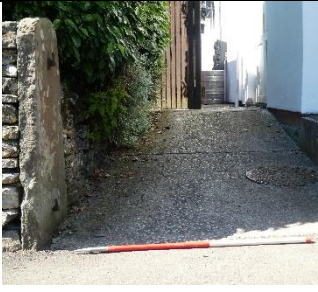
| Feature No. | Feature Type | Description | Condition | Threats | Photographs |
|---|---|---|---|---|---|
| G090 | Gate Stoops (Pair) | Pair of sandstone gate stoops leading to track way. Left stoop has one iron bracketed hinge at the top and one at the base on the inside face. The right stoop has concrete on the top, with an iron gate catch on the inside face going through the stone, with four holes on the outside face (possibly connected to past railings?). | Good | Weathering | |

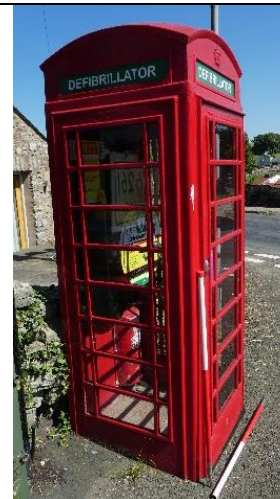
| Feature No. | Feature Type | Description | Condition | Threats | Photographs |
|---|---|---|---|---|---|
| G091 | Telephone Box | Repurposed K6 telephone box, now used to house a defibrillator. The telephone box is painted red and has a St Edwards crown at the top (dating it to post 1953). Below this there is an opening where the "Telephone" sign would have gone, this has been replaced with a green "DEFIBRILLATOR" sign. The main box stands on a small plinth painted black. The windows are mostly glass with some plastic. The door has the original metal and leather hinges on the inside that appear to be in good condition. The Box is situated on the corner at the junction of Front Street and B6260. | Good | Vehicles; removal; erosion | |
