# Small-Scale Heritage Features Survey

Technical Report: Ravenstonedale  
November 2023

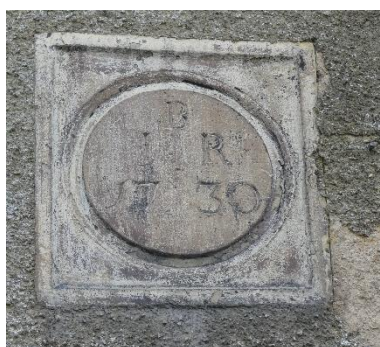
Figure 9 Date stone (A063) of 1730.

4.5 A063 is located on what was once Back Lane Farm but was renamed at the turn of the 19<sup>th</sup>/20<sup>th</sup> century. It is dated to 1730 and has the initials 'I<sup>B</sup>R' for John and Ruth Bousfield. It was previously a house and cottage, with the date stone being located at first floor level on the cottage (Grade II, 1326782). A079 is located on the former dame school. The house to which it is attached is a 16<sup>th</sup> century cottage (with

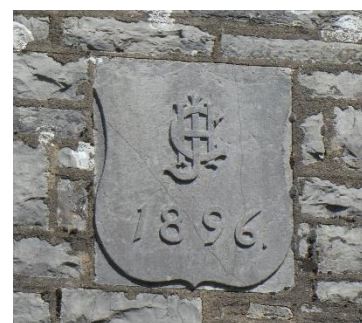
Figure 11 Date stone (A083) of 1896.

later alterations). According to the list description, the dame school was possibly an mid-19<sup>th</sup> century conversion of an earlier outbuilding, with the date stone commemorating this work (Grade II, 1145375). A house at the south end of the village is dated 1896 (A083) – which when built replaced a cottage and farmhouse. It has the intertwined initials of ‘JHC’, John Carver, who built several buildings on the sites of older ones (see 3.32).

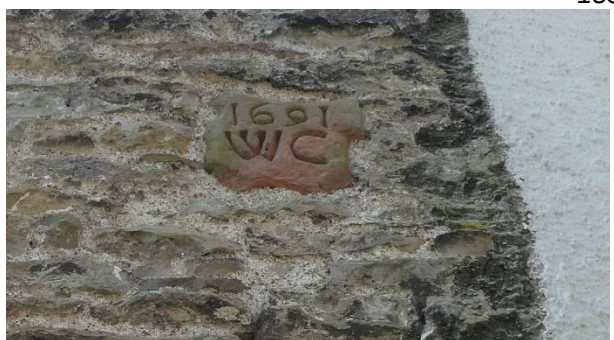
Figure 12 Date stone (A036) of 1691.

4.6 The earliest date stone is of ‘1691’, and this is found on a disused agricultural building. The building itself certainly does not date to this period, and its position is unusual, located at quite a height up the wall near where the barn adjoins the house, as well as not being very visible tucked off to the side of Main Street. This would all suggest that the date stone has been reused. The other date stone located on an agricultural building is A047 which dates to 1905 and has the initials ‘T.A.M-G’ – the Metcalfe-Gibsons were a prominent family in the village (who owned Elm Lodge, see 3.35).

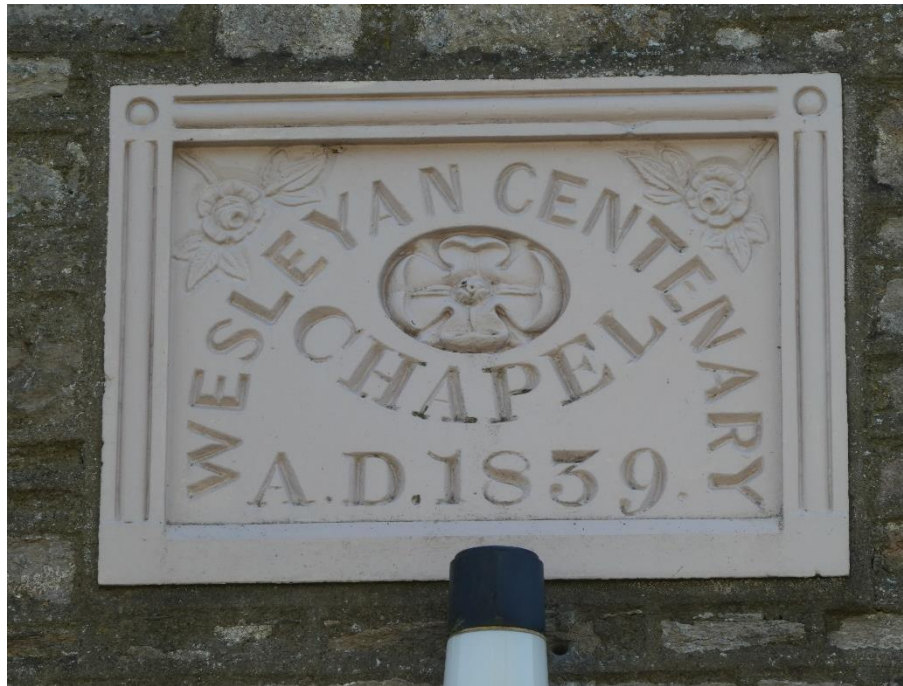
4.7 Only one date stone relates to a non-conformist chapel (see 3.27) - A041 is found on Low Chapel. It is inscribed with ‘WESLEYAN CENTENARY CHAPEL’ and the date ‘A.D.1839’, along with flowers. It is located above the door on the main elevation of the Methodist Chapel. 1739 was the date of the first Methodist Chapel

*Figure 14 Date stone (A041) on Wesleyan Methodist Chapel.*

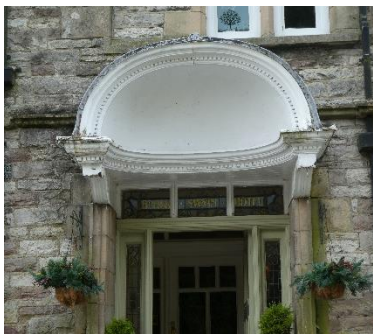
porch (A033d) over it. Due to the location of the hotel on the corner of Main Street, there are two iron cart stops (A035) on its eastern boundary wall.

*Figure 16 Canopy porch (A033d) over the main entrance to the Black Swan Hotel.*

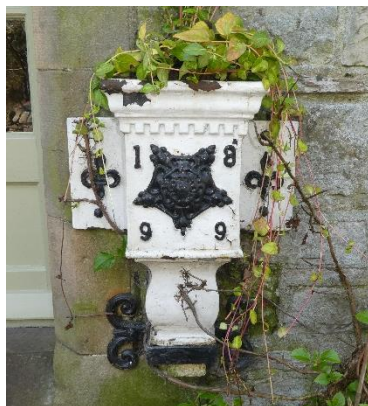
4.12 The Black Swan (A033a; 3.31 to 3.33) is a prominent building in the village. The building that stands today, was rebuilt by John Carver in 1899, and differs greatly to the previous building on the site. This previous building was much more vernacular in character (see Figure 15). The current building is typical of the late 19<sup>th</sup> century – it originally had dated hoppers (A033c) of '1899', but these have now been reused as planters on either side of the main doorway. This doorway has a canopy

*Figure 17 Dated hoppers (A033c) that have been reused as planters.*

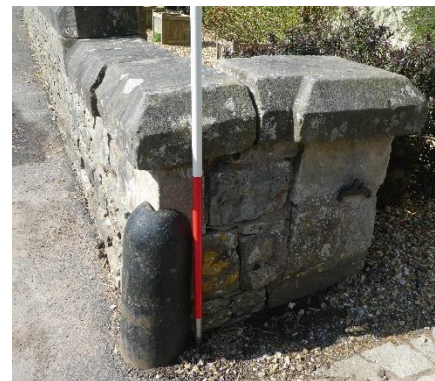
*Figure 18 Cart stops (A035) outside the Black Swan Hotel.*

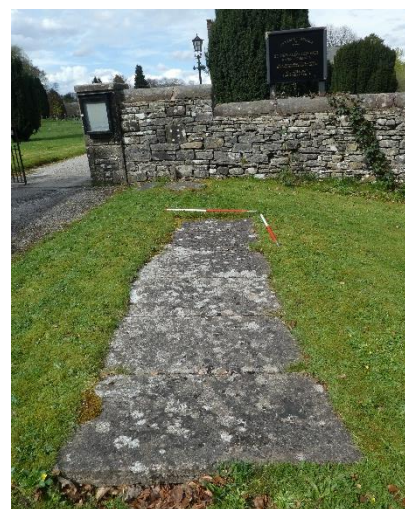
4.13 There are six slabs of brockram<sup>26</sup> (A014) outside the gate entrance to St Oswalds' churchyard. It is thought that this is where the coffin would be placed before entering, in lieu of a lychgate<sup>27</sup>. Coffin stands are usually associated with corpse roads, which provided a practical means for transporting corpses, often from remote communities to cemeteries that had burial rights. However, coffin stones usually had some height, leaving the coffins when placed off the ground, and this one does not. Steppy Lane from Newbiggin-on-Lune is described locally as a coffin route, with coffins being brought to be buried in the consecrated ground at St Oswalds (YDNPA 2023). However, this route would be to the opposite side of the church.

*Figure 19 Possible coffin stand (A014).*

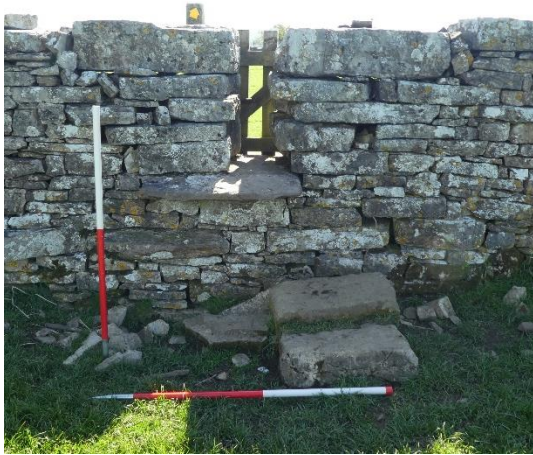
Figure 20 West side of step stile A072 - with two freestanding steps, which are possibly replacing a broken throughstone.

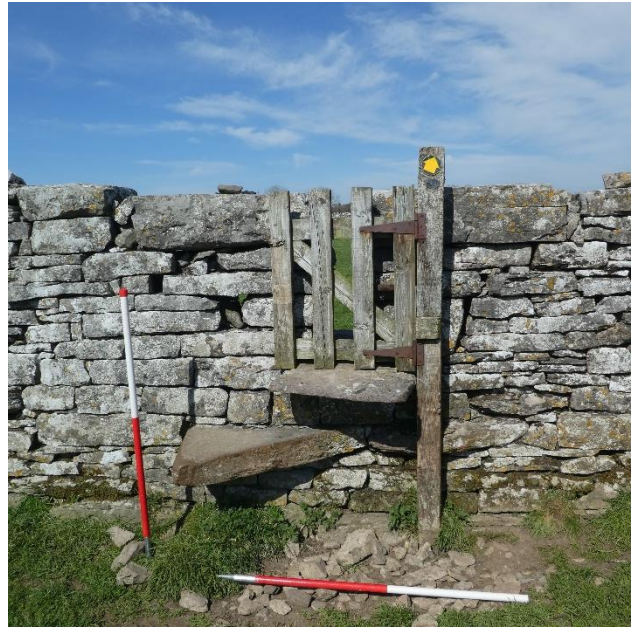
Figure 21 East side of A072 showing one protruding throughstone as step.

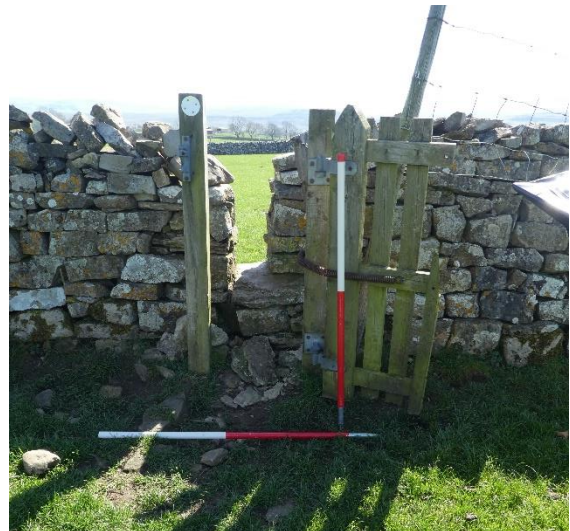
Figure 23 Squeeze stile (A073) that requires a more considerable step up.

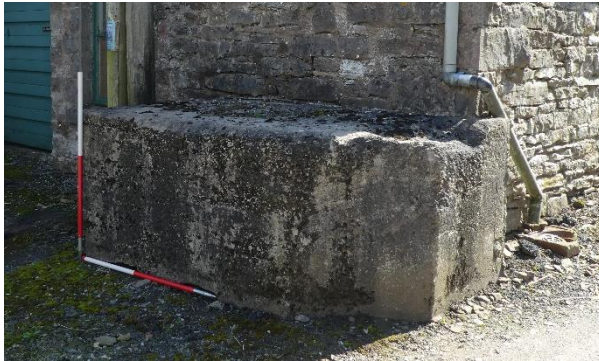
village, appears to be entirely encased in concrete. It is probable that underneath is stone construction, but it is not impossible that it could be entirely made from concrete or similar products. Although not of identical size, they are of similar proportions. However, in contrast, A046 is much longer, being almost four metres. It was reportedly for communal use (or a number of farms). This churn stand is constructed from limestone with a concrete top.

*Figure 24 Churn stand (A040) is encased in concrete.*

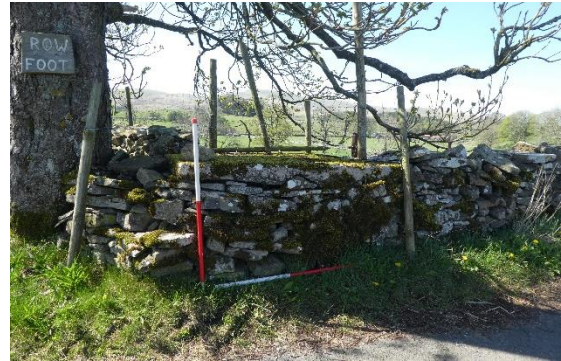
*Figure 25 Churn stand (A074) is built into a dry stone wall.*

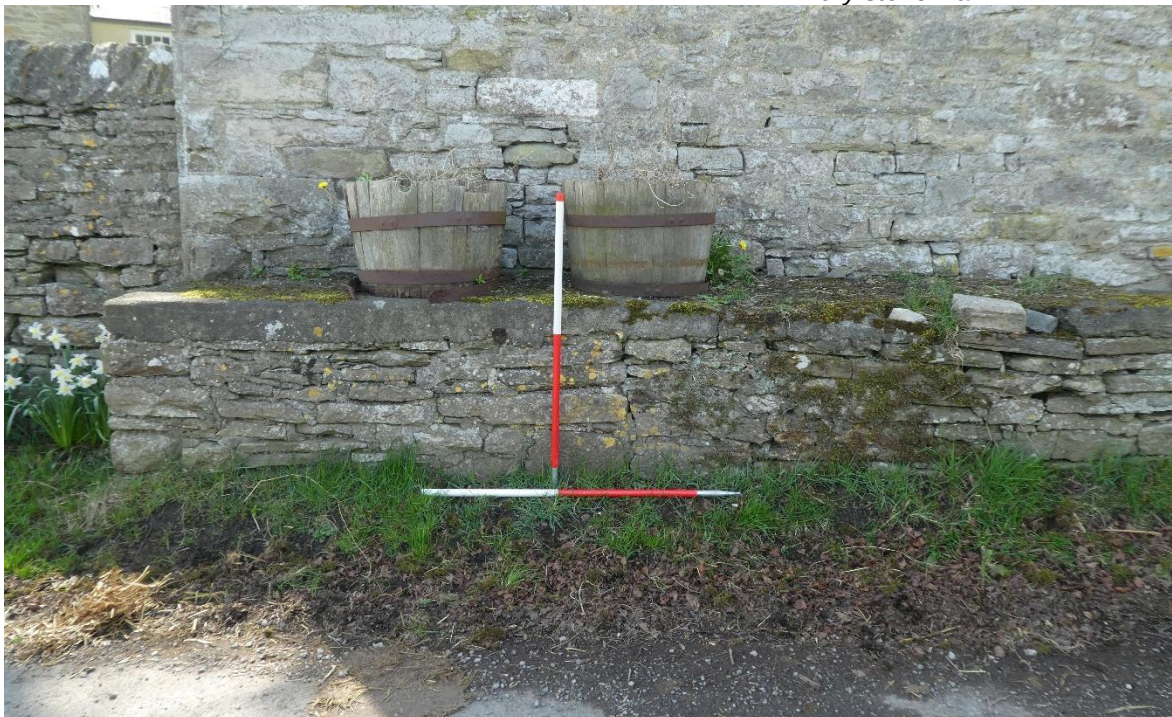
*Figure 26 Churn stand (A046) which is 3.95m long.*

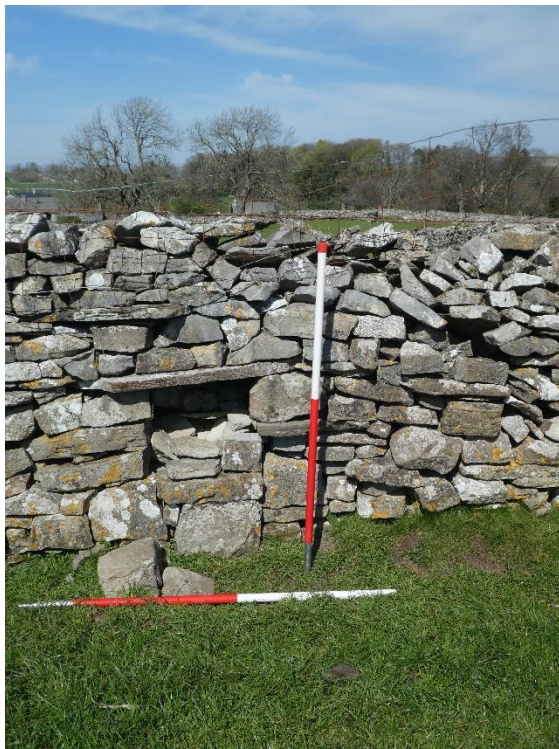
*Figure 27 Sheep smoot (A071)*

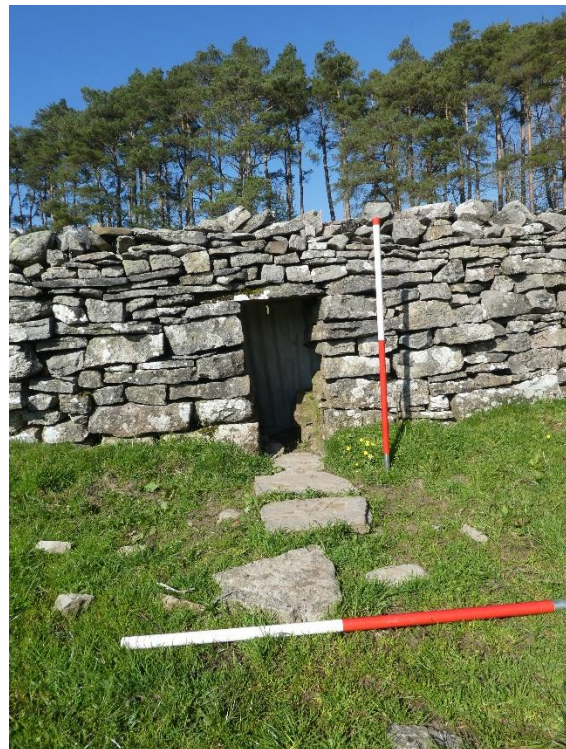
*Figure 28 Sheep smoot (A095)*

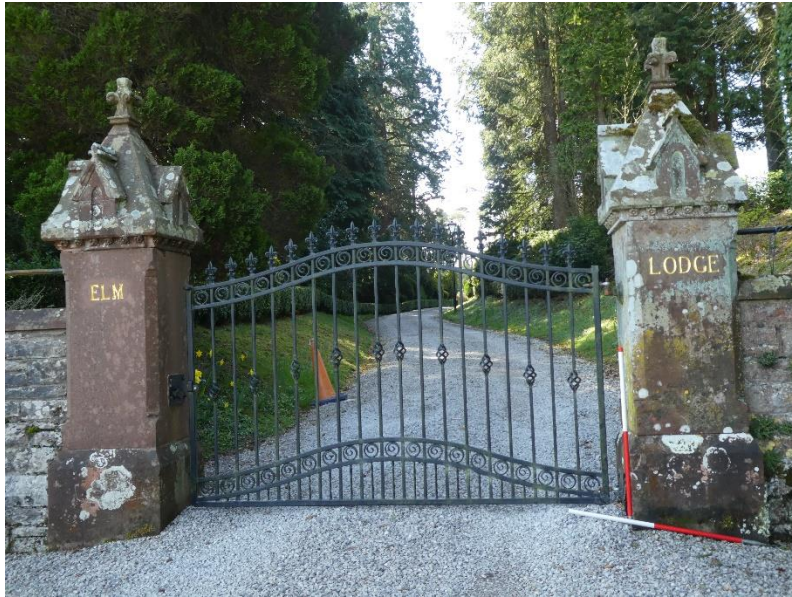
*Figure 29 A pair of gate piers (A003) located at the main entrance to Elm Lodge.*

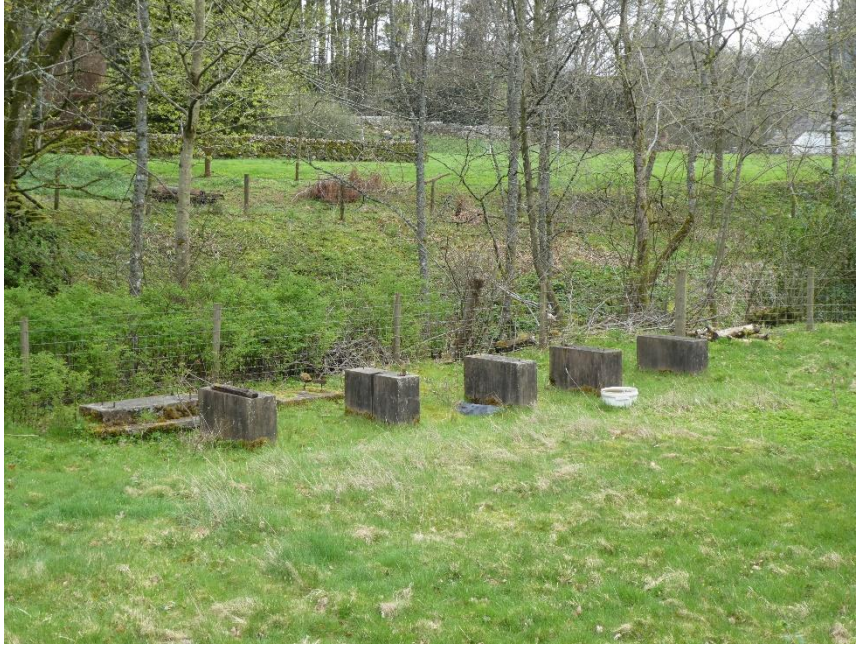
concrete stands (in Figure 30) are not evident in the photos available on the Lakes Guide. Instead they show an open sided building with wooden post frame and corrugated sheet roof (Lakes Guide 2023).

*Figure 30 Evidence of former saw mill (A027).*

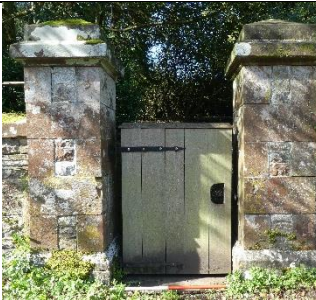
| Feature No. | Feature Type | Description | Condition | Threats | Photo |
|---|---|---|---|---|---|
| A001 | Pair of Gate Piers | Pair of mixed limestone and sandstone gate piers, with a limestone plinth. Both piers have dressed sandstone and dressed ornamental caps. An iron railing is attached to the outside edge of each pier. The piers are located on either side of a gateway relating to Elm Lodge boundary. | Good | Vegetation | |

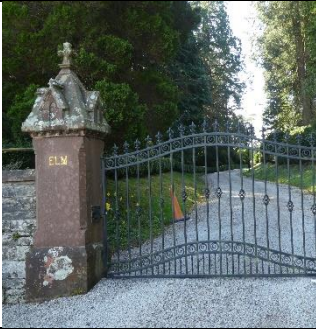
| Feature No. | Feature Type | Description | Condition | Threats | Photo |
|---|---|---|---|---|---|
| A003 | Pair of Gate Piers | Two sandstone gate piers at the main entrance to Elm Lodge. Both piers have ornamental (Gothic Revival) caps, with chamfered pillar edges ending in decorative stops. An iron gate is attached via two hinges on the inside face of the right pier with a gate catch on the inside face of the left pier (the gate was originally wooden). Left pier is inscribed "ELM"; right pier inscribed with | Good | Vehicles; vegetation | |

| | | "LODGE", words painted/inlaid gold and added in 1970s. | | | |

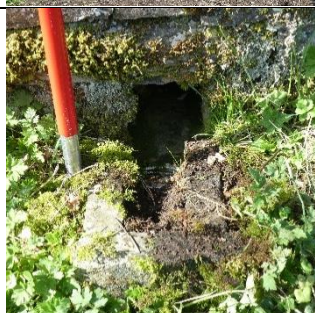
| A006 | Water Smoot | Water smoot in the base of the limestone wall on Elm lodge boundary with raised gully in front of the opening. | Good | Vegetation/debris | |

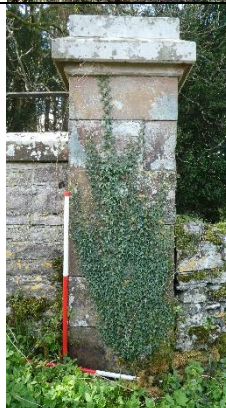
| A008 | Wall Pier | Mixed limestone and sandstone gate pier, with ornamental capstone and an iron railing on one side. No evidence of a plinth. Related to Elm Lodge boundary. | Good | Vegetation | |

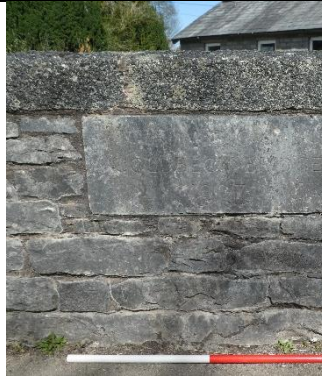
4.8 There are three date stones that are linked to rebuilding works. Both A011 and A026 are found on bridges that were widened by Westmorland County Council in 1967. The bridges are very similar in form, constructed of limestone and sandstone, with four scroll-shaped piers. The date stones are located on one of the parapets. They both appear on maps surveyed in 1858<sup>24</sup> (see 3.42). In addition, there is a date stone of '1970' (A015) in the church boundary wall, which is probably linked to the rebuilding of the wall.

| A011 | Date stone | Limestone and sandstone bridge over Stone Gill. The bridge has four scroll-shape piers which were reused when the road was widened. The top of some of the scrolls and parapet edges have a concrete (?) covering. A date stone is situated on the internal face, in the centre of the north parapet and is engraved with "W C C COLDBECK BRIDGE 1967" over three lines (WCC = Westmorland County Council). Coldbeck bridge is labelled on some of the historic maps. | Good | | |

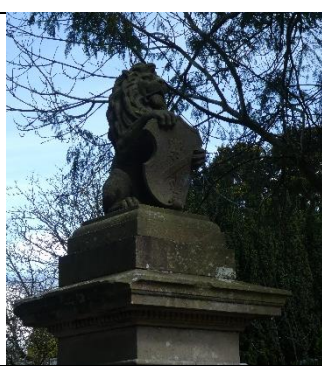
4.29 There are another pair of gate piers (A012a) that lead to a different private residence (a former farmstead), but had, according to a local resident, been relocated from down the road. They have been constructed from a mix of dressed sandstone and limestone, with chamfered edges and decorative stops. The piers are topped with carved lions holding a shield (with fleur-de-lis). There are a pair of cart stops (A012b) positioned with these piers.

| A012a | Gate Piers | Pair of mixed sandstone and limestone gate piers with plinth. Both piers have dressed stone with chamfered pillar edges ending in decorative stops and ornamental caps and finials in the shape of a lion (holding a shield, possibly with fleur-de-lis on). Piers relocated from "down the road from the east" according to local resident. | Good | Vehicles;<br>Erosion | |

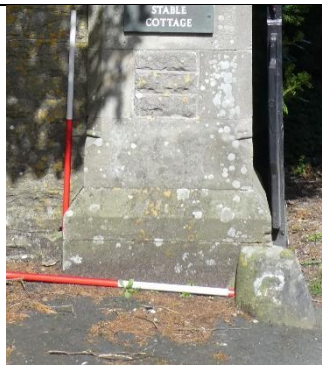
| A012b | Cart Stops | Pair of sandstone cart stops located around the front-internal corner of the gate piers (A012a). They appear to be a separate piece of stone, rather than a continuous carving of the plinth. | Good | Vehicles | |

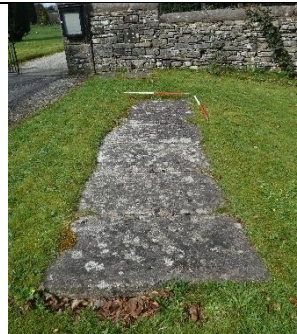
| A014 | Coffin Stand | Six slabs of possible Brockram stone positioned in a line outside the church gate entrance. Place where the hearse would unload the coffin onto a stand. | Good | Vegetation | |

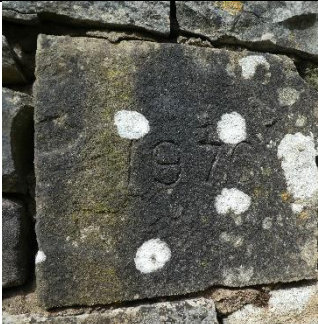
| A015 | Date stone | Date stone engraved with “1970” in church boundary wall, close to gate. Probably linked to (re)building of the wall. | Good | | |

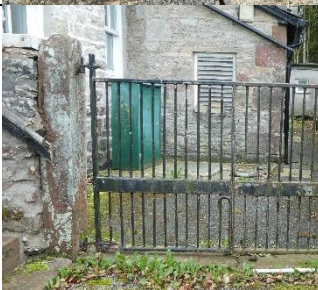
| A016 | Gate Stoops (Pair) | Pair of sandstone gate stoops, with rounded tops and some rustication/tool marks leading to former school. Both stoops have hinges on the inside face with gate attached. | Good | | |

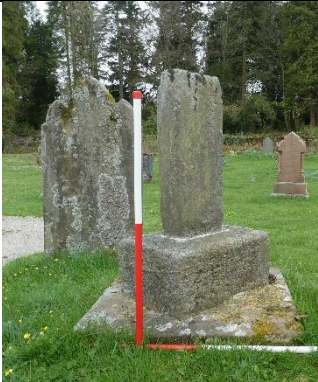
| A018 | Cross Shaft | Base of cross shaft. Sandstone base plinth and unknown stone base and shaft. Evidence of previous attachment on top of shaft. | Poor – plinth cracked, cross missing | Weathering | |

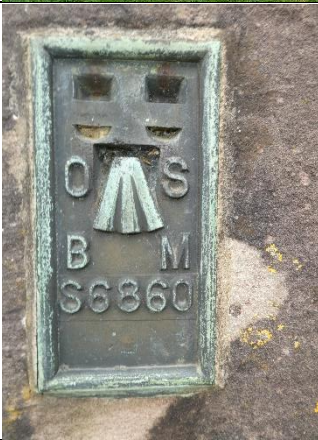
| A019 | OS Benchmark | Copper flush bracket OS benchmark in side of church close to Gilbertine ruins. | Good | | |

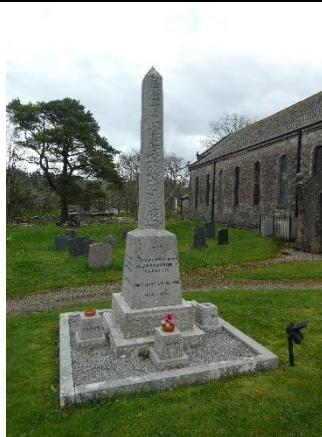
| A020 | War memorial | Limestone obelisk and plinth with some rustication in St Oswald's Churchyard commemorating those who died during WW1 and WW2. | Good | | |

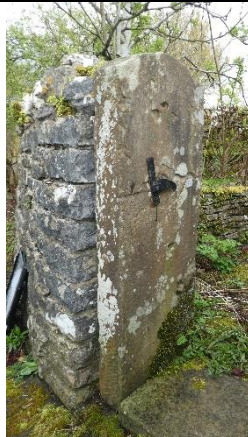
| A025 | Gate Stoops<br>(Pair) | Pair of sandstone gate stoops leading to private garden, rounded tops and some tooling marks on the front face. Left stoop has an iron gate catch on the inside face along with one/two holes; right stoop has two iron hinges on the inside face with gate attached, along with some lettered graffiti. | Fair | Erosion | |

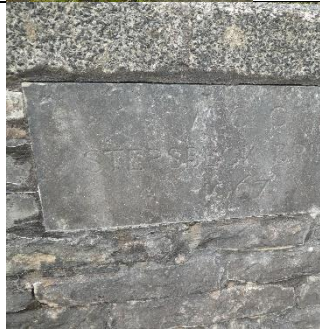
| A026 | Date stone | Stepsbeck Bridge. Bridge has four piers in scroll shape, piers reused following the road being widened. Bridge top covered in concrete (?). A date stone inscribed with "W C C STEPSBECK BRIDGE 1967" (WCC = Westmorland County Council) is located in the centre of the bridge. "Stepsbeck Bridge" is labelled on the first edition 6" OS map (surveyed c. 1858). | Good | | |

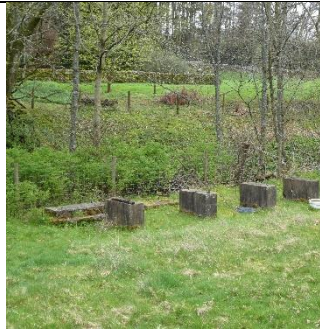
| A027 | Saw Mill | Concrete stands of former saw mill that was in use until the late 20 <sup>th</sup> century, but is not shown on the historic maps. | Poor | Non-use | |

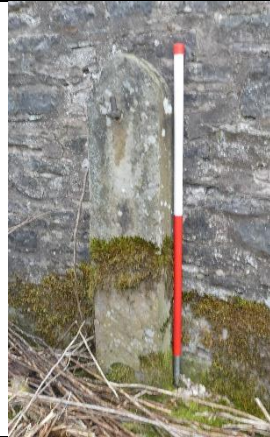
| A028 | Gate Stoop<br>(Single) | Single sandstone gate stoop with rounded pointed top, located adjacent to a small building, marking the right side of former gateway. At least one metal hinge on the inside face. | Fair | Erosion;<br>vegetation;<br>removal | |

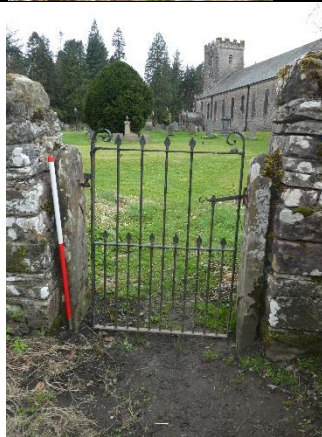
| A029 | Gate Stoops<br>(Pair) | Pair of sandstone gate stoops with rounded tops on footpath entrance to churchyard. Left stoop has two hinges on the inside face with gate attached, right stoop has gate catch on the inside face. | Fair | Erosion | |

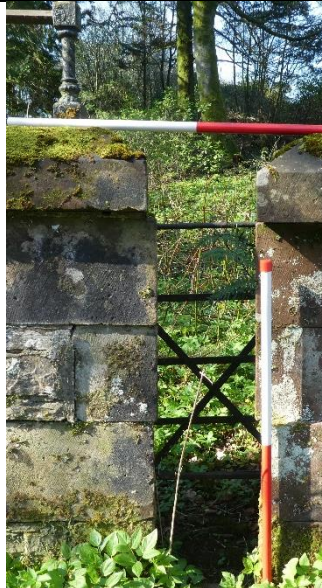
| A030 | Squeeze stile | Squeeze stile in limestone and sandstone wall created by two wall heads on either side (the left has a rail attached to it). There is an iron bar built into the stile near its base and a metal gate on the rear face. The stile marks a private entrance to Elm Lodge gardens and is not on a PROW. | Good | Vegetation | |

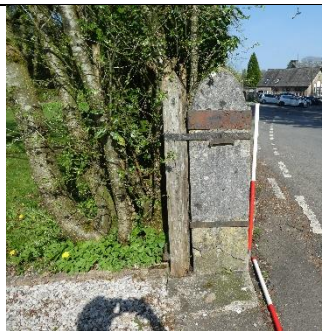
| A032 | Gate Stoops<br>(Pair) | Pair of limestone gate stoops with shoulders and pointed arch tops and tool marks leading to private residence. Left stoop has a broken hinge on the inside face, right stoop has three metal bands around it for support due to cracking and a gate catch on the inside face. | Fair | Erosion;<br>Vehicles | |

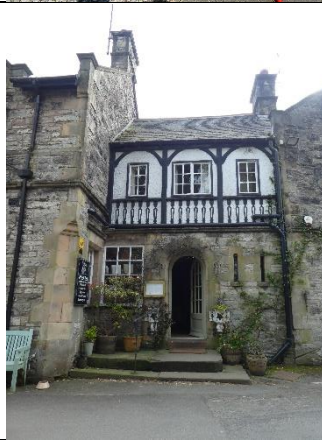
| A033a | Black Swan<br>Pub | Black Swan hotel/pub built on former farmhouse/pub site built in the late 1890s. Limestone with sandstone quoins/lintel, with decorative dated hops (A033c) and stylised porch (A033d) over the front entrance. | Good | | |

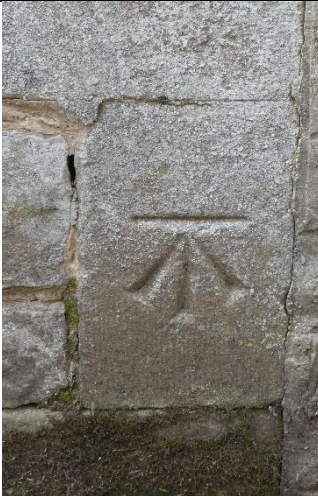
| A033b | OS Benchmark | OS Benchmark on quoin of former doorway at the front of the Black Swan Pub, now blocked. Benchmark only shown on the third edition of the 6" and 25" OS maps. | Good | Erosion | |

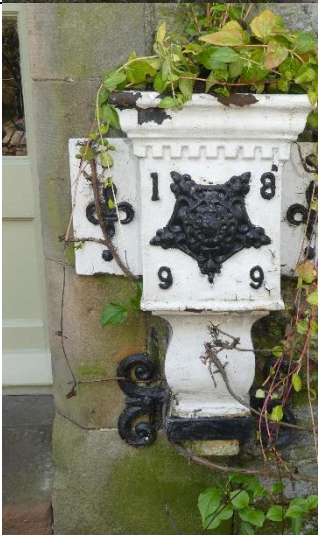
| A033c | Hopper | Four metal decorative hoppers with date 1899 and flower and fleur-de-lis design, now repurposed as planters, located at the front entrance to the Black Swan Inn (A033a). | Good | Removal | |

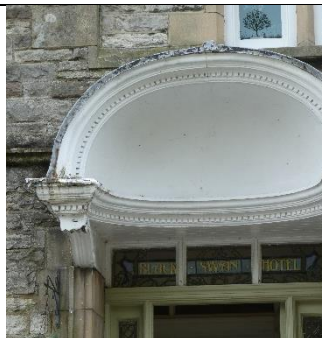
| A033d | Canopy | Stone/stucco(?) decorative canopy over the main entrance to the Black Swann Inn (A033a). Doorway of a Corinthian design with an architrave, frieze below the canopy. | Good | Removal; erosion | |

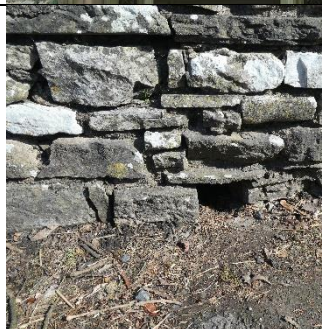
| A034 | Water Smoots | Four water smoots, two with lintels, two with concrete pipes located above Scandal Beck opposite Black Swan Pub. Probably for road water run-off. | Fair | | |

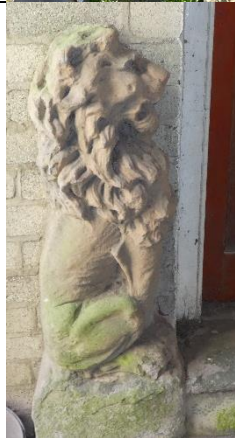
| A038 | Carved Stone Lions | Two carved sandstone lions. The left is a yellow sandstone and shows a lion in profile sitting on a plinth and is located next to a door. Red sandstone lion's head is mounted at the top of the wall by a window to the right of the door. Not on PROW. | Fair | Erosion/disuse | |

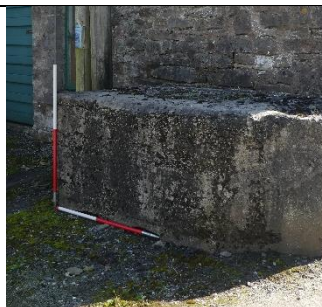
| A040 | Churn Stand | Churn stand located outside of farm, is rectangular and covered in aggregate/concrete. Some damage to the top right side. | Fair | Vehicles; removal; neglect | |

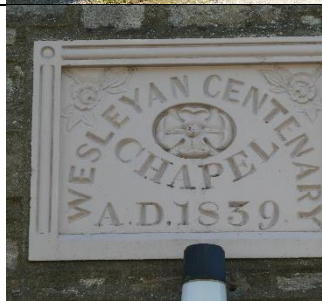
| A041 | Date Stone | Date stone inscribed with "WESLEYAN CENTENARY CHAPEL A.D. 1839" and flowers in a frame painted cream located above door of Methodist Chapel. Unknown material. | Good | Erosion | |

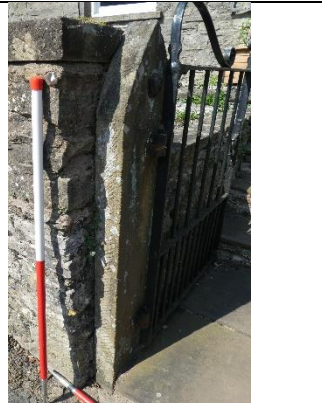
| A042 | Gate Stoop (Single) | Single limestone gate stoop with pointed top and tool marks on the front face, located on the left side of gateway to private house. A bolt(?) going through the stoop probably to the wall is at the top inside face, with two hinges below it and gate attached. | Good | | |

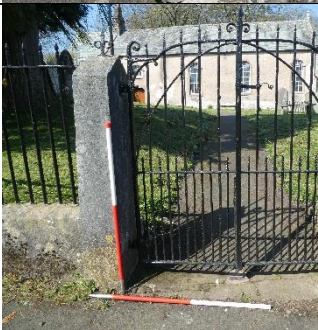
| A044 | Gate Stoops (Pair) | Pair of grit stone (?) tapered gate stoops with pointed tops. Both stoops have two hinges on the inside face with gate attached and railings on the outside face and top. Located at the entrance to High Chapel. | Good | | |

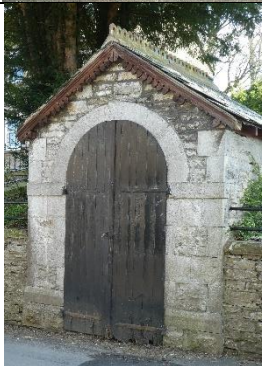
| A045 | Pump House | The pump house housed the first water supply to the village. Has ornamental roof ridges and fascia board. Not labelled but shown on the 2 <sup>nd</sup> edition OS maps. | Good | Removal;<br>neglect | |

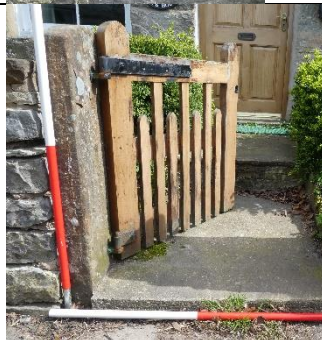
| A054 | Gate Stoops<br>(Pair) | Pair of sandstone gate stoops with curved tops. Left stoop has two hinges on the inside face with gate attached; right stoop has a gate catch on the inside face. Located outside of private residence. | Good | | |

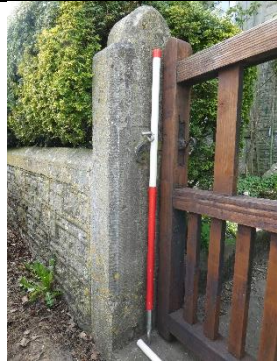
| A058 | Gate Stoops (Pair) | Pair of gritstone (?) gate stoops with shoulders and a rounded-pointed top, chamfered external edges and evidence of tool marks (chamfering and tool marks also visible on house lintels and quoins). Left stoop has a gate catch, with a hook above it; right stoop has two hinges with gate attached. Located outside of private residence. | Good | | |

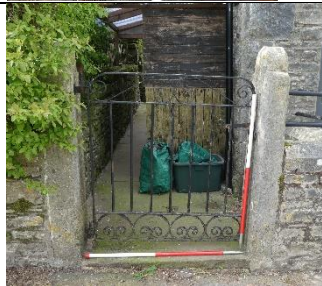
| A059 | Gate Stoops (Pair) | Pair of gritstone (?) gate stoops with shoulders and a rounded top, chamfered external edges and evidence of tool marks. Left stoop has two hinges on the inside face; right stoop has a gate catch on the inside face and railing attached to the outside face. Located outside of private residence. | Good | | |

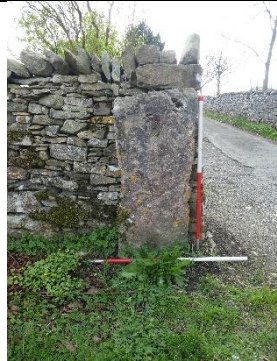
| A061 | Gate Stoop<br>(Single) | Single sandstone gate stoop, unworked with flat top. Two hinges present on the inside face. Located on Back Lane, behind private house on the left side of gateway. | Good | Erosion;<br>vegetation | |

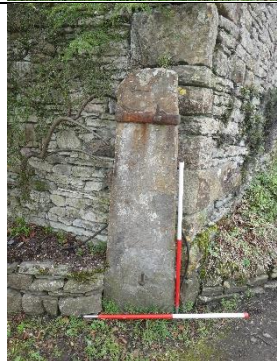
| A062 | Gate Stoop<br>(Single) | Sandstone gate stoop with an irregular flat top. Metal strap around the top of the stoop with hinge attached and a second hinge below. Stoop located on the right side of former gateway giving access to the back lane from a private garden. | Good | Erosion | |

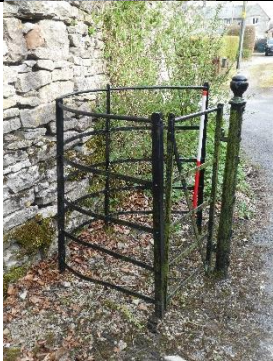
| A065 | Kissing Gate | Iron kissing gate painted black in a half round design with five horizontal railings going around the outside and on the gate. The gate post has a final at the top. | Good | Removal | |

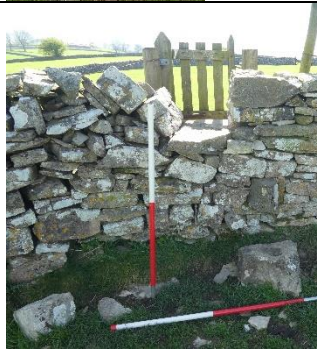
| A070 | Step Stile | Step stile in limestone wall, with stepping surface on the top of the wall, two steps on the ground on the east side and one step on the ground on the west side. | Good | Removal | |

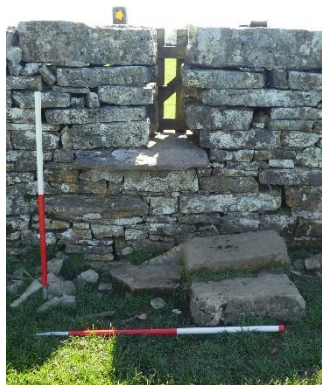
| A072 | Step Stile | Step stile in limestone drystone wall. Two steps on the ground on the west side (possibly replacing a broken through stone). One step (through stone) on the east side incorporated into the walling. Overhanging stone used as the stepping surface in the centre of the stile. | Good | | |

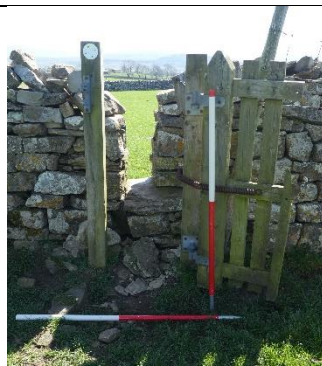
| A073 | Squeeze Stile | Squeeze stile in limestone drystone wall, with raised stepping surface. Some loose stones/packing stone on the ground. | Fair | | |

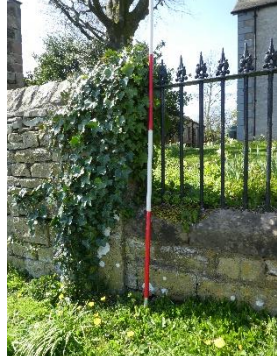
| A078 | Gate Stoop (Single) | Large limestone block with a shaped top to mirroring the wall capping. The stone abuts the wall head to the left and acts as a stoop for iron railings to attach to on the right side. Located outside of private house. | Fair | Vegetation | |

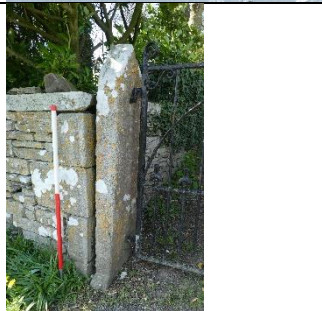
| A080 | Gate Stoop (Single) | Single limestone(?) gate stoop tapered from base to pointed top with plinth/stop at base. Two hinges on the inside face with gate attached. Located on the left side of gateway to private residence. | Good | | |

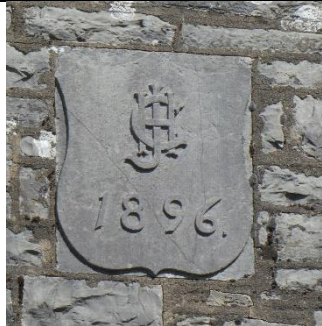
| A083 | Date Stone | Date stone on The Chantry, visible from PROW. Stone cared in relief, showing a shield with the letters JHC intertwined with "1896." date below it. | Good | | |

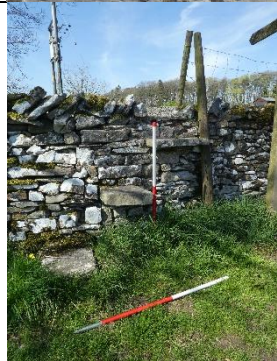
| A084 | Step Stile | Limestone step stile in limestone dry stone wall. Three steps on either side incorporated into the wall. Crossing point on the top of the wall. | Good | Removal | |

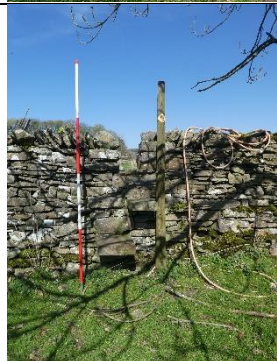
| A085 | Step Stile | Limestone and sandstone step stile, in dry stone wall, two steps on either side. | Good | Removal | |

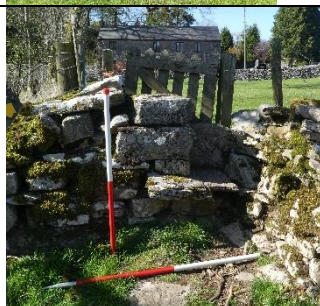
| A092 | Step Stile | Step Stile in limestone wall, with a vertical limestone partition and horizontal limestone through stone acting as step. Some loose wall and packing stone. | Fair | Neglect; removal | |

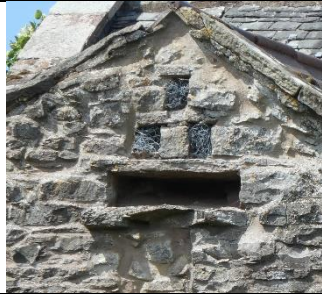
| A106 | Dovecote | Dovecote located in gable end of outshot of former farm building (now private residence). Consists of three holes (one, over two) with a wide opening below it, probably for a further three openings. | Good | Removal | |
