# Small-Scale Heritage Features Survey

Technical Report: Tebay  
November 2023

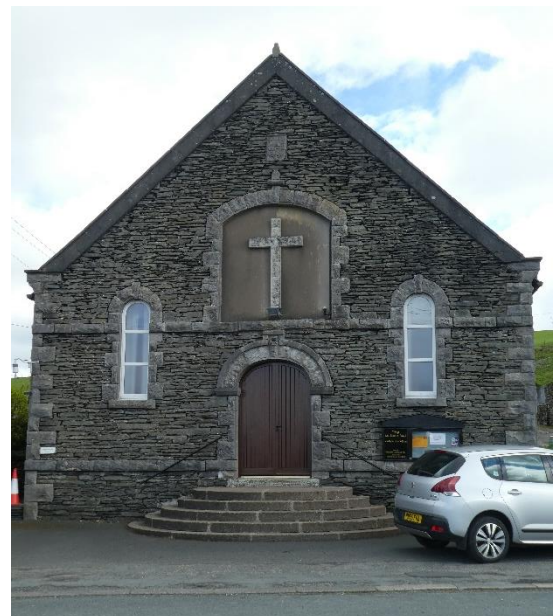
*Figure 3 Methodist Church built in 1885 (J043).*

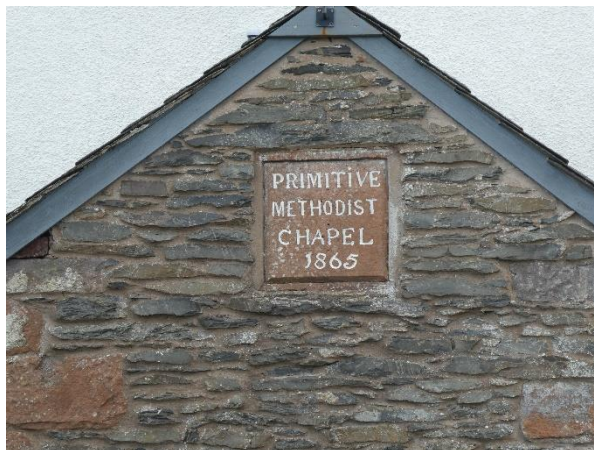
4.7 There are two date stones that relate to Primitive Methodist Chapels, with J041 dating to 1865 and J043 dating to 1885. J041 is found on the porch of a house, and there is debate as to whether it has been moved from its former location (see

Figure 5 Date stone (J041) located on porch of house.

| Feature No. | Feature Type | Description | Condition | Threats | Photograph |
|---|---|---|---|---|---|
| J041 | Date Stone | Sandstone date stone located on porch of a private house at S end of Chapel Terrace inscribed with "PRIMITIVE METHODIST CHAPEL 1865". This building was apparently the first Methodist Chapel in Tebay, and was replaced by the later one (J046) following an increase in membership by the arrival of railway workers. This chapel is not labelled on the historic OS maps. According to resident the house was also formerly a shop. | Good | | |

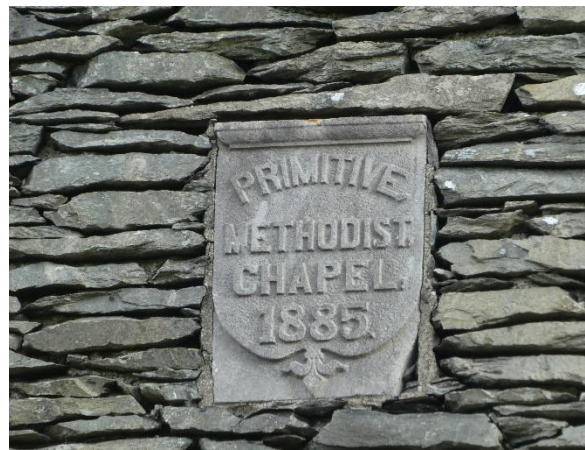
3.22). J043 is located on the front gable of Tebay Methodist Church. The construction of a new Methodist chapel after only 20 years, is probably due to the need for greater capacity linked to the development of the railway. The earlier date stone is much plainer when compared to the latter.

Figure 6 Date stone (J043) located on gable end of chapel.

| Feature No. | Feature Type | Description | Condition | Threats | Photograph |
|---|---|---|---|---|---|
| J043 | Date Stone | Date stone of unknown stone type, located on the front gable (road side) of Tebay Methodist Chapel with "PRIMITIVE METHODIST CHAPEL 1885" in raised text over our lines. This chapel reportedly replaced an earlier Methodist Chapel (J041) following a membership increased because of the railway. Some damage to the lower right corner. | Good | Erosion | |

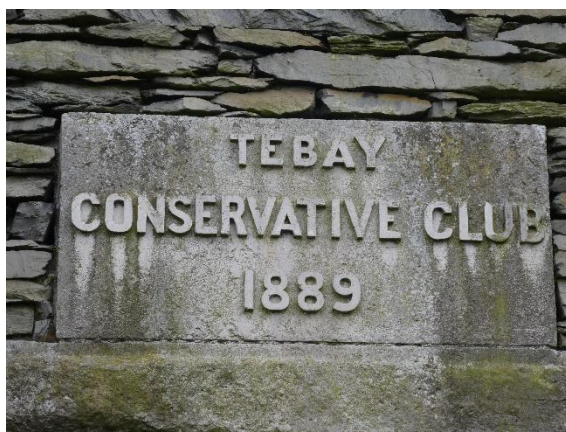
4.8 There are two further public buildings with date stones (see 3.28). There is a date on the former Conservative Club dated to 1889 (J074). The political club movement flourished from the mid-19<sup>th</sup> century until the early 20<sup>th</sup> century (Stevens, 2001). The clubs could vary from working men's clubs to constitutional clubs, and could offer a wider range of facilities. It is unclear what type of club there was in Tebay; it has been converted into a house. However, on the second edition map<sup>24</sup> it is labelled as a 'Reading Room'. J054 is inscribed with 'WESTMORLAND COUNTY COUNCIL / TEBAY POLICE STATION' and the date 1906. This is located on the road-facing side of the porch, on what is now a private house. The police station was formerly located in Orton (Tebay was once part of Orton parish), but due to the railway the population size of Tebay exceeded that of Orton, and was likely a factor in the relocation of the station.

Figure 7 Date stone (J074) of 1889 on the former Conservative Club.

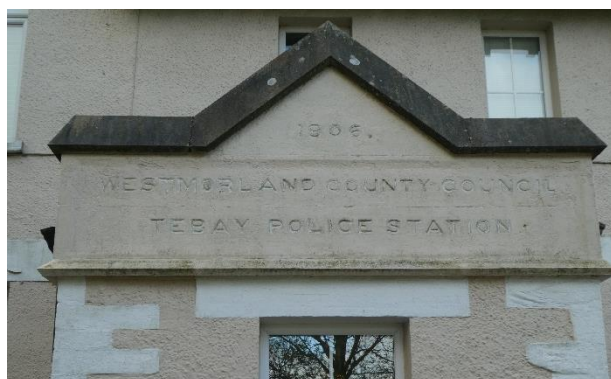
Figure 8 Date stone (J054) of 1906 on the former Police Station.

| Feature No. | Feature Type | Description | Condition | Threats | Photograph |
|---|---|---|---|---|---|
| J054 | Date Stone | Painted date stone inscribed with "1906" "WESTMORLAND COUNTY COUNCIL" "TEBAY POLICE STATION" over three lines at the top of porch on (what is now) a private house. Police Station shown on third edition 6" and 25" maps. | Good | Erosion | |

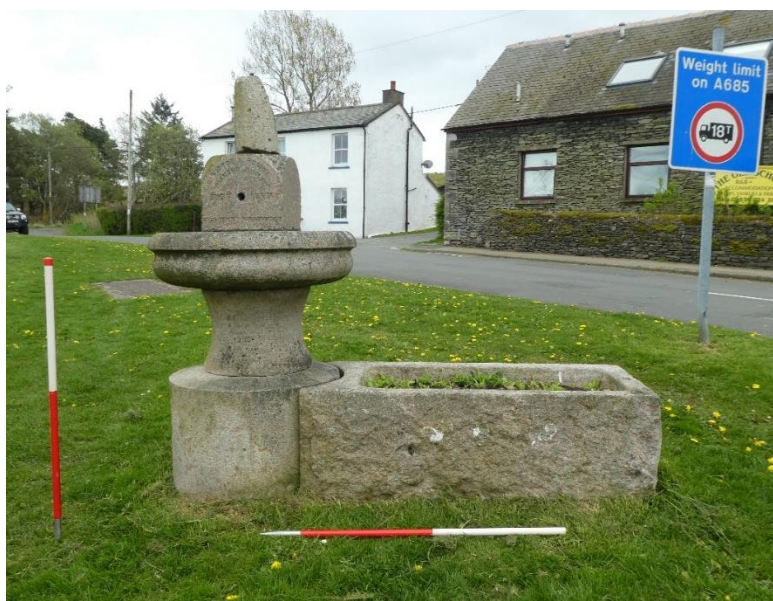
4.9 There are two memorials in Tebay. Firstly, a granite fountain (J072) that commemorates the Diamond Jubilee (1837 to 1897) of Queen Victoria, which was erected by subscription. The fountain itself is now broken, so it is unclear if there was anything sculptural on its top, however the base of the fountain (with inscription) and the attached trough survives. The fountain is located on an area of green in the 'centre' of Tebay, opposite the former school. It was likely erected following the second edition map revision, and therefore does not appear on a map until about 1913<sup>25</sup>, as a 'D. Fn. & Trough' (Drinking Fountain and Trough). Secondly, a Shap granite memorial stone (J079) with a plaque commemorating the workers who were killed maintaining the railway in 2004. It is located on Lunes Bridge.

Figure 9 Memorial fountain (J072) commemorating Queen Victoria's Diamond Jubilee.

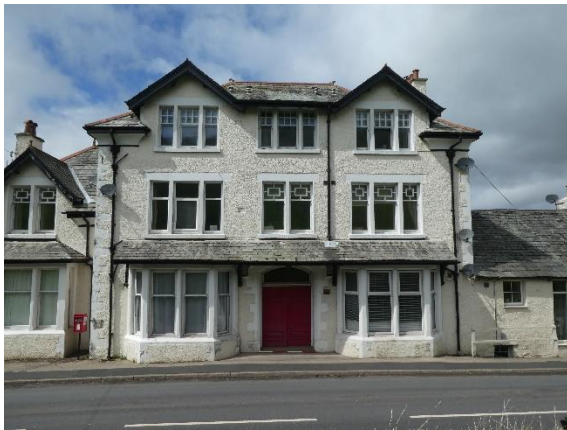
4.11 The Junction Hotel (see 3.24, J035) was recorded as part of this survey, as it was not on the HER and it had several small-scale heritage features on its roadside elevation. These included a lamp over the main door and decorated hoppers. The former hotel has since been converted into flats, but it does retain some of its original character. In addition to the features mentioned, some of the original window framework survives, along with a stained glass fanlight over the main door and decorated ridge tiles. The front elevation is symmetrical with an additional wing to the south in the same style, and a more vernacular wing to the north (that has a crow step gable; the “rear” of which shows a house). It is therefore possible that the more vernacular part preceded the hotel, which was built abutting the earlier structure. Map evidence shows that this was Dyke Beer House (see 3.25).

Figure 10 The front elevation of the former Junction Hotel.

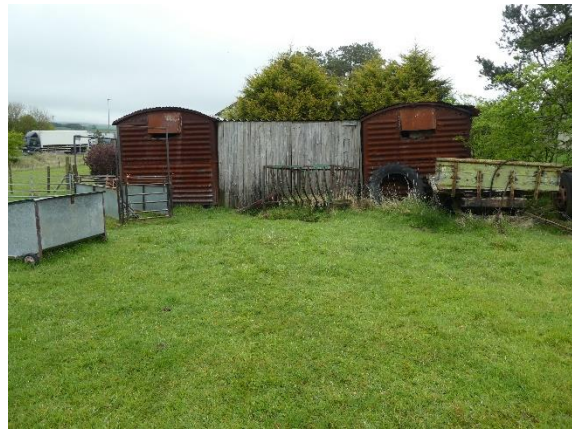
Figure 11 Former goods wagons, now used as outbuilding in field.

4.12 In one of the fields to the north of the village are two disused railway carriages (J016). They are joined by a wooden lean to and is used for storage. These goods wagons can be found around the countryside, being used as outbuildings in fields once they were obsolete. Although it is not clear if the goods wagons were used on

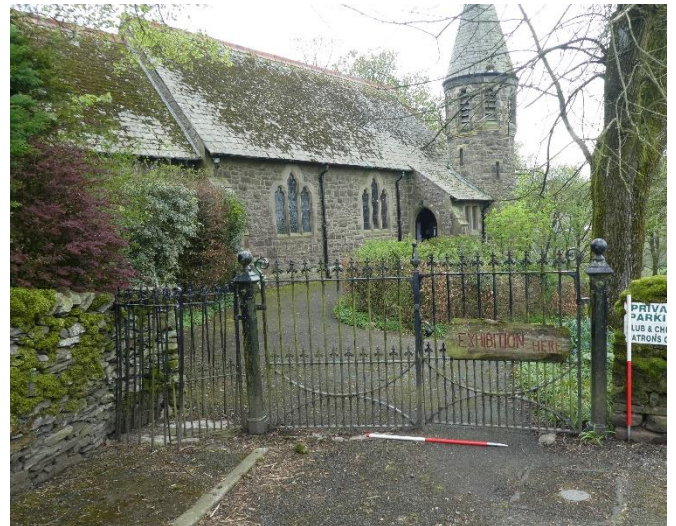
4.14 The gateway to St James' Church consists of cast iron double gates and a kissing gate (J012). It is reported that these were paid for by the railway workers (the church itself was paid for by donations, see 3.21; YDNPA 2023). The kissing gate is in a half-round design, with decorative finials on the rail and posts.

*Figure 12 Gates outside St James' Church.*

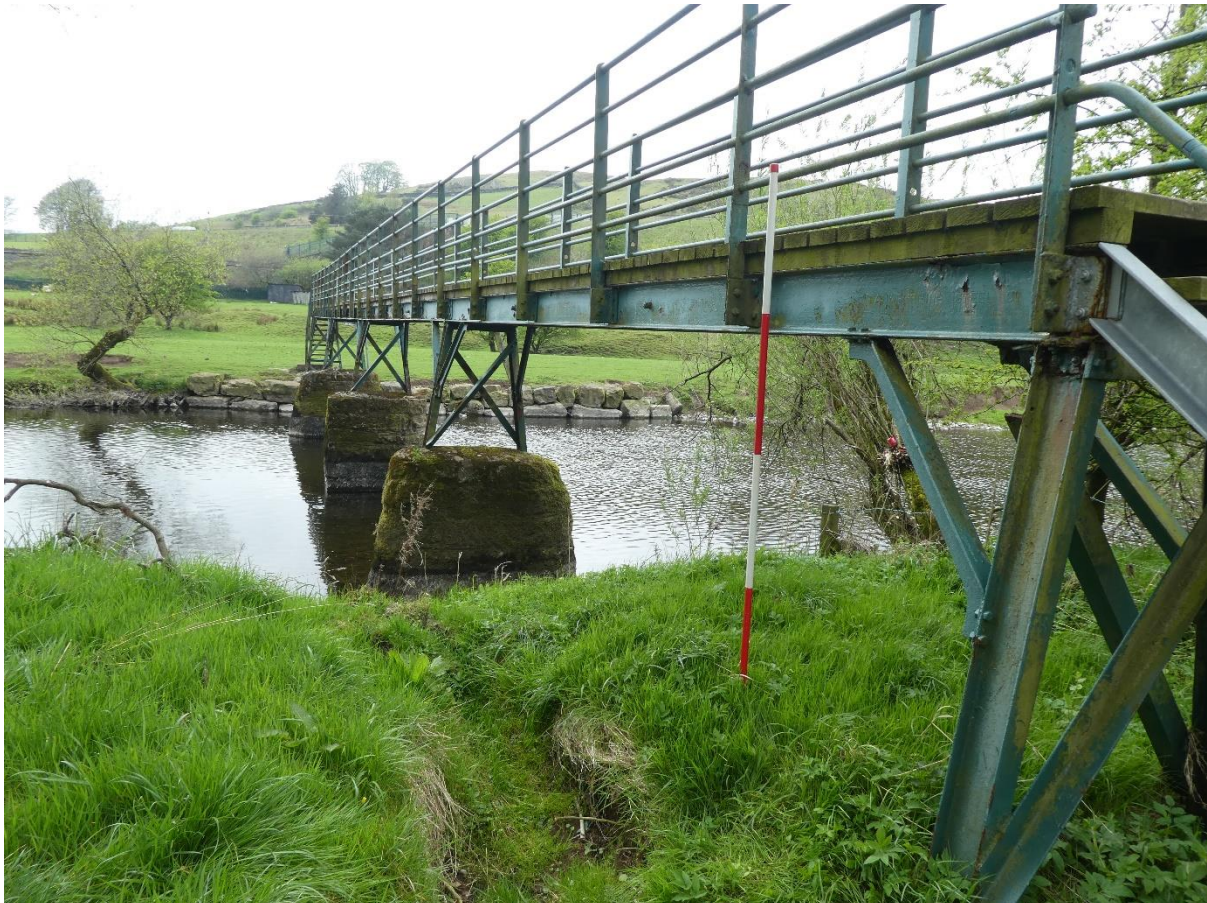
4.18 A steel footbridge (J010) on sandstone plinths crosses the River Lune. The girders forming the base of the bridge are stamped, and are from the Lanarkshire Steel Company (Scotland). There are metal railings, with curled ends at either side of the bridge. There was formerly a ford<sup>27</sup>, then stepping stones were added alongside<sup>28</sup>, which were replaced by a footbridge<sup>29</sup>. Prior to the metal bridge, a wooden bridge was erected to replace the stepping stones (Local resident per comms).

Figure 13 Footbridge (J010).

| Feature No. | Feature Type | Description | Condition | Threats | Photograph |
|---|---|---|---|---|---|
| J010 | Footbridge | Modern steel footbridge on sandstone plinths. Embossed wording is located on the metal girders and probably refers to the Lanarkshire Steel Co Ltd., but is unclear. Metal railings with curled ends at either side of bridge, 2 ends broken on east side, 1 end broken on west side. Steps replaced on east side, original remain on west. Ford and stepping stones marked on 25" OS map. Works were carried out to this footbridge following the survey. | Fair | Neglect, vegetation | |

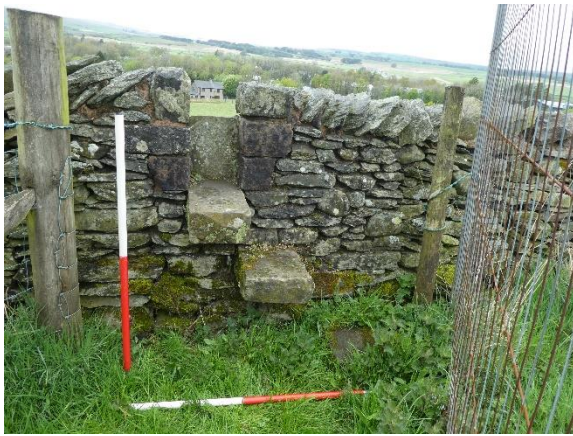
Figure 14 Step stile (J015).

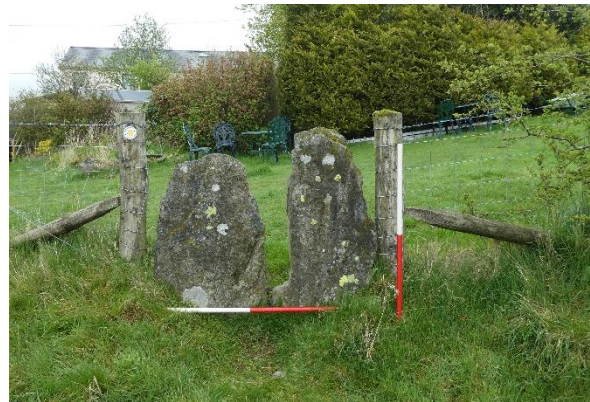
crossing surface, and the other (J078) has topstones of a shorter height. Both squeeze stiles (J017 and J061) are formed by two rough limestone slabs placed vertically.

Figure 15 Squeeze stile (J017).

| Feature No. | Feature Type | Description | Condition | Threats | Photograph |
|---|---|---|---|---|---|
| J017 | Squeeze Stile | Two rough limestone slabs (orthostats) placed vertically creating squeeze stile located on PROW. Situated in post and wire fence. | Good | Erosion, replacement | |

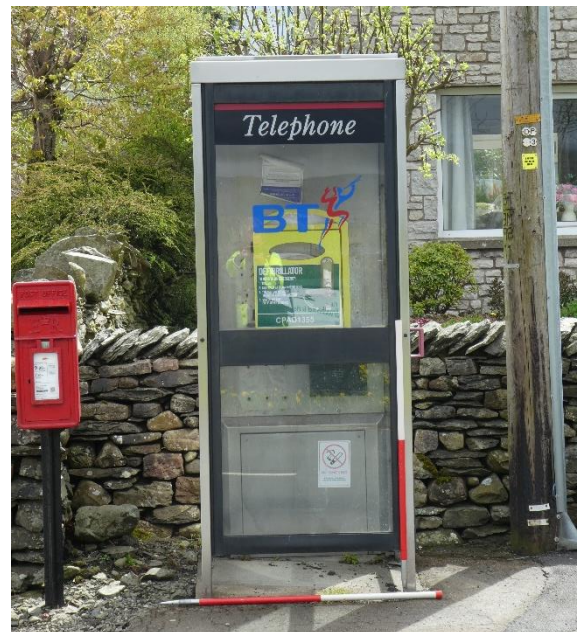
4.20 Three BT telephone boxes (J003, J028 and J046) can be found in Tebay and Old Tebay. They are all of the KX100 series and date from 1991 to 2003, indicated by the new 'Piper' logo that introduced a red moulded handle (The Telephone Box, 2023). It consists of a stainless steel back panel, with the other three sides glass separated by a small plastic panel, one of which has the moulded plastic handle. They have all been repurposed to hold a defibrillator.

Figure 16 Telephone kiosk (J028) situated in Old Tebay. Letter box (J029) is situated to its right.

| Feature No. | Feature Type | Description | Condition | Threats | Photograph |
|---|---|---|---|---|---|
| J028 | Telephone Box (former) | BT telephone box (KX100 series, post 1991 date), now repurposed to hold a defibrillator. Back panel is stainless steel; other three sides of the box are glass separated by a small plastic panel with a moulded plastic handle. Located next to letter box (J029). | Good | Removal | |

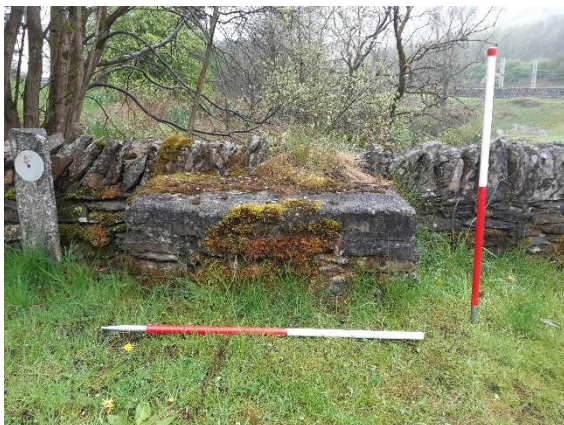
4.23 Two churn stands are located on or nearby to Lunes Bridge (see 3.14). The churn stand located on the bridge itself (J076) dates to when the road over this bridge was in use. It is constructed of stone, with a concrete top. Churn stand J080 likely replaced J076 when the A685 was rerouted over the Roger Howe Bridge (built by 1970). This churn stand has a larger capacity, and also has a lower platform on one side. It is also constructed from stone with a scree top, and the taller platform has a metal band around its top edge. Churn stands typically fell out of use in the 1970s when milk was collected by tanker (instead of by milk cart/lorry), therefore J080 was likely not used for long.

Figure 17 Churn stand (J076) located on the former Lunes Bridge.

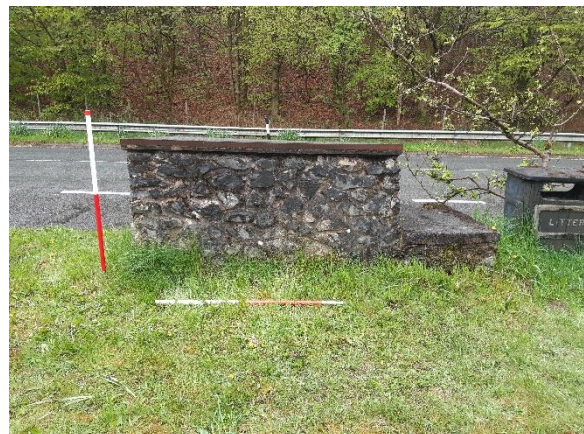
Figure 18 Churn Stand (J080) located on A685 roadside.

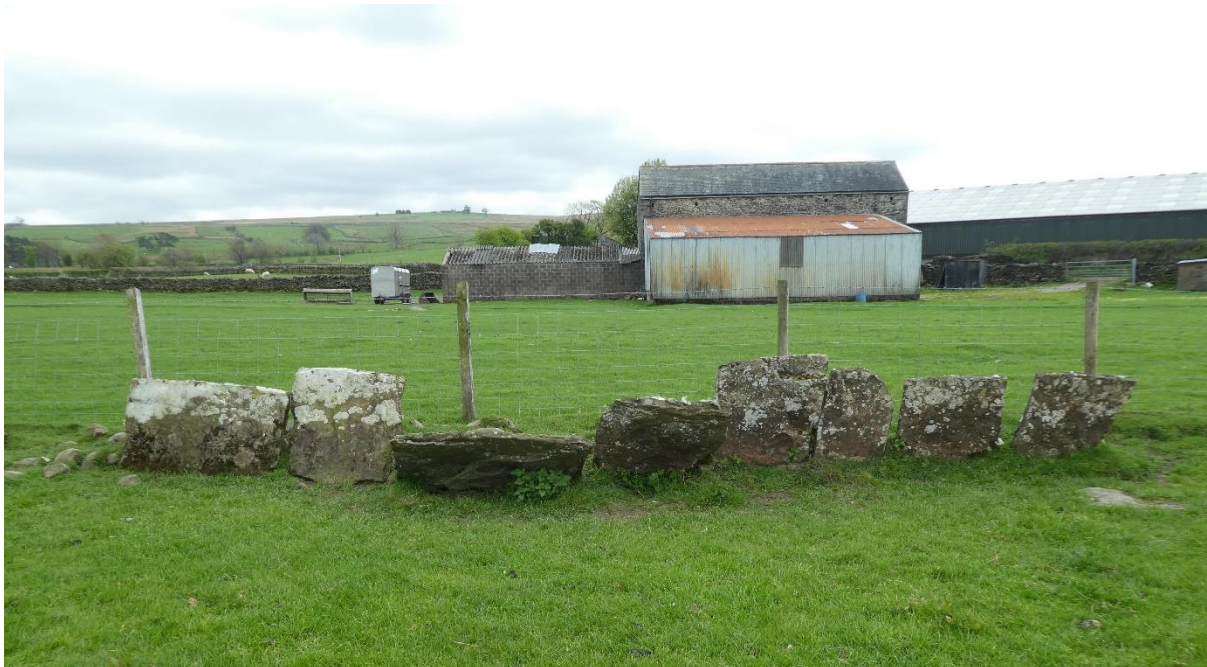
4.26 A section of walling was also surveyed (J064). This comprised of around 24 vertical slabs (in two groupings) running in a line, which would have formed a former boundary. They appear to be Silurian rocks, either mudstones or siltstones. The stones are not very high, so would therefore have limited stock proof function. It also survives in poor condition, with some stones tilting and/or broken. It is now situated next to a post and wire fence. This vertical slab wall type is not common in the Westmorland Dales, however similar walls can be found in the Lake District, especially around Coniston, Hawkshead and Ambleside (Conservation Handbook 2023). A field boundary on this line is visible from the first edition six-inch OS map, first surveyed in 1858<sup>30</sup>.

*Figure 19 Vertical slab wall (J064) situated in a field on the outskirts of Old Tebay.*

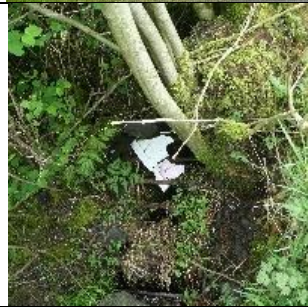
| Feature No. | Feature Type | Description | Condition | Threats | Photograph |
|---|---|---|---|---|---|
| J040 | Culvert | Culvert for watercourse (Tebay Gill?), metal bars over opening. | Fair | Vegetation; flooding | |

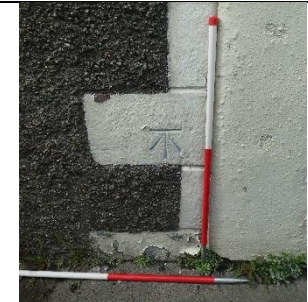
| Feature No. | Feature Type | Description | Condition | Threats | Photograph |
|---|---|---|---|---|---|
| J053 | OS Bench Mark | OS bench mark located on quoin of private house, painted white. Shown on historic OS maps. | Good | Erosion | |
