# **Archaeological Investigation of a Sow Kiln at Pendragon Castle, Mallerstang, Cumbria**

**Project Code PC19**

Report no. 4/2020

For the Yorkshire Dales National Park Authority

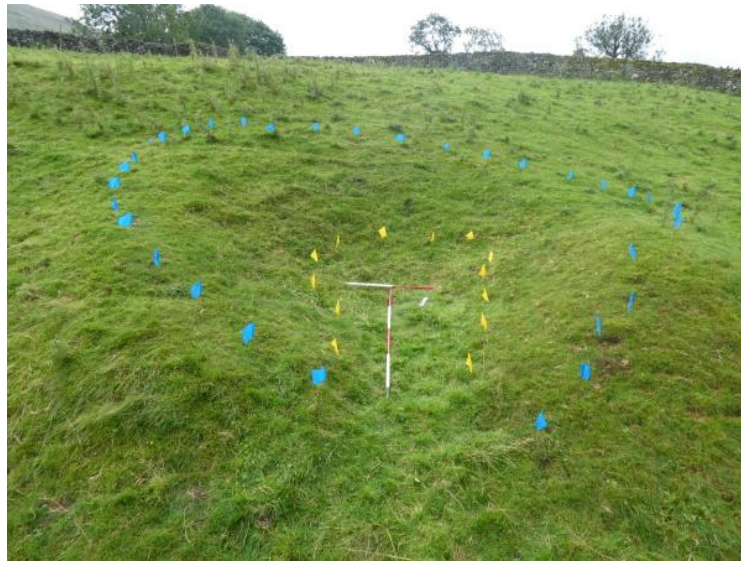
*Fig. 3 The earthwork prior to excavation*

Prior to excavation the pit or bowl extended c. 4.5m in length, north-south, from the rear rim of the pit to the mid point of the frontal channel (Fig. 3). It extends c. 3.3m in width from rim to rim. The frontal channel was estimated prior to excavation at c. 1.5m in length, north-south, by c.1m in width, east-west. Internal depth at the centre of the pit, measured from the turf layer to the height of the rim, was 800mm. It is stressed that these dimensions were estimates only as whatever structural form the feature has was masked by the turf layer.

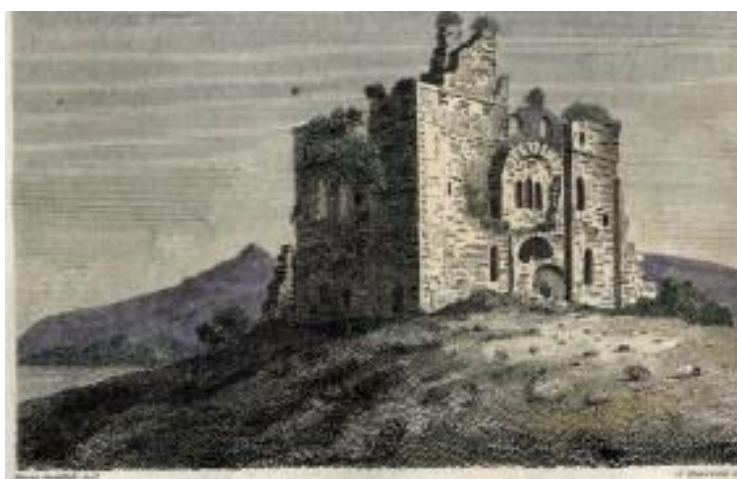
*Fig. 6 Thomas Pennant's depiction of Pendragon, 1773*

The antiquarian and botanist Thomas Pennant passed through Mallerstang in 1773 on his journey from Downing, his home in North Wales, to Alston Moor. He described the castle as a 'small but strong square building, with great marks of age on all of its parts ... of vast thickness, and with rudeness enough for an early period' (Fig. 6) (Pennant 1801, 131-32). Of this, there is no dispute. He went on to write '... it was burnt in an inroad of the Scots about the year 1341, it was restored and sunk again in that of 1541 it having, as the inscription informs us, lain ruinous from that year to 1660 ...' (ibid 133). Sadly, he did not reproduce the inscription and provided no evidence for his latter statement.

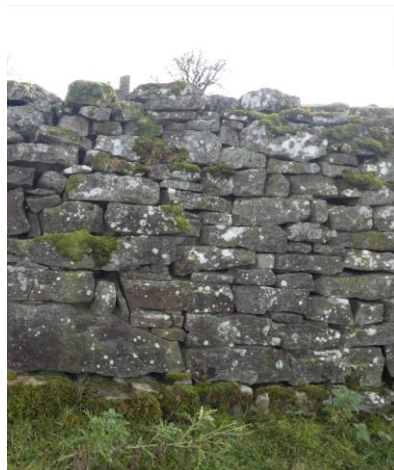
*Fig. 8 A length of wall with straight sides, flat topstones, a plinth and a blocky nature*

Ten quarters translates into a height of 2.3m (7 ft 5 in.) for her curtilage wall and 90 roods to a total length of 453m (495 yds). This writer and his partner, who is an accepted authority on early stone tooling and building styles, examined all the boundary walls in October 2019 with the intention of determining not only their total length but also looking for evidence in the walls that they were all of one build and not modern (ie post-1750) walls. Using a long tape measure, the total length of the boundary walls – bounding Tommy Road and the main valley road as far as the cross wall down to the river south of the castle, along that wall and the now ruinous wall along the riverside all the way to Castle Bridge – was determined as 524m. However, when the length of the set of building earthworks either side of the standing and later field barn is deducted from this total, the actual length of wall is 470m, less than 20m longer than what Lady Anne’s diary stated: 17m – or 2½ roods – for a wall of this length is not a statistically significant discrepancy. It was determined that all of the boundary walls share common characteristics though only one short section, just north of the gate into the castle precinct, meets Lady Anne’s ‘10 quarters’ height figure. It is clear from close examination that most of the walls have been reduced in height. Significant sections still retain topstones laid flat, have straight rather than battered sides, are composed of blocky stone, have a width at the top of 700mm, and evidence of a plinth, all of which are typical of pre-1750 walls (Fig. 8).

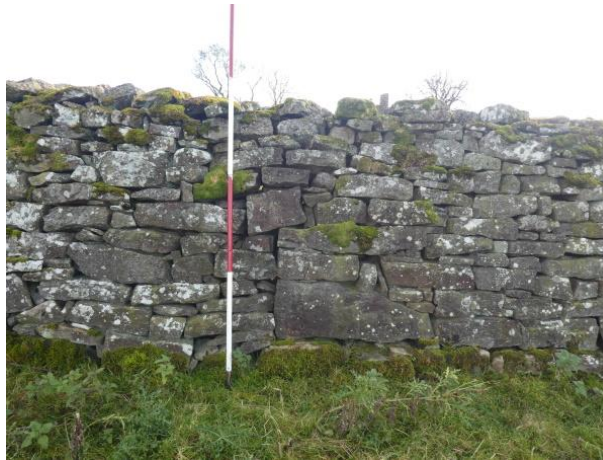
*Fig. 9 The straight joint in the dividing wall, right of the ranging pole, showing the difference in stone type and characteristics either side*

The wall joining the river with the main road, south of the castle, has a corner where both walls are tied in to each other, thus erected at the same time. Similarly, the internal dividing wall north of the castle is tied into the boundary wall alongside Tommy Road. Close examination of this wall shows that the first 2.2m from the roadside wall are much older than the next 5.8m which contains sub-rounded stone of different geology from the shorter section. The remainder of the wall – 54m in length – is the same as the 2.2m. At the point 8m from the (east) wall junction there is a very clear wallhead (Fig. 9); at 2.2m there is a possible wallhead.

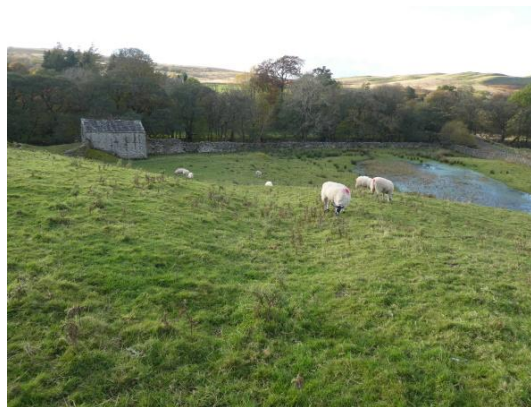
*Fig. 10 The trackway, looking towards the earthworks to the right of the later barn*

It can be concluded that there had been a gateway 5.8m wide allowing access from the castle to the lower, northern part of the curtilage. It is relevant to add that the clear sunken trackway (Fig. 10), rising from the set of earthworks north of the barn, peters out opposite the former gateway which suggests that these long linear earthworks were the 'Stable and Coachouse' built at Lady Anne's behest. What was not immediately apparent, however, was whether or not the walls had been built 'with Lime and Stone', though it is common to find mortar used as an externally-invisible internal binding agent rather than as external pointing. Two gaps in the roadside wall, at the time of the excavation of the sow kiln, provided the means of examining the interior of the wall. In a very small gap a few metres to the north of the entry gate it is possible to see into the centre of the wall either side of the gap: no lime mortar at all was apparent. A long gap, a few metres south of the gate, has a spread of stone from the wall scattered into the field though the gap itself had been 'singled up'. Several pieces of lime mortar were evident among this spread (Fig. 11). If these two short sections are at all typical of the entire precinct wall, it can only be concluded that the wall builders largely ignored Lady Anne's orders as the amount of lime mortar noted was less than minimal.

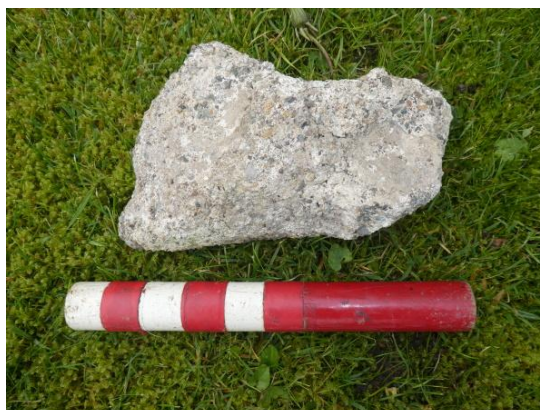
*Fig. 11 A piece of lime mortar, full of inclusions, from within Lady Anne's 90-rood wall (200mm scale).*

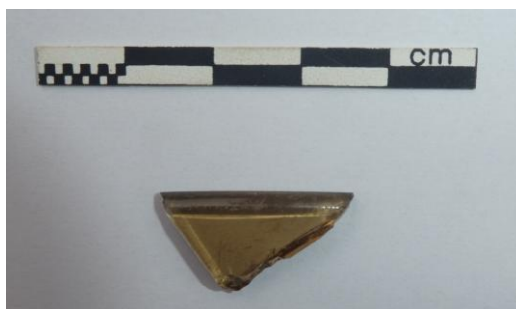
*Fig. 15 Rf 111, façon de Venise vessel fragment*

A single, relatively thick, upright rim fragment was submitted for comment. It came from a secondary fill (107) of the sow kiln. The colourless metal has a distinctive brownish tinge typical of Venetian *cristallo* glass, or glass made elsewhere in Europe in the Venetian manner (*façon de Venise*) (Charleston 1975, 205) and is clearly of good quality (Fig. 15).

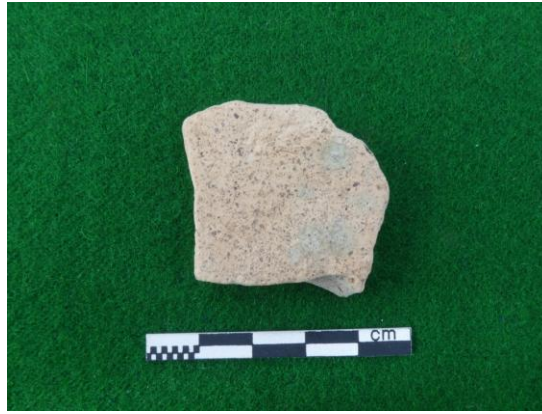
*Fig. 16 Rf 119, base sherd with olive-green glaze*

Rf 119, from Context 113 (lower primary backfill), is a sherd of reduction-fired buff gritty fabric with splashes of green glaze (Fig. 16). This sherd similarly fits into the thirteenth to sixteenth century date range.

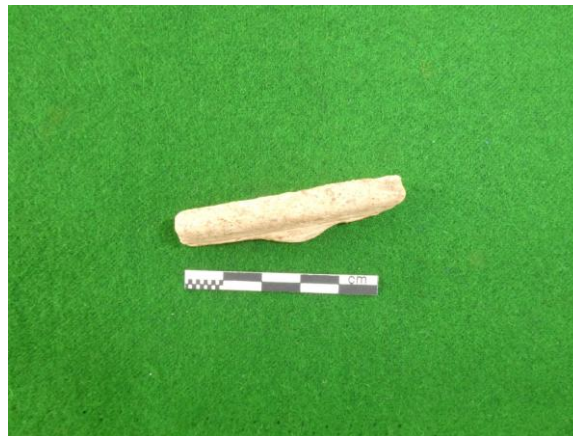
*Fig. 17 Rf 122, unglazed rim sherd of jar or cook pot*

Rf 122, also from Context 113, is a portion of the rim of a vessel of oxidised gritty ware which had a maximum diameter of 110mm (Fig. 17). It is unglazed. This sherd has a tighter date range, specifically twelfth or thirteenth century.

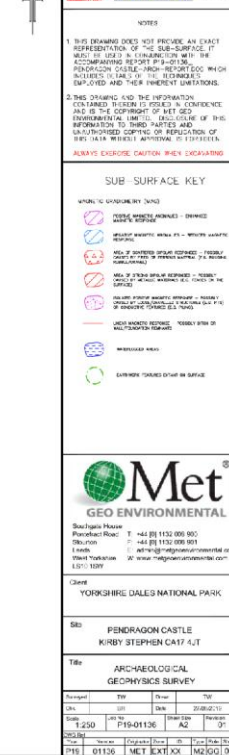
Key to Figure 2, top to bottom

- Purple hatching – positive magnetic anomalies
- Blue hatching – negative magnetic anomalies
- Orange triangles – area of scattered dipolar responses
- Red hatching – area of strong dipolar responses
- Purple dots – isolated dipolar responses
- Red line – linear magnetic response
- Blue stippling – waterlogged area
- Green – earthwork features
