# Small-Scale Heritage Features Survey

Technical Report: Crosby Garrett  
November 2023

WESTMORLAND DALES

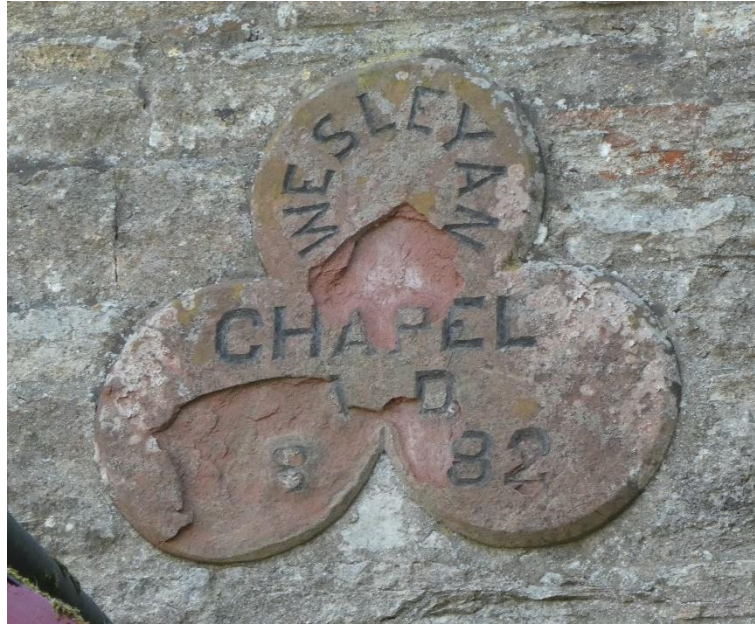
4.6 Feature C003 is a sandstone date stone in a trefoil shape and is located above the porch of the Wesleyan Methodist Chapel (MYD69745). The trefoil shape is often associated with churches and Christianity as the three interlocking circles are used to represent the Holy Trinity.

*Figure 4: Image showing trefoil date stone on the Wesleyan Methodist Chapel*

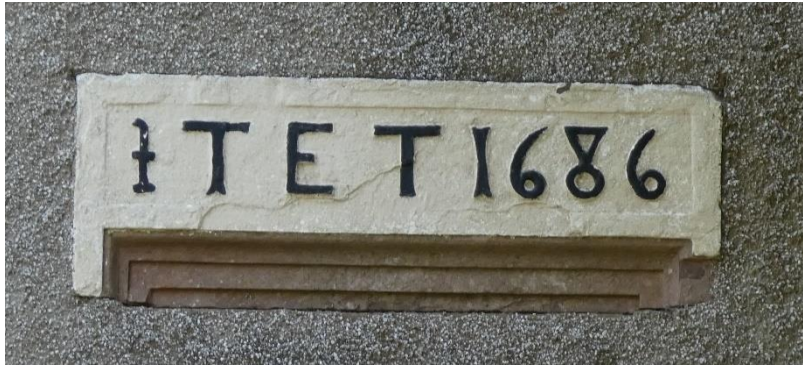
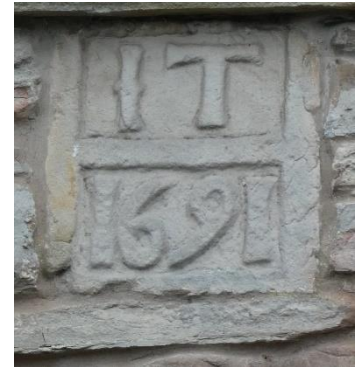
4.7 Four of the dates stones within the village have letters on them, which likely commemorate the owner or occupant. The oldest of these is feature C006d (Figure 5) which has the date 1686 on it along with the letters “ITET” and possibly refers to John and Elizabeth Taylor (Turnbull 2008, Ancestry 2022). The stone was been relocated from either The Limes or an adjoining property before it was added to the current extension.

4.8 A smaller date stone C062a (Figure 5) also possibly links to the Taylor family, with the letters “IT” carved in relief with the date “1691” below it; this possibly refers to John Taylor (John and Elizabeth’s son). The stone is situated above a former doorway, now window.

Figure 5: Image showing two dates stones identified in Crosby Garrett. Left 1686 date stone (C006d) possibly refers to John and Elizabeth Taylor. Right 1691 date stone (C062a) possibly referring to John Taylor.

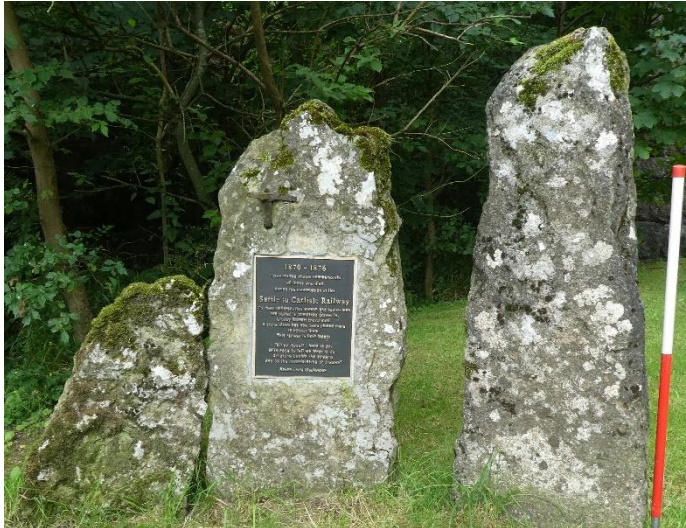
4.11 The second memorial - C074 - comprises three limestone gate stoops (Figure 7) and is located on the north side of the viaduct, to the south of the village. A plaque is attached on the centre stoop and includes an extract from the poem - The Land of Nod - by Robert Louis Stephenson.

Figure 7: Image showing the memorial to the railway workers located to the north side of the viaduct.

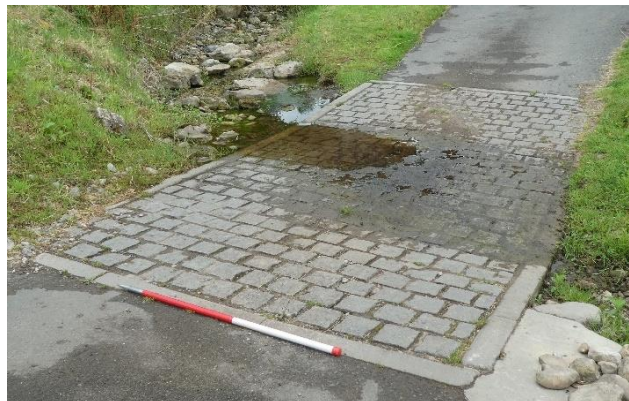
4.20 Two fords were recorded as part of the survey, one of which is shown on the historic OS maps and one which is not. The ford that is shown on the map – C026 – is at the north end of the village. The historic maps show two fords in the area, one of these now seems to have been turned into a formal bridge. The second ford – C071 – is located to the south of the village and is not shown on the maps, suggesting it has developed more recently.

4.21 Both the fords have been reinforced, now being set with modern granite stone-sets and curbing (Figure 11).

*Figure 11: Ford to the south of the village (C071) showing the modern stone-sets and curbing.*

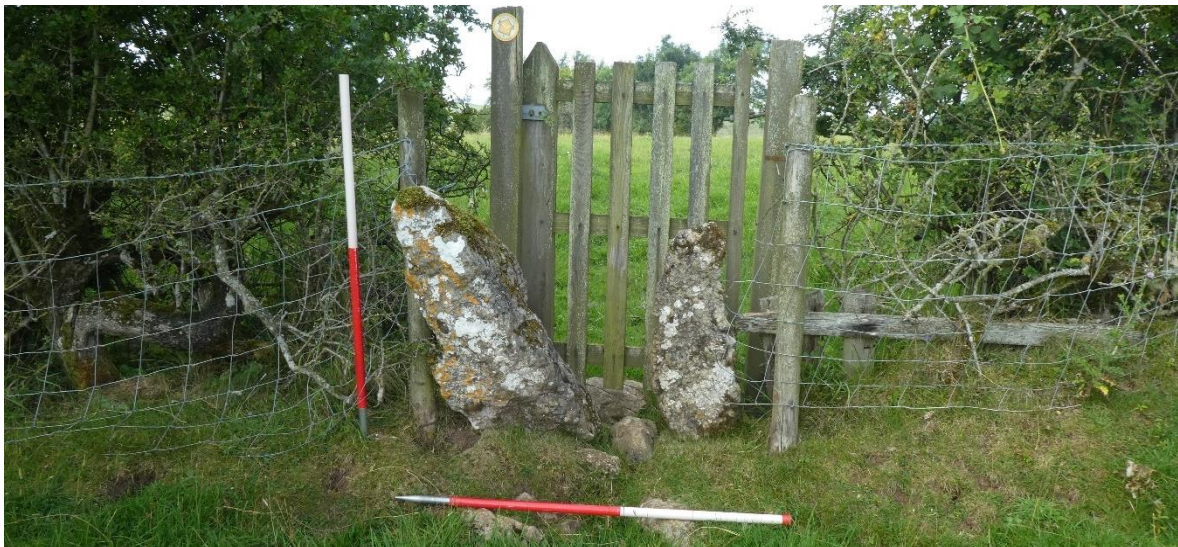
4.34 Stile C102 is created from two slabs of limestone (pavement) that have been

*Figure 15: Image showing a limestone squeeze stile with the hedgerow and bank on either side.*

placed together to form a “V” shaped squeeze stile (Figure 15). The design of this style is more rudimentary than the other squeeze stiles (which are created from a gap being built into the wall), suggesting it might be older.

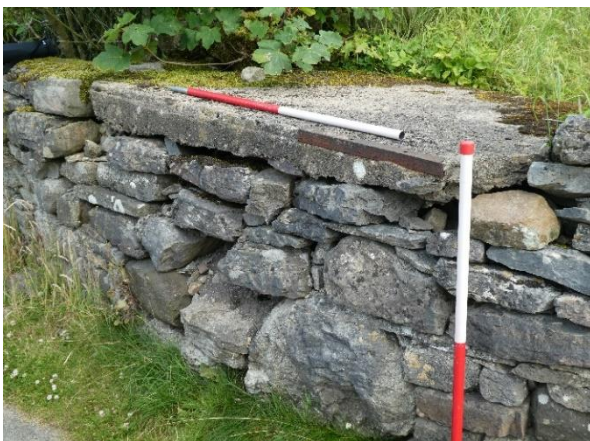
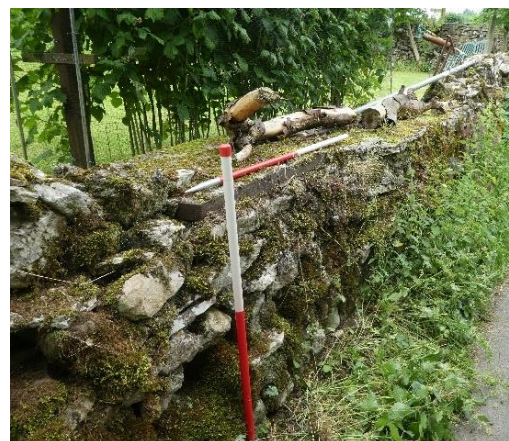
4.41 Six churn stands were recorded within the village, which is significantly more than in other villages. The churn stands recorded take two main forms, those that are part of a dry stone wall (C018 and C042, Figure 17) and those that are ‘free standing’ (C041, C051, C061, C078). The wall forms demonstrate how existing features around the village were utilised and adapted to serve a dual purpose. All the churn stands recorded are associated with former farmsteads or farm buildings, a majority of which have since been converted into private residence.

Figure 17: Image showing two churn stands built into two different walls - left C018, right C042.

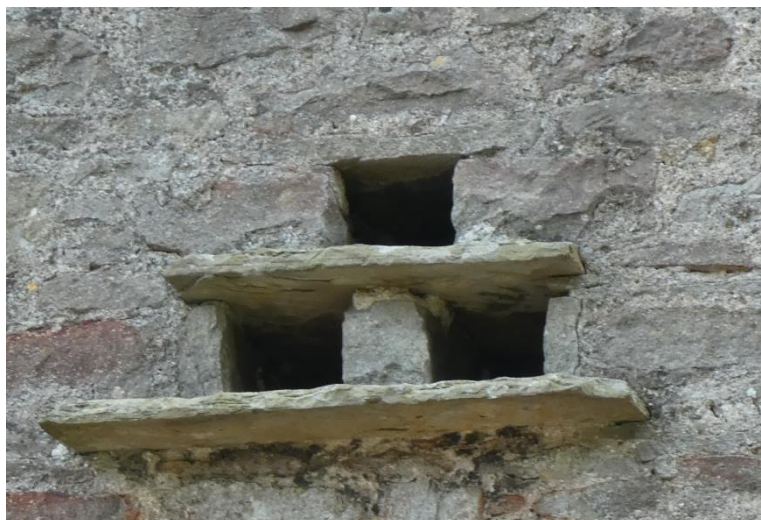
4.45 Dovecote C020 (Figure 18) is made up of three-square holes with sills in a triangular formation and is located in the gable end of a former stables (MYD64468; 1145023). The stables are thought to date from the 18<sup>th</sup> century (also see paragraph 4.13, feature C034) and are associated with the Old Rectory (MYD66012; 1145022). The inclusion of the dovecote in a building associated with a rectory is not unusual as they were often a way of showing status, as well as the dove being a bird highly associated with Christianity.

*Figure 18: Image showing dovecote C020.*

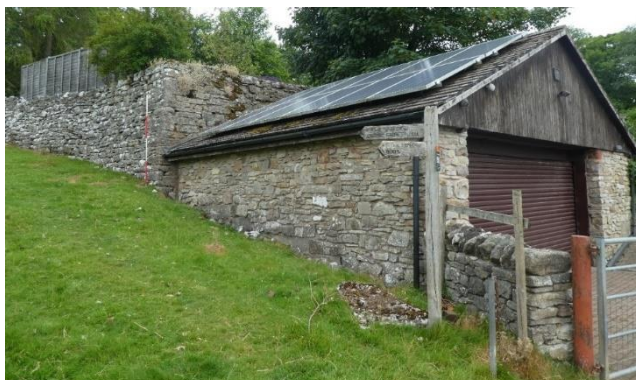
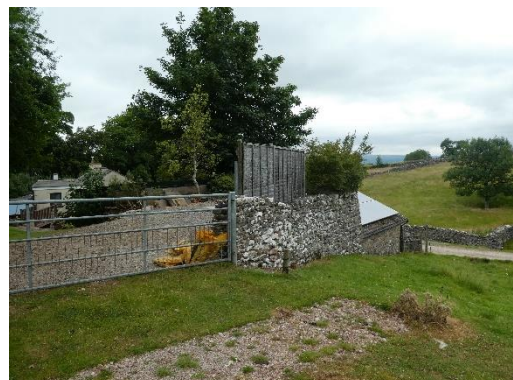
Figure 20: Image showing feature C084, the former "Gill Cottage Limekiln" labelled on the 25" OS maps, it currently has a garage built over the draw/front face.

4.49 During the survey, the lime kiln to the south of Gill Cottage on the map was identified (C084). The kiln currently has a garage built onto the draw/front face, and the top of the lime kiln is now part of a private garden (Figure 20).

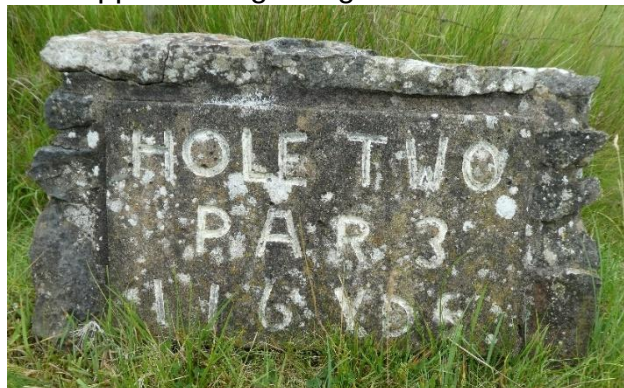
4.52 One of the most unusual finds discovered during the survey was a golf course fairway marker (C085, Figure 23) located on Crosby Garrett Fell. Additionally, a semi-levelled platform created from mixed limestone and sandstone revetment (C089, Figure 24) was also recorded and appears one of the golf courses 'greens'.

*Figure 24: Feature C085, a golf course fairway marker located on Crosby Garrett Fell.*

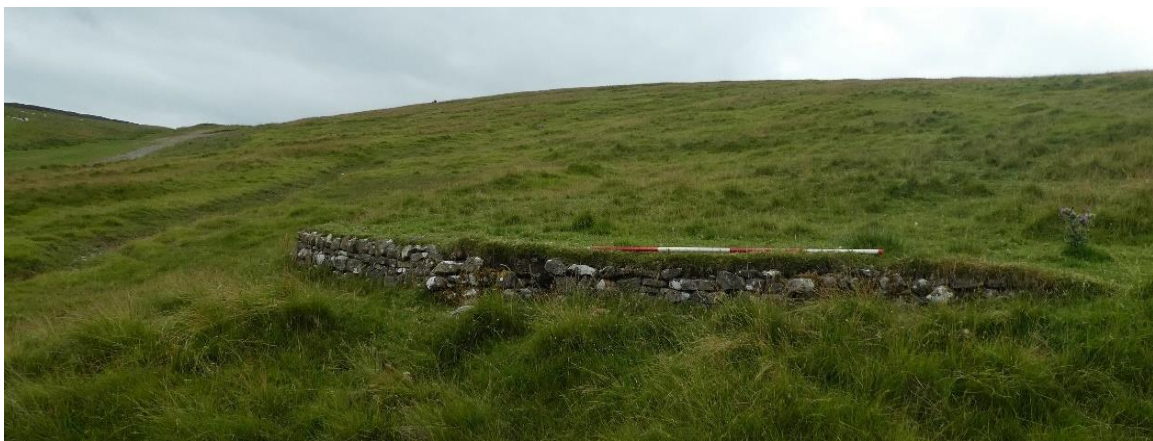
*Figure 23: The semi-levelled stone platform (C089) built into the side of the fell and probably associated with the golf course.*

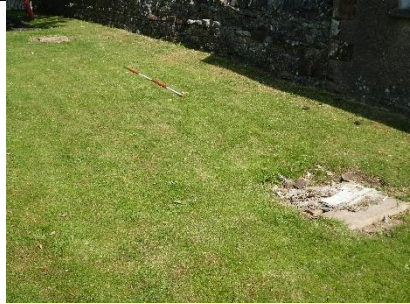
| Feature No. | Feature Type | Description | Condition | Threats | Photograph |
|---|---|---|---|---|---|
| C001 | Quoit Squares | Two areas covered by wood and concrete located on the play area by the Village Hall (former school) used for playing quoits. Probably installed for the silver Jubilee of Queen Elizabeth II. | Fair | Erosion; removal | |

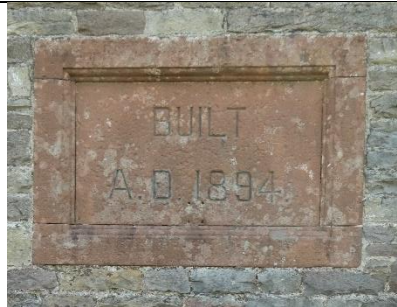
| Feature No. | Feature Type | Description | Condition | Threats | Photograph |
|---|---|---|---|---|---|
| C002a | Date Stone | Sandstone date stone inscribed with "BUILT A.D. 1894" located on the side of the former school (C002b). | Good | Erosion | |

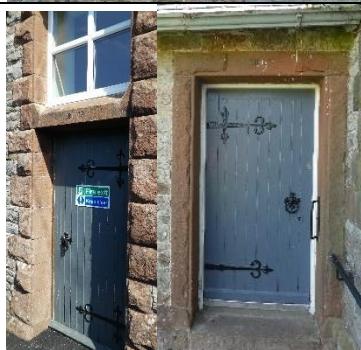
| Feature No. | Feature Type | Description | Condition | Threats | Photograph |
|---|---|---|---|---|---|
| C002b | School | School marked on historic 6" and 25" OS Maps. The building has two entrances with "BOYS" inscribed on the lintel on the south facing porch and "GIRLS" inscribed on the lintel on the west facing porch entrance, with a date stone (C002a) on the west facing elevation. Building now used as the Village Hall. | Good | Erosion | |

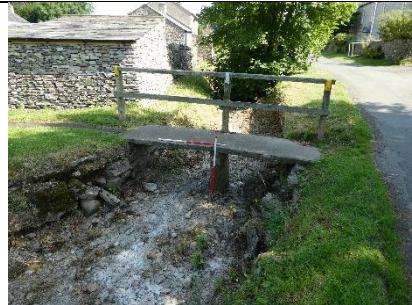
| Feature No. | Feature Type | Description | Condition | Threats | Photograph |
|---|---|---|---|---|---|
| C004 | Clapper Bridge | Footbridge marked on 25" OS map. Clapper bridge over Crosby Garrett Beck made of two sandstone slabs with metal staples in the centre, with a sandstone upright acting as support. Additional newer wooden rail along one side. | Good | Erosion; flooding | |

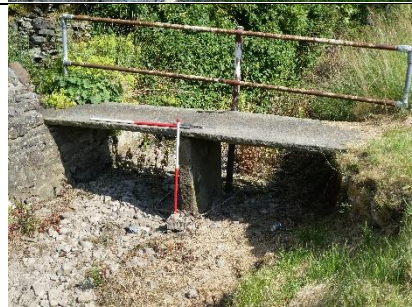
| Feature No. | Feature Type | Description | Condition | Threats | Photograph |
|---|---|---|---|---|---|
| C005 | Clapper Bridge | Foot bridge marked on 25" OS map. Clapper bridge over Crosby Garrett Beck made up of two sandstone slabs with metal staples in the centre, with a sandstone upright acting as support. Wall on western bank and revetment on eastern bank with modern metal hand rail on one side. | Good | Erosion; flooding | |

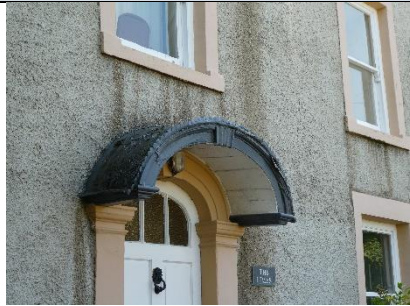
| Feature No. | Feature Type | Description | Condition | Threats | Photograph |
|---|---|---|---|---|---|
| C006a | Canopy Porch | Wooden canopy porch painted grey above the door on the front of The Limes (private house). | Good | Erosion | |

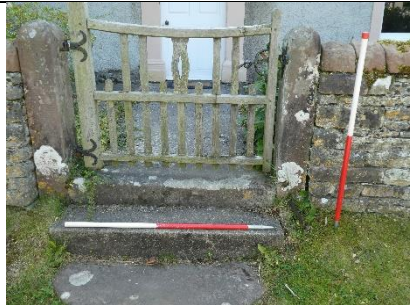
| Feature No. | Feature Type | Description | Condition | Threats | Photograph |
|---|---|---|---|---|---|
| C006b | Gate Stoops (Pair) | Pair of sandstone gate stoops with curved pyramidal tops. Two hinges on left stoop and catch on right stoop; wooden gate attached. Located at the garden entrance to The Limes (private house). | Good | Erosion; removal | |

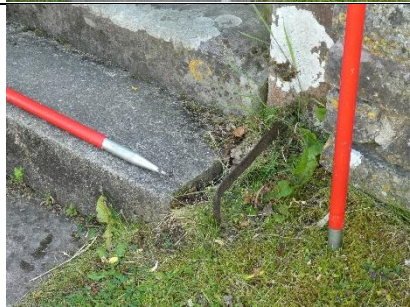
| Feature No. | Feature Type | Description | Condition | Threats | Photograph |
|---|---|---|---|---|---|
| C006c | Boot Scraper | Iron boot scraper painted black, located and attached to the base of the right gate stoop (C006b). Located outside The Limes (private house). | Good | Erosion | |

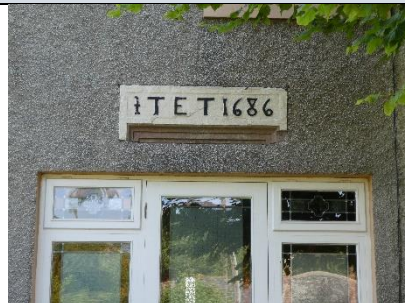
| Feature No. | Feature Type | Description | Condition | Threats | Photograph |
|---|---|---|---|---|---|
| C006d | Date Stone | Date stone (including part of the former moulding) painted white with letters and date "ITET 1686" painted black. Stone repositioned above the window on the extension to The Limes (private house). The letters probably refer to John and Elizabeth Taylor. | Good | Erosion | |

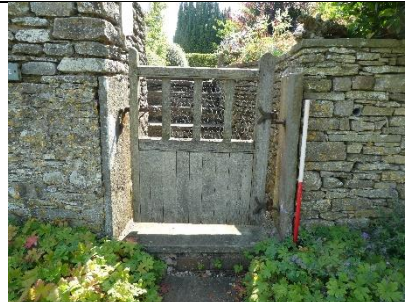
| Feature No. | Feature Type | Description | Condition | Threats | Photograph |
|---|---|---|---|---|---|
| C007 | Gate Stoops (Pair) | Pair of thin sandstone gate stoops leading to private residence. Left stoop built into the wall with square top and metal gate catch on the inside face. The right stoop has a square top and two hinges on the inside face with gate attached. The right stoop has some cracking at the top and base of the stoop is broken and out of alignment. Metal work on stoops and gate is decorative. | Fair | Erosion | |

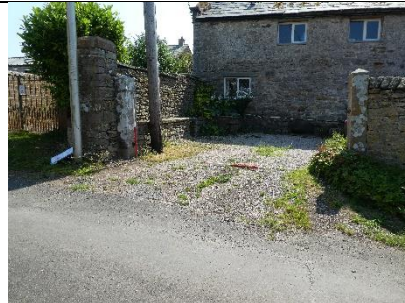
| Feature No. | Feature Type | Description | Condition | Threats | Photograph |
|---|---|---|---|---|---|
| C008 | Gate Stoops (Pair) | Pair of limestone(?) gate stoops with pyramidal tops. Left stoop has two hinges (one broken) on the inside face, with some damage near the top that has been infilled with mortar. Right stoop has gate catch on the inside face with some chipping on one corner. Located outside of former Baptist Chapel (now private residence) as shown on historic maps. | Fair | Erosion; vehicles | |

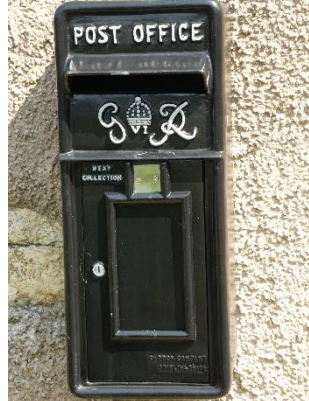
| Feature No. | Feature Type | Description | Condition | Threats | Photograph |
|---|---|---|---|---|---|
| C009 | Letter Box | Decommissioned letter box probably not from Crosby Garrett but reused/positioned from elsewhere. The letter box is metal and painted black, "POST OFFICE" is embossed and painted white at the top of the box, with the G VI R insignia directly below the opening and also painted white. "NEXT COLLECTION" is embossed and painted white next to the former 'day' token. Letter box located on the gable end of Hill Top Cottage. | Good | Removal | |

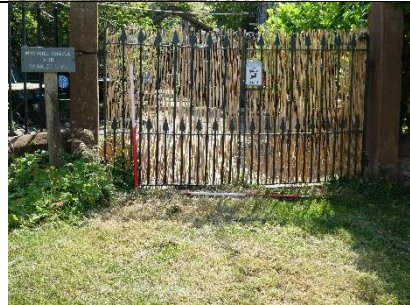
| Feature No. | Feature Type | Description | Condition | Threats | Photograph |
|---|---|---|---|---|---|
| C010 | Gate Stoops (Pair) | Baptist Chapel marked on the historic 6" and 25" OS maps, now a private residence. A pair of sandstone gate stoops with rounded tops, located outside the entrance to the building. The left stoop has two hinges on the inside face with a metal gate attached, a bad crack runs horizontally through the top third of the stoop. The right stoop has two hinges on the inside face with gate attached. | Fair | Erosion; vehicles | |

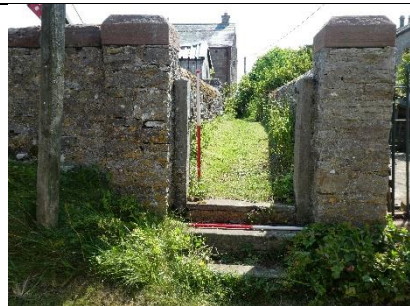
| Feature No. | Feature Type | Description | Condition | Threats | Photograph |
|---|---|---|---|---|---|
| C011 | Gate Stoops (Pair) | Pair of thin limestone gate stoops with flat shaped tops located at entrance to PROW leading to the former back lane. The left stoop has a gate catch on the inside face; the right stoop has two hinges on the inside face and the stoop has been fixed to the wall with concrete. Three limestone steps lead up to the gateway. Wall piers with dressed sandstone tops on either side of stoops. | Good | Erosion | |

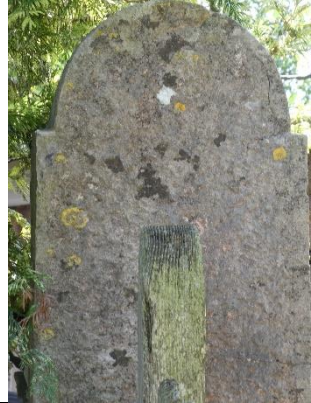
| Feature No. | Feature Type | Description | Condition | Threats | Photograph |
|---|---|---|---|---|---|
| C013 | Gate Stoop (Single) | Single sandstone gate stoop with a rounded top and shoulders in front of private residence. Two hinges attached to the inside face with gate attached. A small crack at the top of the stoop. | Good | Erosion; vegetation | |

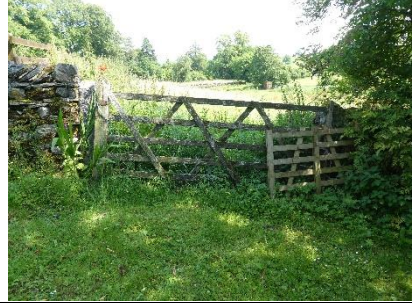
| Feature No. | Feature Type | Description | Condition | Threats | Photograph |
|---|---|---|---|---|---|
| C014 | Gate Stoops (Pair) | Pair of limestone gate stoops, with rounded tops and shoulders. Left stoop has gate catch and right stoop has two hinges. Right stoop likely moved/repositioned. Wooden gate placed in front of stoops (not clear if attached to the stoops). Both stoops covered in vegetation and lead to fields. | Good | Erosion; vegetation; removal | |

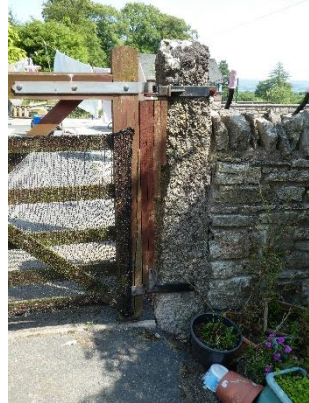
| Feature No. | Feature Type | Description | Condition | Threats | Photograph |
|---|---|---|---|---|---|
| C015 | Gate Stoop (Single) | Single limestone gate stoop which tapers. Located on the right side of the gateway to a garden entrance of a converted barn (MYD66009, now private residence). Two metal hinge brackets attached to the stoop with newer gate attached. | Good | Erosion; vehicles; removal | |

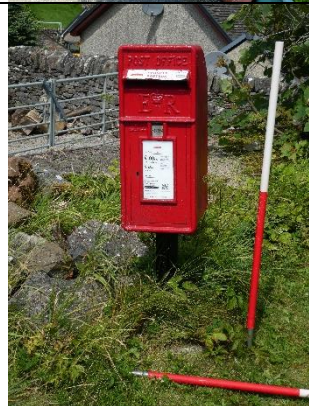
| Feature No. | Feature Type | Description | Condition | Threats | Photograph |
|---|---|---|---|---|---|
| C016 | Letter Box | Metal ER II letter box painted red and situated on a black metal pole. "POST OFFICE" is embossed above the opening with "E II R" and the crown insignia below the opening. "NEXT COLLECTION" is embossed to the left of the day token. Letter box is situated outside the current Post Office and was made a priority box during the Covid-19 pandemic. | Good | Vehicles, removal | |

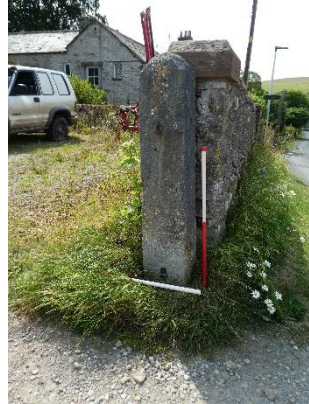
| Feature No. | Feature Type | Description | Condition | Threats | Photograph |
|---|---|---|---|---|---|
| C017 | Gate Stoop (Single) | Single limestone gate stoop on the right side of gateway to private residence/Post Office (former farmstead (MYD66009) and bank barn (MYD63038)). Stoop has a rounded top, with one hinge at the top and one broken hinge at the base. Matching gate stoop laid on floor close by. | Good | Erosion; removal | |

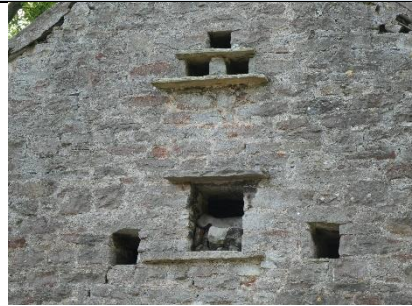
| Feature No. | Feature Type | Description | Condition | Threats | Photograph |
|---|---|---|---|---|---|
| C020 | Dovecote | Dovecote located at the top off former stables (MYD64468; 1145023 part of The Rectory, see MYD66012; 1145022). Dovecote made up of three square holes in a triangular formation all with sills. An owl hole with a lintel and sill is located below the dovecote, four putlog ventilation holes are on either side of the owl hole. | Good | Erosion | |

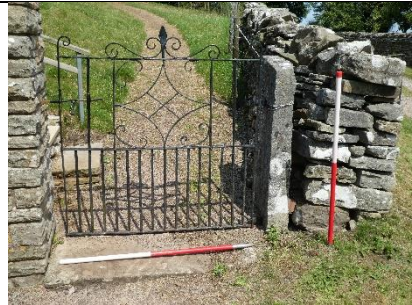
| Feature No. | Feature Type | Description | Condition | Threats | Photograph |
|---|---|---|---|---|---|
| C021 | Gate Stoop (Single) | Single limestone gate stoop on the right of gateway entrance to St Andrew's Church. Stoop has two hinges on the inside face and metal gate attached. | Good | Erosion | |

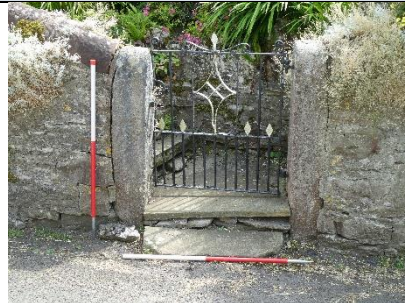
| Feature No. | Feature Type | Description | Condition | Threats | Photograph |
|---|---|---|---|---|---|
| C023 | Gate Stoops (Pair) | Pair of limestone gate stoops with rounded tops at entrance to Rose Cottage garden (private residence). Left stoop has quarry marks and metal catch with recess on inside face. Right stoop has two hinges and metal gate attached on the inside face. Both stoops mortared into the wall surrounding the garden, some vehicle damage. | Good | Vehicles | |

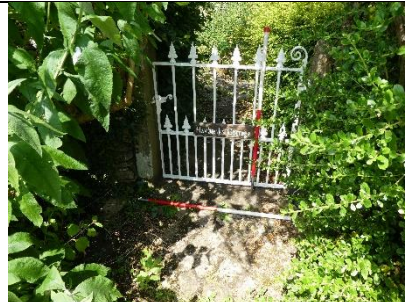
| Feature No. | Feature Type | Description | Condition | Threats | Photograph |
|---|---|---|---|---|---|
| C024 | Gate Stoops (Pair) | Pair of unmatched sandstone gate stoops at entrance to Haybanks Cottage (private residence). Left stoop is sandstone with a rounded top, a gate catch on the inside face and a hole below it. The right stoop is limestone with a crudely rounded top, and a hinge on the inside face. | Good | Erosion; vegetation | |

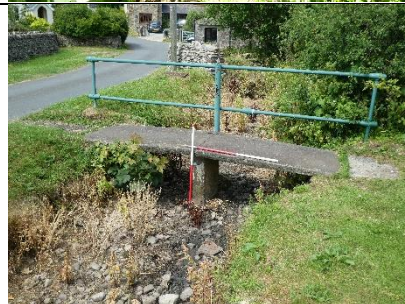
| Feature No. | Feature Type | Description | Condition | Threats | Photograph |
|---|---|---|---|---|---|
| C025 | Clapper Bridge | Foot bridge marked on the 6" and 25" OS map. Clapper bridge over Crosby Garrett Beck made up of two sandstone slabs with metal staples in the centre, and one limestone(?) flag stone adjacent to the main slabs. One sandstone upright acting as support beneath the bridge. Additional newer metal handrail painted green along one side. | Good | Flooding; Erosion | |

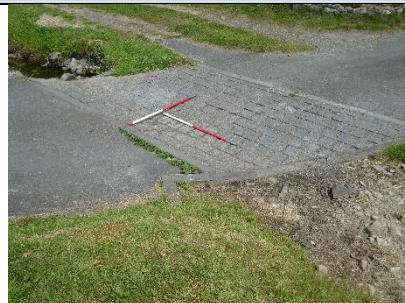
| Feature No. | Feature Type | Description | Condition | Threats | Photograph |
|---|---|---|---|---|---|
| C026 | Ford | Ford marked on historic 6" and 25" OS map. Ford allows vehicles to cross Crosby Garrett Beck. Surface newly re-laid with granite(?) stone setts and curbing. | Good | Flooding; vehicles | |

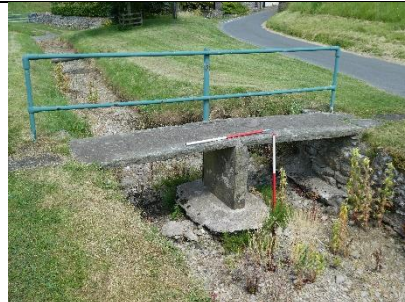
| Feature No. | Feature Type | Description | Condition | Threats | Photograph |
|---|---|---|---|---|---|
| C027 | Clapper Bridge | Foot bridge marked on 6" and 25" OS map. Clapper bridge over Crosby Garrett Beck made up of two slabs of sandstone with metal staples in the centre. One sandstone upright acting as support beneath bridge. Stone revetment on both sides of the beck, with two flags adjacent on eastern side. Additional metal handrail painted green along one side, rail is rusting and corroded. | Good | Flooding; erosion | |

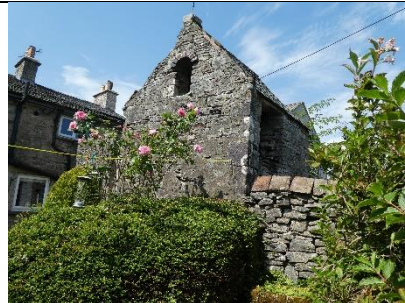
| Feature No. | Feature Type | Description | Condition | Threats | Photograph |
|---|---|---|---|---|---|
| C028 | Dovecote | A former agricultural building known locally as a dovecote located at the back of Hill House (former farmstead MYD66010). Opening on the east gable end of former barn created from a bricked arched voussoir opening, opening also on the north elevation. Spike for former weather vane located above opening on the ridge stone. | Fair | Erosion; collapse | |

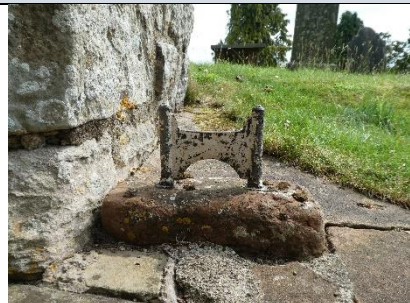
| Feature No. | Feature Type | Description | Condition | Threats | Photograph |
|---|---|---|---|---|---|
| C029 | Boot Scraper | Metal boot scraper in H shape, leaded into a sandstone block on the right hand entrance to the porch of St Andrew's Church (MYD62384). Possibly had finials on the ends (now removed/broken). Previously painted black, paint now flaking. | Fair | Erosion; deterioration; removal | |

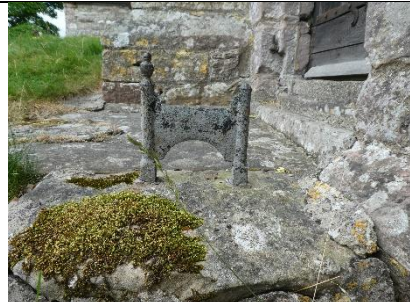
| Feature No. | Feature Type | Description | Condition | Threats | Photograph |
|---|---|---|---|---|---|
| C030 | Boot Scraper | Metal boot scraper in H shape with one finial on the top outside edge (finial on inside edge probably broken off). Scraper is leaded into the stone outside the priests' door of St Andrew's Church (MYD62384). Previously painted black, paint now flaking. | Fair | Erosion; deterioration; removal | |

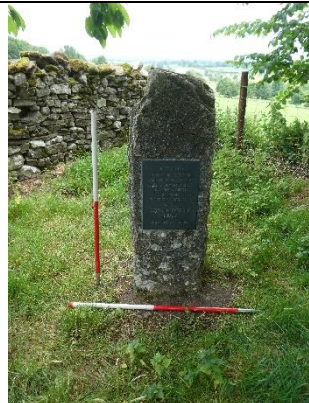
| Feature No. | Feature Type | Description | Condition | Threats | Photograph |
|---|---|---|---|---|---|
| C031 | Memorial | Single limestone gate stoop with a former hinge on bottom left, acting as a memorial to the railway workers and families buried in unmarked grave in St Andrew's Churchyard. Memorial erected in 2019, with a second memorial (C074) situated near the railway viaduct. | Good | Removal | |

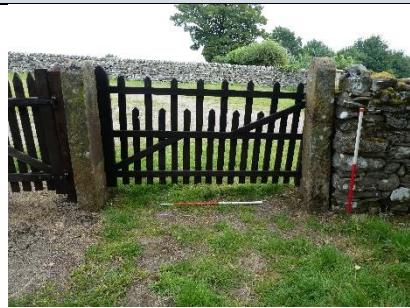
| Feature No. | Feature Type | Description | Condition | Threats | Photograph |
|---|---|---|---|---|---|
| C032 | Gate Stoops (Pair) | Pair of sandstone gate stoops with rounded tops, some tooling marks visible. Right stoop has a lead hole on the inside face and chain around the top; left stoop has two metal hinges. Gate way leading to car park. | Good | Erosion | |

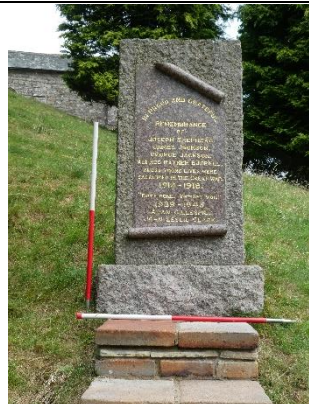
| Feature No. | Feature Type | Description | Condition | Threats | Photograph |
|---|---|---|---|---|---|
| C033 | Memorial | Shap granite memorial to those who died in the First and Second World Wars. Memorial situated in the lower end of St Andrew's Churchyard on a plinth. Stone has a scroll relief carving that has been polished with inscribed text on the front that is inlaid with gold leaf. Steps leading up to memorial from pathway. | Good | Erosion | |

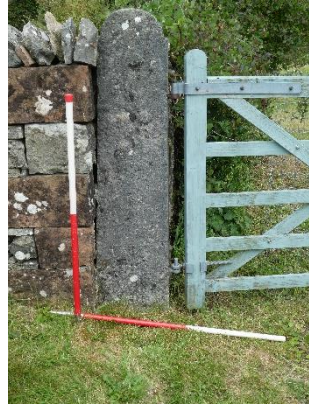
| Feature No. | Feature Type | Description | Condition | Threats | Photograph |
|---|---|---|---|---|---|
| C035 | Gate Stoop (Single) | Single limestone(?) gate stoop with curved tops and shoulders on the left side of gateway to fields. Three broken hinges on front face with two leaded hinge on inside face, with wooden gate attached. | Good | Erosion | |

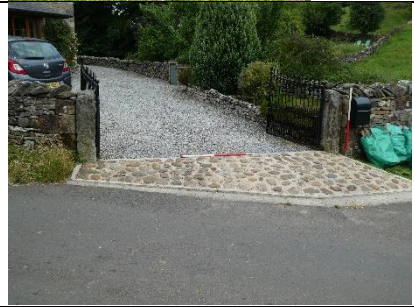
| Feature No. | Feature Type | Description | Condition | Threats | Photograph |
|---|---|---|---|---|---|
| C036 | Gate Stoops (Pair) | Pair of rough limestone gate stoops, left stoop has two hinges with metal gate attached, one hinge not in use and one leaded area (probably for a former hinge). Right stoop has two hinges with metal gate attached. Wall probably has some reused stone. Located on driveway to private residence. | Good | Erosion; vehicles | |

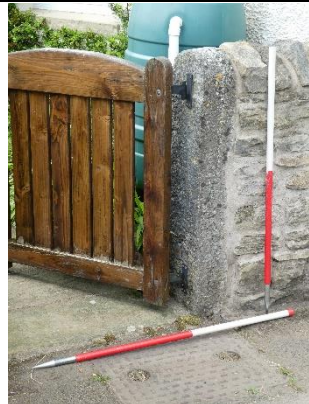
| Feature No. | Feature Type | Description | Condition | Threats | Photograph |
|---|---|---|---|---|---|
| C037 | Gate Stoop (Single) | Single limestone gate stoop with curved top, newer hinges on metal plates screwed into wall. At entrance to private house. | Good | Vehicles | |

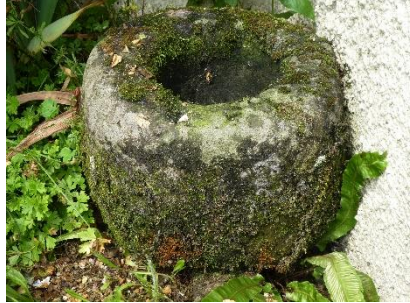
| Feature No. | Feature Type | Description | Condition | Threats | Photograph |
|---|---|---|---|---|---|
| C038 | Plague Stone | Limestone block with rounded sides and hollowed out in the centre, reportedly found in a wall. It is now located in a private garden. The stone is covered in moss and no inscriptions were visible. Probably a plague stone. | Good | Vegetation; removal | |

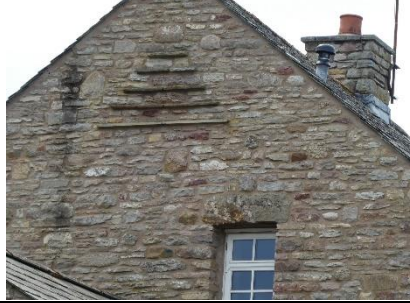
| Feature No. | Feature Type | Description | Condition | Threats | Photograph |
|---|---|---|---|---|---|
| C040 | Dovecote | Rebuilt possible former dovecote on the gable end of a converted former farm building. | Fair | | |

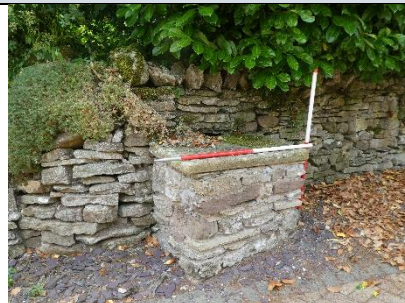
| Feature No. | Feature Type | Description | Condition | Threats | Photograph |
|---|---|---|---|---|---|
| C041 | Churn Stand | Possible bink (a bench/seat commonly found near a door, may be associated with domestic cheese making) or churn stand located outside a former linear farmstead (MYD66015), opposite the cart entrance. Likely for domestic use. Made from a mixture of limestone and sandstone blocks with a sandstone slab top, probably been rebuilt/mortared more recently. | Fair | Vehicles; removal | |

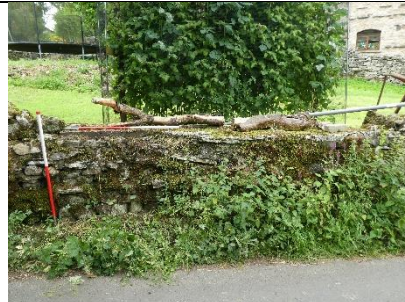
| Feature No. | Feature Type | Description | Condition | Threats | Photograph |
|---|---|---|---|---|---|
| C042 | Churn Stand | Concrete aggregate slab placed on a mixed limestone and sandstone wall for use as a churn stand. Metal strap/bracket with rivets around the slab on the left end, an indentation on the right side suggesting it possibly had a metal strap/bracket in the past. The slab is in a state of disrepair with cracks and some breakage, with vegetation on the verge to the front. Probably used by Mains Farm (MYD66014 and MYD66015) | Poor | Vehicles; vegetation; erosion; neglect | |

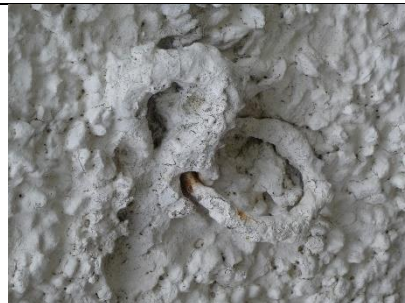
| Feature No. | Feature Type | Description | Condition | Threats | Photograph |
|---|---|---|---|---|---|
| C043 | Tie Ring | Metal horse tie ring located on the back entrance to Rose Cottage, to the left of the gate. Ring and fixture covered in the same render as the building. | Poor | Removal; vehicles; render | |

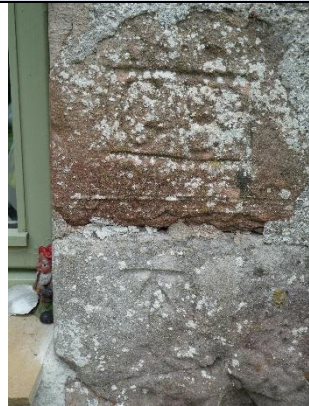
| Feature No. | Feature Type | Description | Condition | Threats | Photograph |
|---|---|---|---|---|---|
| C044 | OS Bench Mark | OS bench mark and letters “GB” inscribed onto two sandstone quoins of former doorway (now window) on the front face of former barn (now a private residence, MYD66008). Letters ‘GB’ inscribed on the top quoin with a line above and below the letters. On the quoin below is an unusually small bench mark symbol. Bench mark not shown on historic maps suggesting the quoin has been reused from elsewhere. | Good | Erosion | |

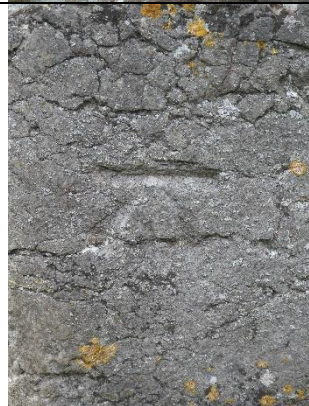
| Feature No. | Feature Type | Description | Condition | Threats | Photograph |
|---|---|---|---|---|---|
| C045 | OS Bench Mark | OS bench mark shown on historic 6” and 25 “OS maps. Mark is unusually small and inscribed on the second quoin from the base on the west face of barn (left side). Top horizontal incision deeper and more visible than vertical lines. | Fair | Vehicle; erosion | |

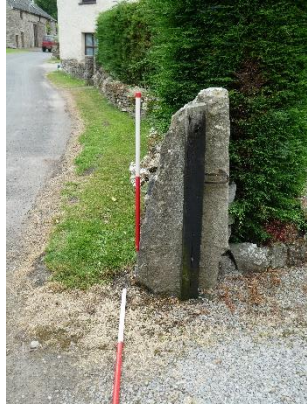
| Feature No. | Feature Type | Description | Condition | Threats | Photograph |
|---|---|---|---|---|---|
| C046 | Gate Stoop (Single) | Single thin rough limestone gate stoop on the left side of gateway entrance to private house, top is broken. Bolt fixing stoop and wooden gate post together. | Good | Vehicle; erosion | |

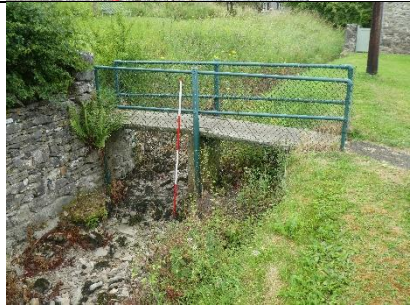
| Feature No. | Feature Type | Description | Condition | Threats | Photograph |
|---|---|---|---|---|---|
| C047 | Clapper Bridge | Footbridge possibly shown on the 25" OS maps. Clapper bridge over Crosby Garrett Beck, made from two sandstone slabs with metal staples in the centre and three bolts on the northern side. Sandstone upright beneath slabs acting as support. Metal railings with metal wire fencing on both sides of bridge with stone revetment on both sides of the Beck. | Good | Erosions; Flooding | |

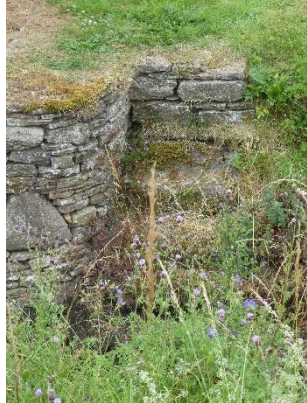
| Feature No. | Feature Type | Description | Condition | Threats | Photograph |
|---|---|---|---|---|---|
| C049 | Steps | Four limestone steps (potentially five in the past) built into the bank leading down to Crosby Garrett Beck located to the left of Becksides Barn. Nothing shown on historic mapping. Purpose unknown. | Poor | Vegetation; neglect | |

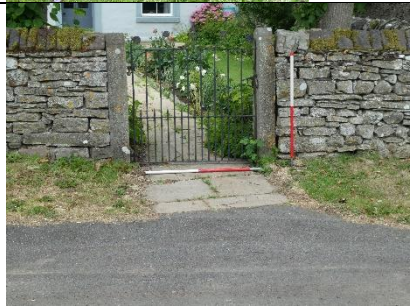
| Feature No. | Feature Type | Description | Condition | Threats | Photograph |
|---|---|---|---|---|---|
| C050 | Gate Stoop (Single) | Single limestone gate stoop with rounded top and shoulders located on the right side of gateway to private residence (MYD6606). Stoops profile is inscribed on the inside face about 3 cm away from edge and two metal hinges on the inside face. Stoop on the left is a concrete replica. | Good | Erosion | |

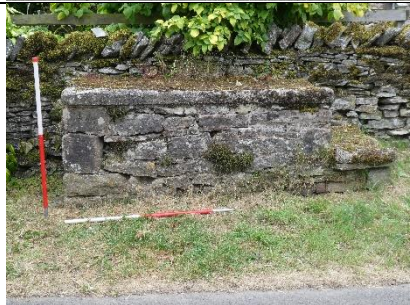
| Feature No. | Feature Type | Description | Condition | Threats | Photograph |
|---|---|---|---|---|---|
| C051 | Churn Stand | Churn stand (MYD64427), with a step on the right side and concrete aggregate on the top. Stand made predominantly from limestone. | Good | Vegetation; vehicles | |

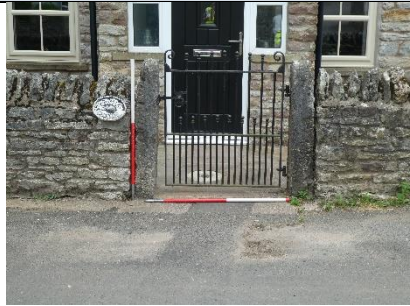
| Feature No. | Feature Type | Description | Condition | Threats | Photograph |
|---|---|---|---|---|---|
| C052 | Gate Stoops (Pair) | Pair of limestone gate stoops located outside of private house with curved tops, left stoop has metal gate catch on the inside face and some damage to rear face. Right stoop has two metal hinges on the inside face with gate attached and broken hinge at the top. | Fair | Erosion; vehicles | |

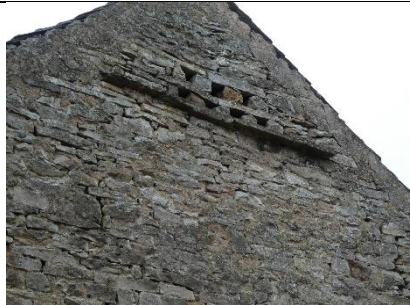
| Feature No. | Feature Type | Description | Condition | Threats | Photograph |
|---|---|---|---|---|---|
| C053 | Dovecote | Dovecote located on the gable end of building. Dovecote made up of two rows, bottom row has four holes, with three in the row above. Possibly had rows above this but has possibly been rebuilt removing any evidence of them. Fleece Inn marked on 25" OS map. | Good | Building neglect | |

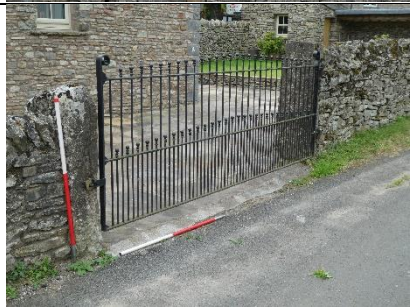
| Feature No. | Feature Type | Description | Condition | Threats | Photograph |
|---|---|---|---|---|---|
| C054 | Gate Stoops (Pair) | Pair of limestone gate stoops with roughly rounded tops at entrance to driveway to private house. Left stoop has broken metal hinge and metal eye (used to secure modern gates) on the front face; right stoop has metal hinges on the front face with metal gate attached. | Good | Vehicles; erosion | |

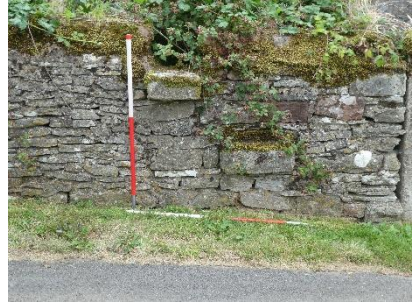
| Feature No. | Feature Type | Description | Condition | Threats | Photograph |
|---|---|---|---|---|---|
| C055 | Step Stile | Step stile built into wall leading into farm yard (for private use). First step is limestone with metal leaded into the end (use not clear). Top step creating crossing point is concrete. | Fair | Vegetation | |

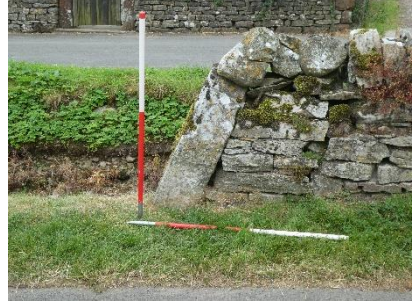
| Feature No. | Feature Type | Description | Condition | Threats | Photograph |
|---|---|---|---|---|---|
| C056 | Gate Stoop (Single) | Single limestone gate stoop tapers to a point at the top, with a hinge on the south side projecting into a small section of wall (of unknown purpose) at an angle/misaligned. Use of stoop unknown. Stoop possibly connected to the bottom step of stile opposite (C055). Stoop on opposite side of wall section is C057 (photos of wider location included in folder, nothing shown on historic mapping). | Fair | Vehicles | |

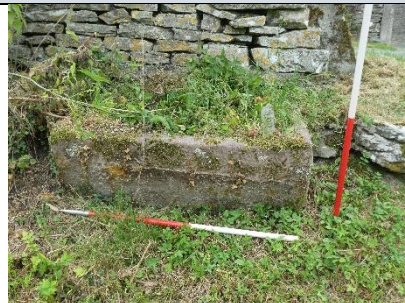
| Feature No. | Feature Type | Description | Condition | Threats | Photograph |
|---|---|---|---|---|---|
| C058 | Trough | Sandstone trough located behind short wall section on the bank of Crosby Garrett Beck, tooling marks are visible on the side. Not clear why the trough has been re-positioned here. | Good | Vegetation; flooding | |

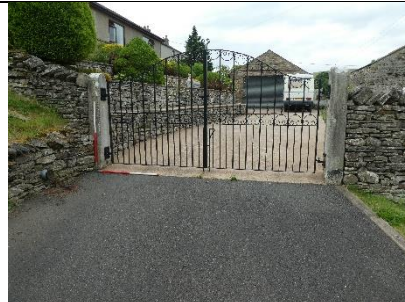
| Feature No. | Feature Type | Description | Condition | Threats | Photograph |
|---|---|---|---|---|---|
| C059 | Gate Stoops (Pair) | Pair of limestone gate stoops with rounded tops and shoulders outside driveway to Rock Dene (private residence). | Good | Vehicles | |

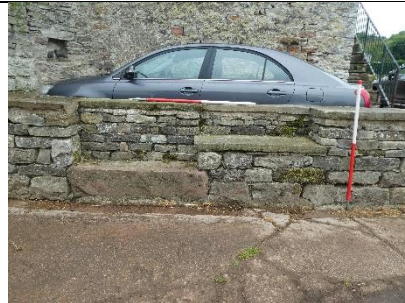
| Feature No. | Feature Type | Description | Condition | Threats | Photograph |
|---|---|---|---|---|---|
| C060 | Mounting Block | Two steps of different sizes, one limestone, one sandstone, built into wall and currently used as a mounting block. Possibly associated with farmhouse (MYD65619) and farmstead (MYD66005). It is an unusual form for a mounting block (along with its location directly onto the road) and might have originally been a bink (bench-form of churn stand). | Good | Vehicles; removal | |

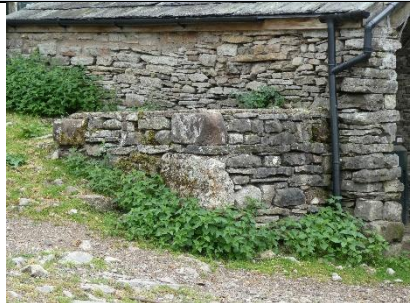
| Feature No. | Feature Type | Description | Condition | Threats | Photograph |
|---|---|---|---|---|---|
| C061 | Churn Stand | Churn stand built into bank at rear of barn close to the cart entrance. Possibly for domestic use as not directly on roadside. | Good | Vehicles | |

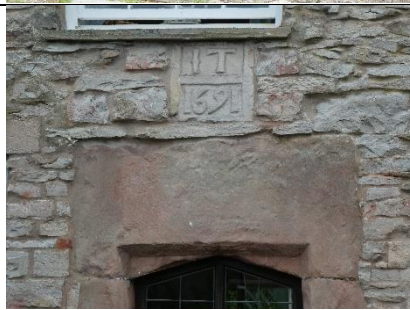
| Feature No. | Feature Type | Description | Condition | Threats | Photograph |
|---|---|---|---|---|---|
| C062a | Date Stone | Square sandstone date stone with relief carving of "IT 1691" (IT = John Taylor) situated above former doorway (now window) of house. Possibly associated with the date stone C006d. | Good | Erosion | |

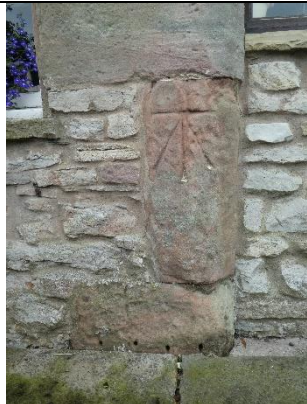
| Feature No. | Feature Type | Description | Condition | Threats | Photograph |
|---|---|---|---|---|---|
| C062b | OS Bench Mark | OS Bench mark marked on 6" and 25" OS maps, carved onto quoin located on the left side of former door (now window) of house. | Good | Erosion | |

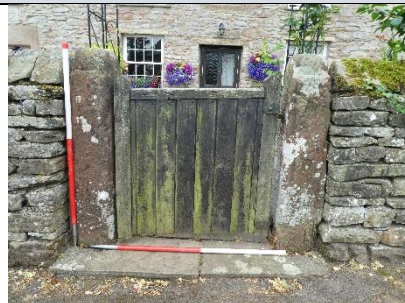
| Feature No. | Feature Type | Description | Condition | Threats | Photograph |
|---|---|---|---|---|---|
| C062c | Gate Stoops (Pair) | Pair of sandstone gate stoops with shoulders and rounded tops at entrance to private garden garden. Left stoop has metal hinge on the rear face and hole for modern gate bolt on inside face; right stoop has two hinges with gate attached on the inside face. | Good | Erosion | |

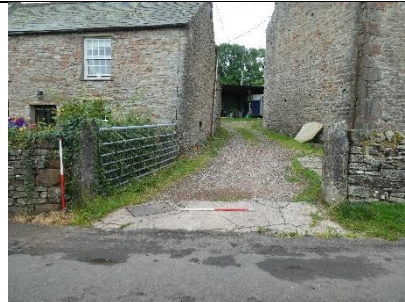
| Feature No. | Feature Type | Description | Condition | Threats | Photograph |
|---|---|---|---|---|---|
| C063 | Gate Stoops (Pair) | Pair of limestone gate stoops at entrance to farmyard track. Left stoop has two hinges on rear face with modern gate attached. Right stoop is broken at the top and has broken metal attachment on rear face and broken metal bolt on inside face. | Good | Vegetation; erosion; vehicles | |

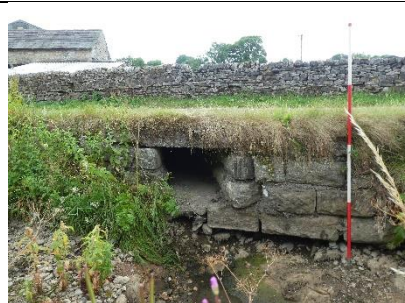
| Feature No. | Feature Type | Description | Condition | Threats | Photograph |
|---|---|---|---|---|---|
| C064 | Culvert | Culvert in west side of mixed limestone and sandstone river-bank revetment, has concrete top/lintel. Culvert goes under road. | Good | Vegetation; flooding | |

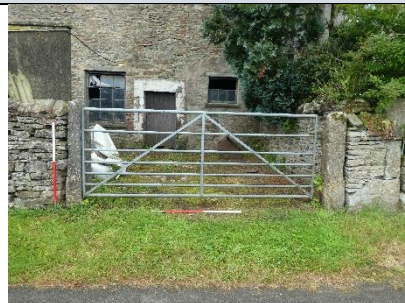
| Feature No. | Feature Type | Description | Condition | Threats | Photograph |
|---|---|---|---|---|---|
| C065 | Gate Stoops (Pair) | Pair of limestone gate stoops. Left stoop has metal gate catch on inside face; right stoop has two metal hinges with modern gate attached. Located at entrance to an old barn (MYD70153). | Good | Erosion; vehicles; removal | |

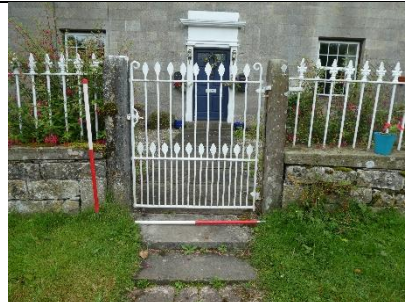
| Feature No. | Feature Type | Description | Condition | Threats | Photograph |
|---|---|---|---|---|---|
| C066 | Gate Stoops (Pair) | Pair of gate stoops, both have rounded tops and shoulders. Left stoop is limestone with gate catch on the inside face and cracking leading from this. Right stoop is sandstone with two iron hinges on the inside face, stoop has bracket around the top linking the stoop to the iron railings, bracket and railings painted white. Stoops outside of private residence (MYD66003). | Good | Erosion | |

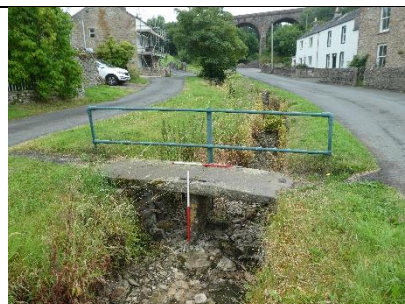
| Feature No. | Feature Type | Description | Condition | Threats | Photograph |
|---|---|---|---|---|---|
| C067 | Clapper bridge | Clapper bridge over Crosby Garrett Beck made up of two sandstone slabs with metal staples in the centre. Limestone upright beneath the slabs acting as support. Stone revetment on west side carrying on past bridge, some revetment on east side but limited to bridge area. Modern metal railings painted green on one side. Bridge not shown on historic mapping. | Good | Flooding | |

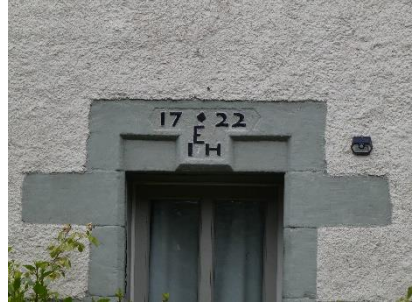
| Feature No. | Feature Type | Description | Condition | Threats | Photograph |
|---|---|---|---|---|---|
| C068 | Date Stone | Lintel and quoins painted green, date in the middle of the lintel with letters in a triangular formation below it. Date and letters "17[diamond] 22 I <sup>E</sup> H" painted black. This style of date stone is extremely common in Lancashire, but can also be found in Cumbria and Yorkshire. | Good | Erosion | |

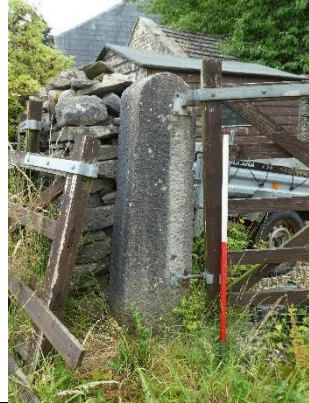
| Feature No. | Feature Type | Description | Condition | Threats | Photograph |
|---|---|---|---|---|---|
| C069 | Gate Stoop (Single) | Single limestone gate stoop with rounded top on the left side of gateway leading to farm (MYD66509). The stoop is tapered with two hinge plates attached to inside face, modern gate attached. | Good | Erosion; removal; vehicles | |

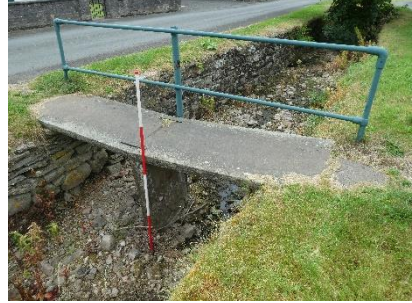
| Feature No. | Feature Type | Description | Condition | Threats | Photograph |
|---|---|---|---|---|---|
| C070 | Clapper Bridge | Footbridge shown on historic 6" and 25" OS map. Two sandstone slabs with staples in the centre across Crosby Garrett Beck, with a sandstone upright in the centre and concrete around the base. One sandstone slab on the east side of the bridge, and stone abutments on either side of the bank. Modern metal railings painted green now rusted and corroded. | Good | Flooding | |

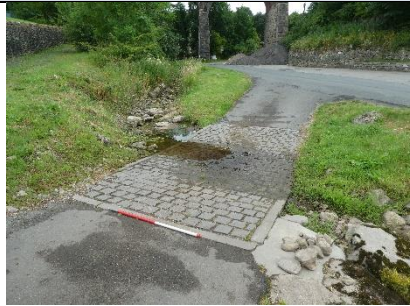
| Feature No. | Feature Type | Description | Condition | Threats | Photograph |
|---|---|---|---|---|---|
| C071 | Ford | Ford through Crosby Garrett Beck, recently set with modern granite stone-sets and curbing. Ford not shown on historic mapping. | Good | Flooding; vehicles | |

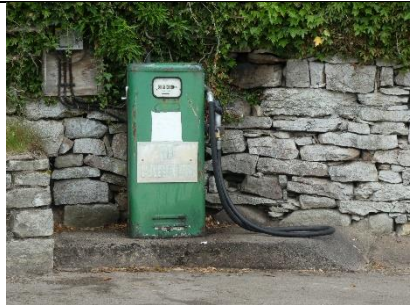
| Feature No. | Feature Type | Description | Condition | Threats | Photograph |
|---|---|---|---|---|---|
| C072a | Fuel Pump | Old green metal fuel pump (Tokheim 93XA Commercial Pump) with rubber hose on a concrete plinth, part of Handley's Lorry Yard recessed into wall on the south-west side of yard and still in use. | Good | Removal; vehicles | |
