# Small-Scale Heritage Features Survey

Technical Report: Crosby Garrett  
November 2023

WESTMORLAND DALES

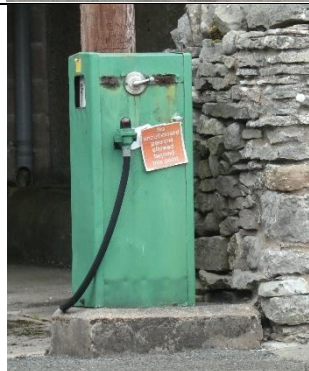
| Feature No. | Feature Type | Description | Condition | Threats | Photograph |
|---|---|---|---|---|---|
| C072b | Fuel Pump | Old green metal fuel pump with rubber hose, sitting on a concrete plinth on north side of Handley's Lorry Yard near the back. Pump still in use. | Good | Removal; vehicles | |

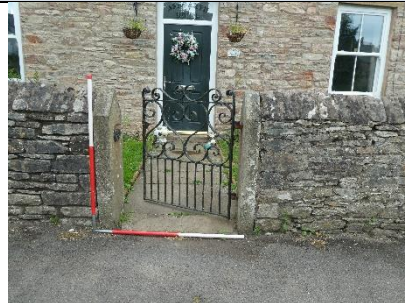
| Feature No. | Feature Type | Description | Condition | Threats | Photograph |
|---|---|---|---|---|---|
| C073 | Gate Stoops (Pair) | Pair of sandstone gate stoops with triangular pointed tops which match the wall coping. Left stoop has metal catch with groove on the inside face; right stoop has two metal hinges on the inside face with metal gate attached. Stoops located at front entrance to private house (MYD66002). | Good | Erosion; vehicles | |

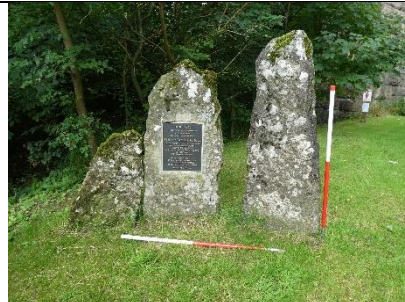
| Feature No. | Feature Type | Description | Condition | Threats | Photograph |
|---|---|---|---|---|---|
| C074 | Memorial | Memorial for the Settle-Carlisle Railway Workers and their families created from three gate stoops donated by local villagers, erected in 2019. The left stoop is the smallest, middle stoop has a metal plaque with a dedication fixed to the front, with an old iron gate catch above it; the right stoop has a hinge attachment on the west face and crack in the top which has been leaded in. The plaque on centre stoop reads "1870-1876 These retired stoops commemorate all those who died during the construction of the settle to Carlisle railway. Thirteen children, five women and twelve men area buried in unmarked graves in Crosby Garrett churchyard. A stone stoop (C031) has now been placed there to honour them. This railway is their legacy.<br><i>"All by myself I have to go,<br/>With none to tell me what to do –<br/>All alone besides the stream<br/>And up the mountains of dreams"</i><br>Robert Louis Stephenson." | Good | Removal | |

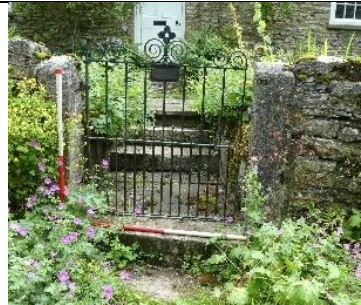
| Feature No. | Feature Type | Description | Condition | Threats | Photograph |
|---|---|---|---|---|---|
| C076 | Gate Stoops (Pair) | Pair of limestone gate stoops which taper with rounded tops. Left stoop has two hinges on the inside face, right stoop has a gate catch on the inside face. Located at entrance to front garden of private residence (MYD66001). | Good | Vegetation | |

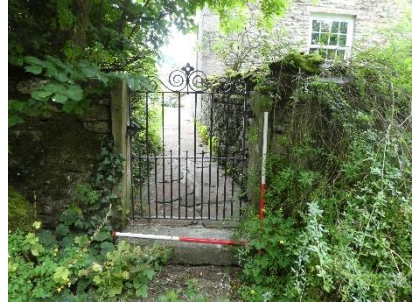
| Feature No. | Feature Type | Description | Condition | Threats | Photograph |
|---|---|---|---|---|---|
| C077 | Gate Stoops (Pair) | Pair of sandstone gate stoops with flat tops leading to private garden. Left stoop has a gate catch on the inside face and one leaded hole. Right stoop has two hinges and one disused hole. Located at side, giving access to rear of private house. | Good | Vegetation | |

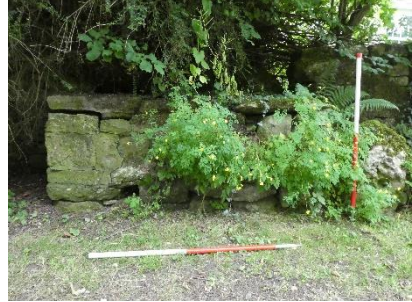
| Feature No. | Feature Type | Description | Condition | Threats | Photograph |
|---|---|---|---|---|---|
| C078 | Churn Stand | Churn stand associated with farmstead (MYD66001) made from a mixture of limestone and sandstone with some mortar in place. No concrete top. Churn stand recessed into wall on the right side. In poor condition with cracking and obscured by vegetation. | Poor | Vegetation; collapse; neglect | |

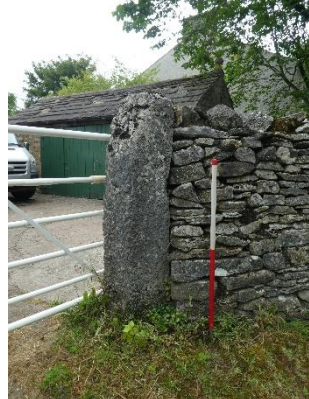
| Feature No. | Feature Type | Description | Condition | Threats | Photograph |
|---|---|---|---|---|---|
| C079 | Gate Stoop (Single) | Single limestone gate stoop at entrance to farmyard on right side of gateway. Stoop is broken at the top. Two painted hinges on the rear face with metal gate attached. | Good | Vehicles; erosion | |

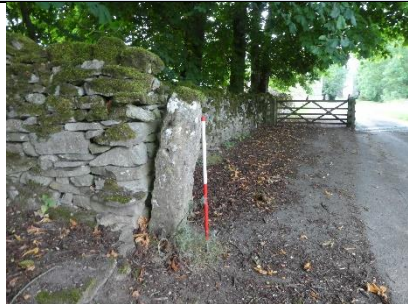
| Feature No. | Feature Type | Description | Condition | Threats | Photograph |
|---|---|---|---|---|---|
| C080 | Gate Stoop (Single) | Single limestone gate stoop. Located on west side of road/track leading to the fell – possibly remains of old fell gate (shown on the historic 6" and 25" maps). Two hinges on the north face of stoop, one hole located below the top hinge and one hole located above base hinge. Stoop now set at an angle. Historic mapping possibly shows a gate/wall in the same location going across the track. | Good | Erosion; vehicles; removal | |

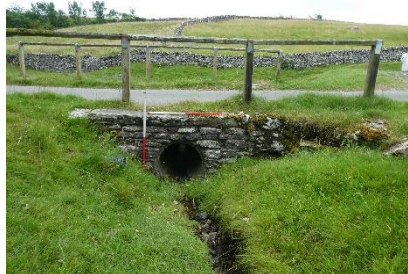
| Feature No. | Feature Type | Description | Condition | Threats | Photograph |
|---|---|---|---|---|---|
| C081 | Culvert | Concrete pipe set into limestone revetment running straight under the road/track leading to the fell. Probably used to direct run-off water from the fells. East revetment wall smaller than the west. | Good | Flooding | |

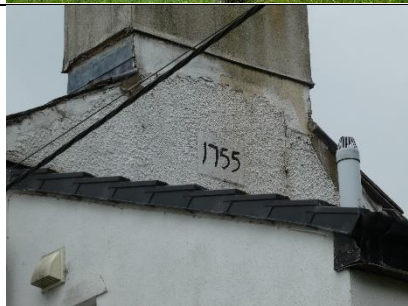
| Feature No. | Feature Type | Description | Condition | Threats | Photograph |
|---|---|---|---|---|---|
| C082 | Date Stone | Gill Cottage marked on the 2nd edition OS maps. A date stone painted white with "1755" engraved on it and painted black is located on the chimney stack of the north gable end of Gill Cottage, above outshot. Gable end of building covered in white render, date stone also painted white, with the date painted black. | Good | Erosion; removal | |

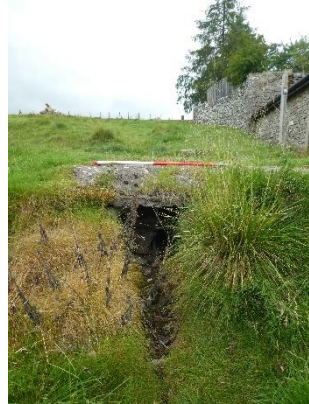
| Feature No. | Feature Type | Description | Condition | Threats | Photograph |
|---|---|---|---|---|---|
| C083 | Culvert | Culvert is stone lined and runs west-east under road, probably for the run-off from the fell. East side larger than the west. | Good | Flooding | |

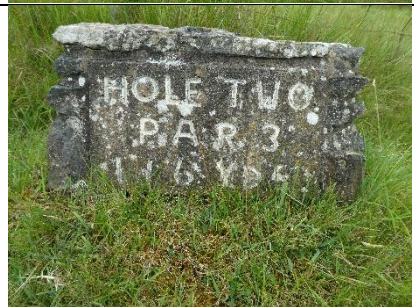
| Feature No. | Feature Type | Description | Condition | Threats | Photograph |
|---|---|---|---|---|---|
| C085 | Golf Course | A sandstone block with plaque inscribed with "HOLE TWO PAR 3 116 YDS" (yards)" wording painted white. Block located on the fell, close to an enclosed area. This is part of the remains of golf course created in the 1970s by the local community/village, remains of the golf course are reportedly still visible across Crosby Garrett Fell. | Fair | Removal | |

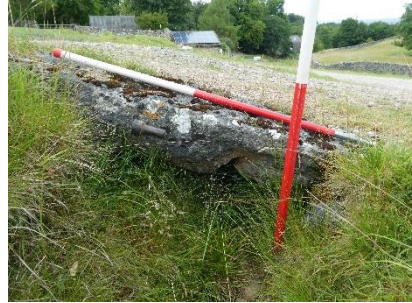
| Feature No. | Feature Type | Description | Condition | Threats | Photograph |
|---|---|---|---|---|---|
| C086 | Culvert | Culvert leading under trackway from the fell, probably for water run-off. South side lintel is reused gate stoop with one metal hinge still visible. North side has concrete pipe. | Good | Erosion; flooding | |

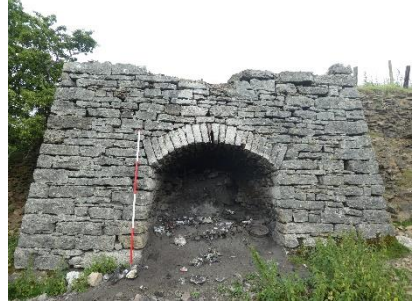
| Feature No. | Feature Type | Description | Condition | Threats | Photograph |
|---|---|---|---|---|---|
| C087a | Lime Kiln | “Old Limekiln” marked on the 25” OS map. West facing lime kiln. The back of the kiln has fallen through, with the top degrading. Tree on the north side is causing damage. Kiln has been used to burn modern waste/fly tipping. Associated quarrying also visible and included in wider photos. | Poor | Erosion; neglect; vegetation | |

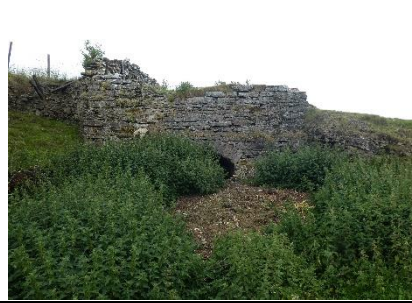
| Feature No. | Feature Type | Description | Condition | Threats | Photograph |
|---|---|---|---|---|---|
| C087b | Lime Kiln | “Old Limekiln” marked on the 25” OS map. North facing lime kiln built into bank, in seemingly better condition than C087a. The draw face is partially blocked by vegetation with some crumbling of material on top. Associated quarrying also visible and included in wider photos. | Fair | Erosion; neglect; vegetation | |

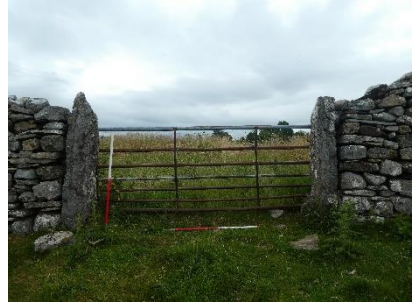
| Feature No. | Feature Type | Description | Condition | Threats | Photograph |
|---|---|---|---|---|---|
| C088 | Gate Stoops (Pair) | Two limestone gate stoops on gateway leading out onto the fells, with the land to the east of the gate improved land. Left stoop has one hole on the inside face; the right stoop has broken metal hinge at the top and one hinge at the base. Metal gate in situ and held to the stoops by barbed wire. | Good | Erosion; vehicles | |

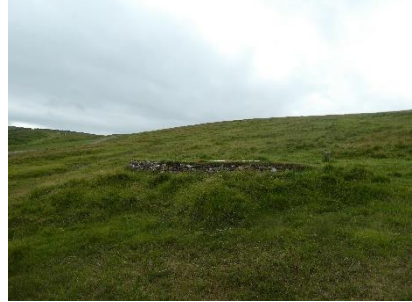
| Feature No. | Feature Type | Description | Condition | Threats | Photograph |
|---|---|---|---|---|---|
| C089 | Unknown | Semi-levelled platform created from mixed limestone and sandstone revetment built into the side of the fell used to create "golfing greens". Some stone missing from revetment sides. | Good | Vegetation; livestock | |

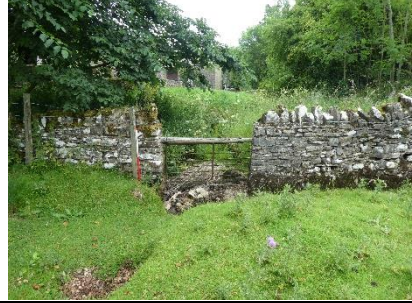
| Feature No. | Feature Type | Description | Condition | Threats | Photograph |
|---|---|---|---|---|---|
| C090 | Water Gate | Water gate built into fell wall, for water run-off leading to Crosby Garrett Beck. Reused iron field gate acting as sluice gate and attached to wooden pole. Pole built into wall heads on either side of opening, wall a mixture of limestone and sandstone. Gate shown on historic OS map, with first edition 6" map labels a weir in this area. | Good | Flooding; erosion; vegetation | |

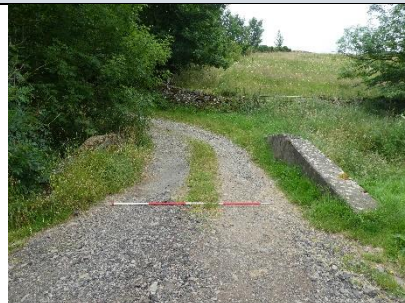
| Feature No. | Feature Type | Description | Condition | Threats | Photograph |
|---|---|---|---|---|---|
| C091 | Bridge | Bridge shown on historic 6" and 25" OS maps with stone lined culvert underneath. South side has large opening, with stone walls channelling the water. North side mostly covered in vegetation. Trackway running over bridge, bridge parapets made from modern concrete designed to fit together. | Good | Vegetation | |

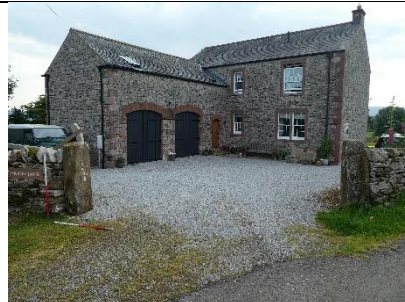
| Feature No. | Feature Type | Description | Condition | Threats | Photograph |
|---|---|---|---|---|---|
| C092a | Gate Stoops (Pair) | Pair of sandstone gate stoops. Left stoop has two hinges, right stoop has two cemented hinges and one leaded hinge. Stoops probably new/reused as the OS bench mark (located on left stoop, inside face C092b) is not on historic maps. | Good | Vehicles; erosion | |
| C092b | OS Bench Mark | OS bench mark located on the inside face of left stoop on driveway to Long Acre House. Stoops probably new/reused as the bench mark is not shown on historic OS maps. | Good | Vehicles; erosion | |

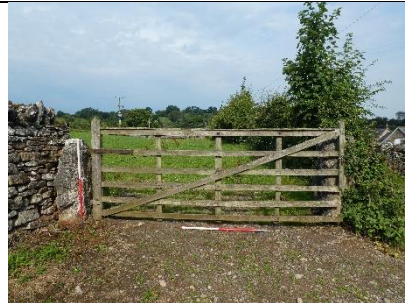
| Feature No. | Feature Type | Description | Condition | Threats | Photograph |
|---|---|---|---|---|---|
| C093 | Gate Stoops (Pair) | Pair of limestone gate stoops roughly cut, leading to fields from probable former back lane (see historic OS maps). Left side has two hinges and one hole on inside face. Wooden gate attached. Right stoop possibly has a gate catch on the inside face. | Good | Erosion; vehicles | |

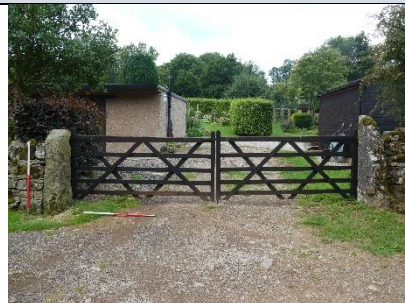
| Feature No. | Feature Type | Description | Condition | Threats | Photograph |
|---|---|---|---|---|---|
| C094 | Gate Stoops (Pair) | Pair of gate stoops, left stoop is sandstone with two hinges on rear face. Right stoop is limestone and in a triangular shape, roughly cut with two hinges on the rear face. Newer wooden gates attached. Gateway leading to private garden, was former fields (see historic OS maps). | Good | Vehicles; erosion | |

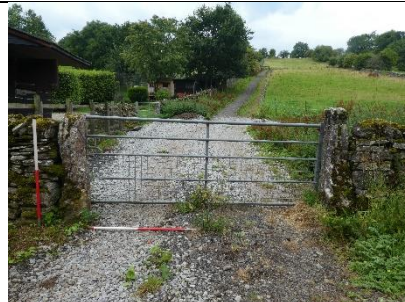
| Feature No. | Feature Type | Description | Condition | Threats | Photograph |
|---|---|---|---|---|---|
| C095 | Gate Stoops (Pair) | Pair of limestone gate stoops leading to fields. Left stoop has gate catch on rear face. Right stoop has two hinges on rear face, with metal gates attached and barbed wire around the top. | Good | Erosion; vehicles | |

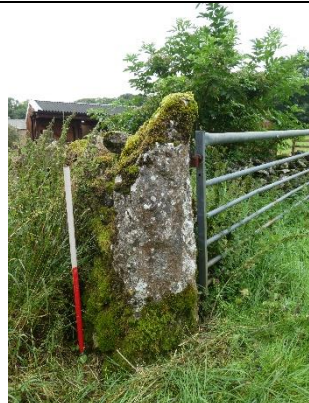
| Feature No. | Feature Type | Description | Condition | Threats | Photograph |
|---|---|---|---|---|---|
| C096 | Gate Stoop (Single) | Single limestone gate stoop located on the left side of field entrance, two leaded hinges on the rear face. | Good | Vegetation; erosion; vehicles | |

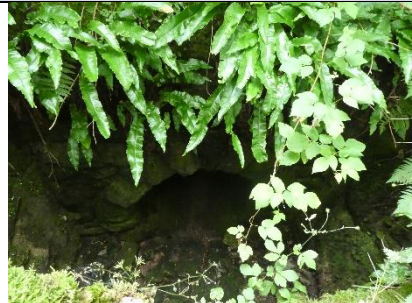
| Feature No. | Feature Type | Description | Condition | Threats | Photograph |
|---|---|---|---|---|---|
| C097 | Culvert | Very large culvert located in the base of the railway embankment below ground level, with a revetment wall at back. Arch visible on the front and shows signs of rustication on key stone. Culvert seems to lead under the railway. Metal railings out the front for safety(?). | Fair | Vegetation; flooding; erosion | |

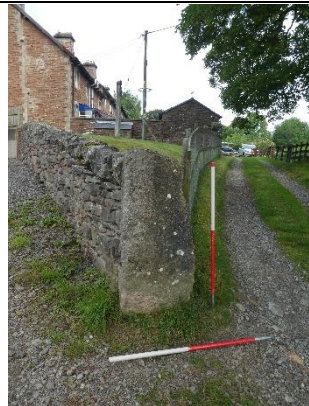
| Feature No. | Feature Type | Description | Condition | Threats | Photograph |
|---|---|---|---|---|---|
| C098 | Gate Stoop (Single) | Single roughly cut rectangular granite(?) gate stoop with concrete on the top. Located on the wall end of a private garden/driveway leading to railway cottages. Two leaded hinges near the base. | Good | Vehicles; removal; erosion | |

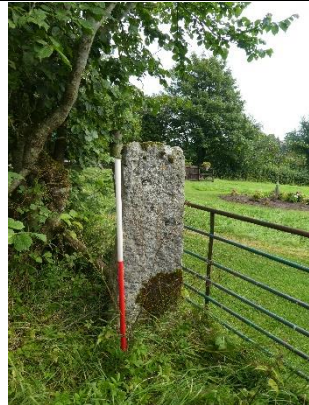
| Feature No. | Feature Type | Description | Condition | Threats | Photograph |
|---|---|---|---|---|---|
| C099a | Gate Stoop (Single) | Limestone gate stoop with flat top located on the left side of left gateway between private garden (former field?) and the former back lane. Stoop has metal eye bolted into the inside face. | Good | Removal; erosion | |

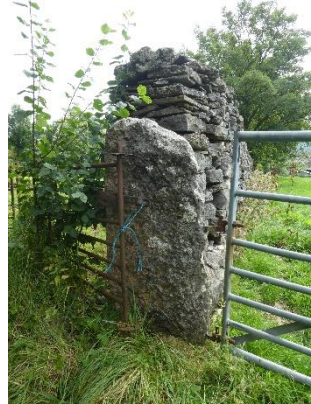
| Feature No. | Feature Type | Description | Condition | Threats | Photograph |
|---|---|---|---|---|---|
| C099b | Gate Stoop (Single) | Rough block of limestone gate stoop located between two gateways on the former back lane. Stoop has two hinges on the front face and two hinges on the right side with gate attached. | Good | Removal; erosion | |

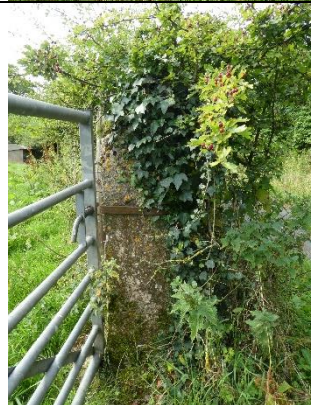
| Feature No. | Feature Type | Description | Condition | Threats | Photograph |
|---|---|---|---|---|---|
| C099c | Gate Stoop (Single) | Limestone gate stoop located on the right side of right gateway between the former back lane and fields. Stoop has a metal band around the top which holds a gate catch in place that the modern gate uses. A disused hole is located on the inside face of the stoop | Good | Removal erosion | |

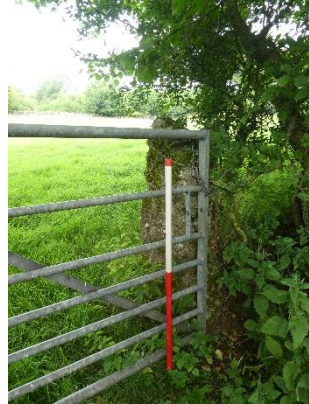
| Feature No. | Feature Type | Description | Condition | Threats | Photograph |
|---|---|---|---|---|---|
| C100 | Gate Stoop (Single) | Single roughly cut gate stoop on right side of gateway to fields. One hole on the inside face, with metal eye and chain on the front face. Modern metal gate held in situ by barbed wire that the gate attaches to. Metal post on the left side. | Good | Vegetation; erosion; removal | |

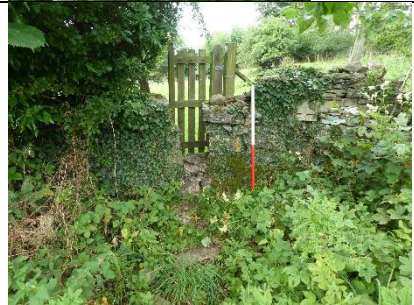
| Feature No. | Feature Type | Description | Condition | Threats | Photograph |
|---|---|---|---|---|---|
| C101 | Squeeze Stile | Limestone squeeze stile with wooden gate on the west side; with two stone steps leading to the crossing point on the east side. Only the wall immediately surrounding the stile is still present as a hedgerow now grows on either side. | Fair | Erosion; vegetation; wall collapse; removal | |

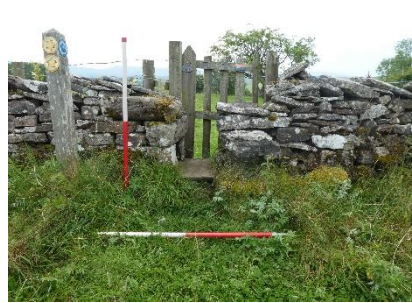
| Feature No. | Feature Type | Description | Condition | Threats | Photograph |
|---|---|---|---|---|---|
| C103 | Squeeze Stile | Mixed limestone and sandstone squeeze stile with step up on one side built into drystone wall, wooden gate and fencing on one side. | Good | Erosion; collapse | |

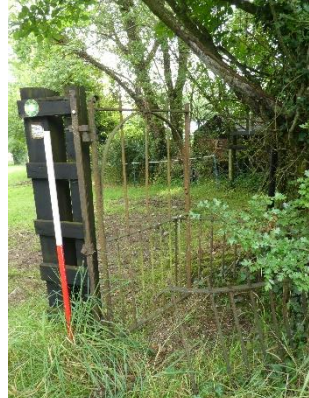
| Feature No. | Feature Type | Description | Condition | Threats | Photograph |
|---|---|---|---|---|---|
| C104 | Kissing Gate | Metal kissing gate in a half round style, located on public right of way leading to the back of the Old Smithy (MYD66008). Railings have been cut/damaged and removed. | Fair | Removal; erosion | |

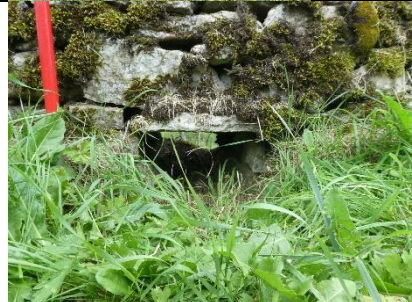
| Feature No. | Feature Type | Description | Condition | Threats | Photograph |
|---|---|---|---|---|---|
| C105a | Water Smoot | Water smoot in limestone wall with lintel, probably for water run-off from road. | Good | Erosion; flooding; wall collapse | |

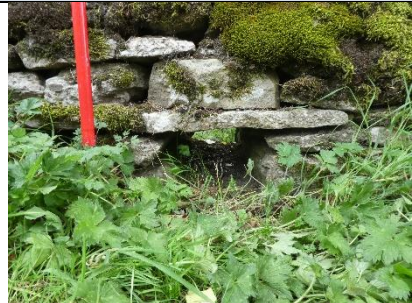
| Feature No. | Feature Type | Description | Condition | Threats | Photograph |
|---|---|---|---|---|---|
| C105b | Water Smoot | Water smoot in limestone wall with lintel, probably for water run-off from road. | Good | Erosion; flooding; wall collapse | |
